Engineering Failure Analysis 13 (2006) 1116–1125

# Fatigue failure of a helical gear in a gearbox

This paper presents a failure analysis of a helical gear used in gearbox of a bus, which is made from AISI 8620 steel. The helical gear had been in service about three years when several teeth failed. The failed helical gear had a number of adjacent teeth and random teeth breakage at one end of teeth. An evaluation of the failed helical gear was undertaken to assess its integrity that included a visual examination, photo documentation, chemical analysis, micro-hardness measurement, and metallographic examination. The failure zones were examined with the help of a scanning electron microscope equipped with EDX facility. Results indicate that teeth of the helical gear failed by fatigue with a fatigue crack initiation from destructive pitting and spalling region at one end of tooth in the vicinity of the pitch line because of misalignment.

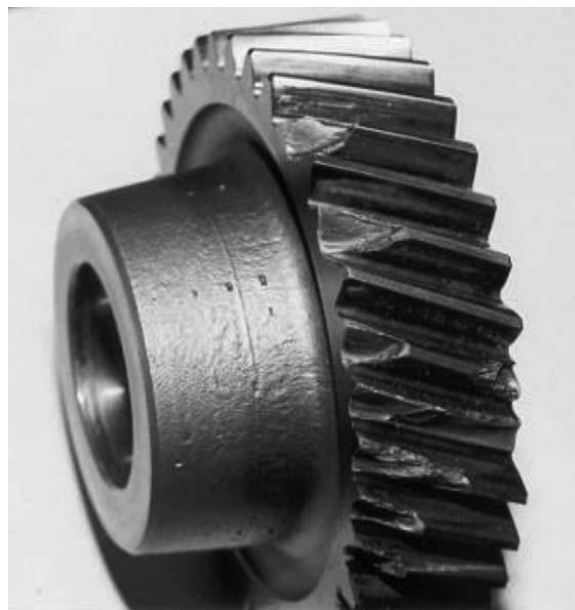
Fig. 1. General appearance of the failed helical gear.

Visual examination of the failed helical gear showed that a number of adjacent teeth and random teeth failed by fatigue, as shown in Fig. 1. Typical macro-fracture appearance of the failed helical gear tooth is shown in Fig. 6. The fracture surface presents typical features of fatigue failure. Similar fracture appearance was also observed on the other fracture surface of the gear teeth. A triangular piece of the gear teeth had broken off like large chips at one end of teeth. These pieces are as wide as one-third of the face width. The fracture surface of the tooth exhibits a distinct crack initiation site (indicated white arrow) and progressive

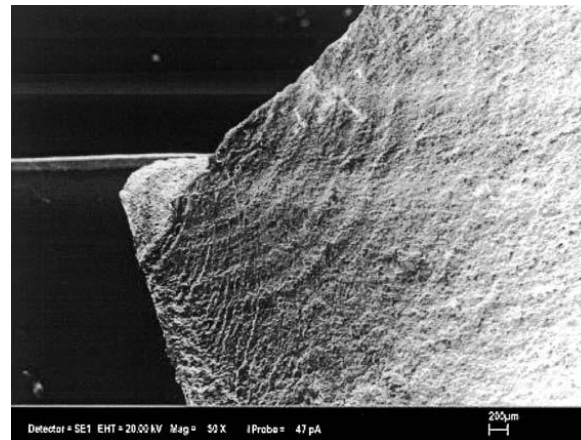
The fractured surfaces and tooth surface of the failed helical gear were examined with the help of a scanning electron microscope (SEM) in order to identify the cause of fatigue crack initiation and propagation. Fig. 8 shows crack initiation and propagation region. Beach marks can be observed clearly on the fracture surface, which is a typical feature of fatigue failure [3]. Beach marks indicate that the fatigue crack penetrated a large portion of the tooth before a piece broke off. The fracture surface is characteristic of a high cycle fatigue failure. River-like pattern could be seen in the propagation zone, which is a typical feature of fatigue failure, as shown in Fig. 9.

Fig. 8. SEM micrograph showing the crack initiation and propagation region.

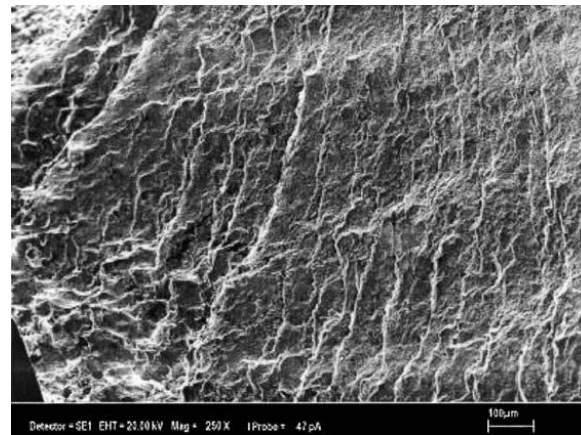
Fig. 9. SEM micrograph showing typical brittle fracture observed in the crack propagation region.

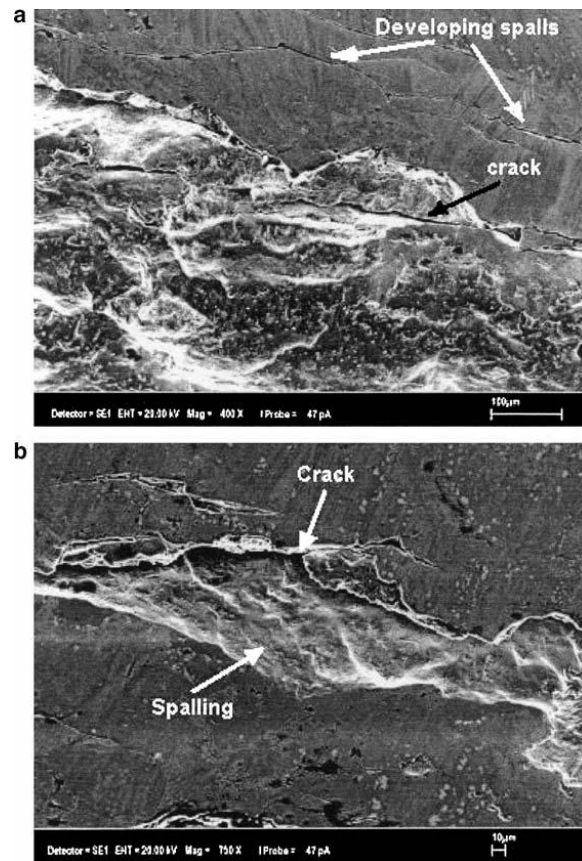
SEM examination indicated that although there were destructive pitting and spalling area on the active side of the gear tooth in the area of the pitch line (Fig. 10), there was micropitting in some areas in the dedendum section of the gear tooth (Fig. 11). The area immediately above or below the pitch line is very susceptible to pitting. Not only is the rolling pressure great at this point but sliding is now a real factor [1]. Spalling regions and fatigue cracks initiation sites from spalling region at the pitch line of the failed helical gear tooth can be seen clearly, as shown in Fig. 10. In addition, Fig. 10(a) shows top view of developing spalls in the vicinity of the pitch line.

Fig. 10. SEM micrograph showing two damaged area at the pitch line at the different magnification. Note, spalling areas containing cracks and developing spalls in the vicinity of pitch line.

SEM analysis showed that the destructive pitting and spalling area are located in the vicinity of the pitch line. Fatigue cracks originated from these damaged areas and propagated subsurface. In other words, it was proved that the tooth fracture is caused by destructive pitting and spalling and does not involve other damage processes. Why, in this situation, did destructive pitting and spalling occur along pitch line? Once the contact point moves into the vicinity of the pitch line, the number of gear pairs in contact becomes minimal, so that the normal Hertzian contact stresses is maximum on this region. Surface contact fatigue can occur when two surfaces slide against each other under high contact pressure and cyclic loading. This mode of failure leads to crack initiation at or near the contact surface, and may subsequently lead to damage varying in extent from microscopic pitting to severe spalling. Pitting is usually caused by gear tooth surfaces not properly conforming to each other or not fitting together properly. This can be a result of minor involute errors or local surface irregularities, but most often it occurs because there is not proper alignment across the full face width of the gear mesh [1,3].
