Engineering Failure Analysis 13 (2006) 1116–1125

# Fatigue failure of a helical gear in a gearbox

This paper presents a failure analysis of a helical gear used in gearbox of a bus, which is made from AISI 8620 steel. The helical gear had been in service about three years when several teeth failed. The failed helical gear had a number of adjacent teeth and random teeth breakage at one end of teeth. An evaluation of the failed helical gear was undertaken to assess its integrity that included a visual examination, photo documentation, chemical analysis, micro-hardness measurement, and metallographic examination. The failure zones were examined with the help of a scanning electron microscope equipped with EDX facility. Results indicate that teeth of the helical gear failed by fatigue with a fatigue crack initiation from destructive pitting and spalling region at one end of tooth in the vicinity of the pitch line because of misalignment.

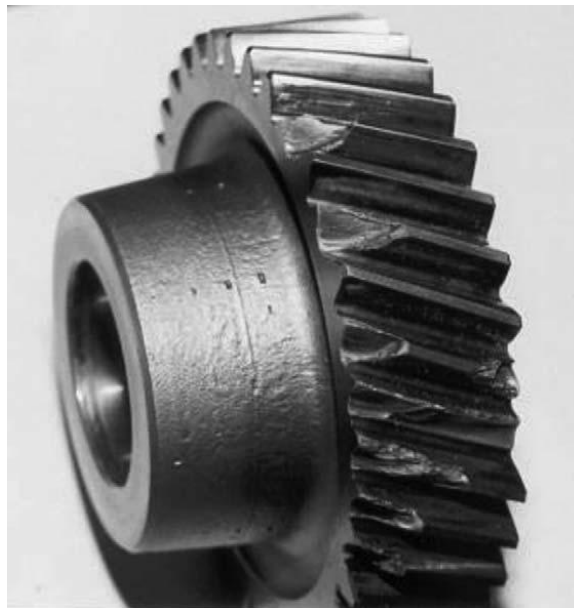
Fig. 1. General appearance of the failed helical gear.

general appearance of the failed helical gear is shown in Fig. 1. The helical gear, fourth speed drive gear, had been in service about 3 years when several teeth failed. The bus has six-speed gearbox and 275 kW at 2200 rpm engine power. The basic data of the failed helical gear is given in Table 1. For convenience, relevant nomenclature of a helical gear is shown in Fig. 2.

Visual examination of the failed helical gear showed that a number of adjacent teeth and random teeth failed by fatigue, as shown in Fig. 1. Typical macro-fracture appearance of the failed helical gear tooth is shown in Fig. 6. The fracture surface presents typical features of fatigue failure. Similar fracture appearance was also observed on the other fracture surface of the gear teeth. A triangular piece of the gear teeth had broken off like large chips at one end of teeth. These pieces are as wide as one-third of the face width. The fracture surface of the tooth exhibits a distinct crack initiation site (indicated white arrow) and progressive

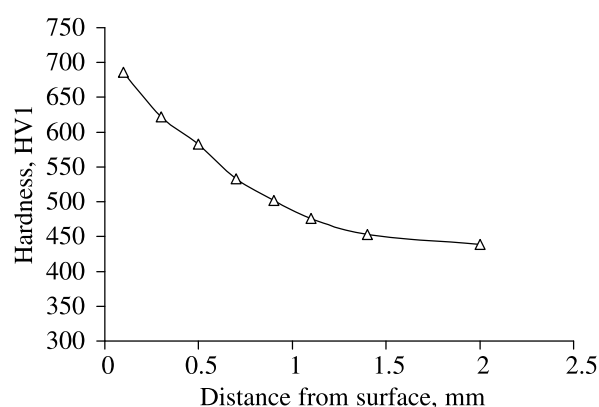
chemical composition. Spectrum analysis and micro-hardness measurement revealed that the failed helical gear material was AISI 8620 steel as carburised, which is usually used for gears in the surface-hardened conditions. The micro-hardness distribution across the helical gear tooth thickness at the pitch line was measured using a Vickers hardness tester with 1 kg load, and the results are given in Fig. 3. Also, the core and surface hardness were measured to be 439 and 686 HV, respectively. The carburized case depth was found to be about 0.63 mm. Carburized case depth is defined as the depth from surface where hardness reaches a value of 550 HV.

Fig. 3. Hardness distribution across the helical gear tooth thickness at the pitch line.

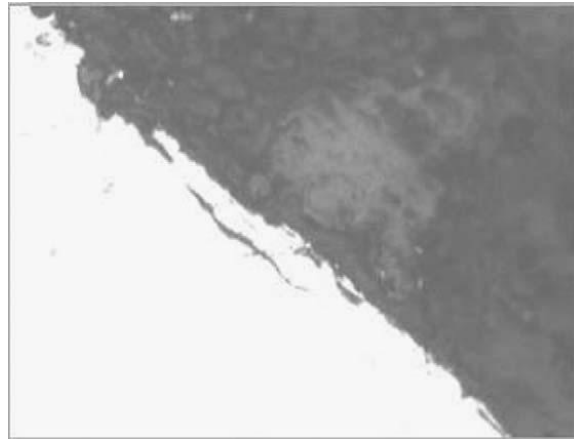
A specimen from the pitted area of one gear tooth was metallographically prepared and observed in an optical microscope in both unetched and etched condition. In the unetched condition, significant fatigue cracks were observed at the pitch line region due to destructive pitting or spalling, as shown in Fig. 4. This crack orientation was typical of all the significant cracks observed. Optical microscopy view of case microstructure of the failed helical gear tooth after etching with Nital solution is shown in Fig. 5. As shown, the case microstructures consist of martensite (which appears dark) and retained austenite (which appears white). This is typical of case hardened steel. No abnormality was observed in the microstructure.

Fig. 4. Unetched metallographic cross section through gear tooth showing typical fatigue crack formed by pitting at the pitch line.

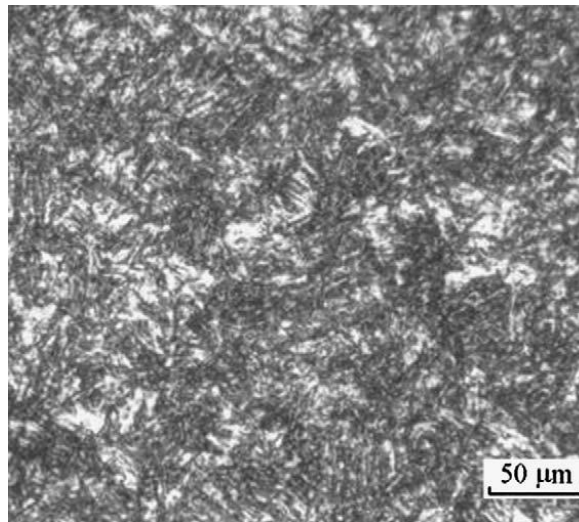
Fig. 5. Microstructure of the tooth showing a mixture of martensite and retained austenite.

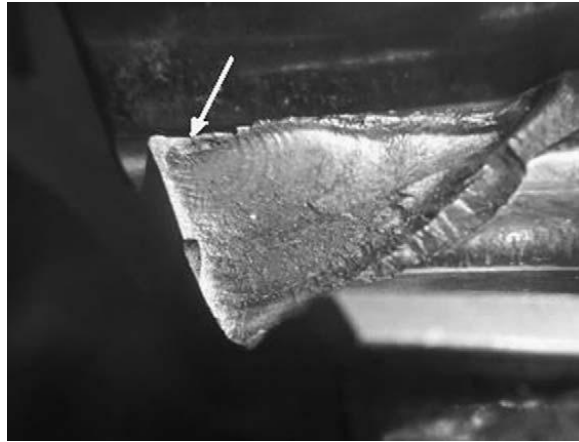
flat fatigue fracture region, and the final fracture region. The crack initiation region and beach marks could be seen clearly with naked eye. The origin of the crack was at the pitch line region close to one end of the teeth. In all cases, the crack initiation sites were close to one end of the gear teeth, suggesting that the loads were highest in this region. This implies that there was incorrect contact between the gear teeth, possibly resulting from misalignment. The origin of the crack was surrounded by curved beach marks. Also, the fracture surface at the fatigue region had a smooth appearance with a rippled beach mark pattern. Visual inspection indicated that fatigue had initiated at the pitch line region and had grown out towards the roots of the teeth. A small area has a rough, jagged look where the last portion of the tooth broke away. No corrosion media were found on fracture surfaces.

Fig. 6. Higher magnification photograph of the fracture surface of the failed helical gear tooth.

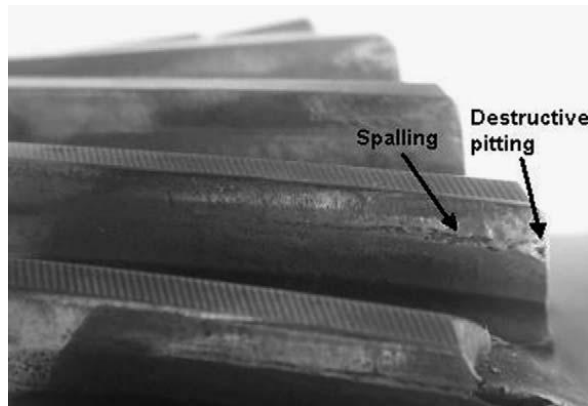
Destructive pitting and spalling were also noted on the active (i.e. loaded) side of each tooth at one end of tooth at the pitch line, as shown in Fig. 7. Destructive pitting appears as much larger pits than initial pitting. These larger craters usually are caused by more severe overload conditions. Spalling is similar to destructive pitting except that the pits are usually larger in diameter and quite shallow. Often the spalled

Fig. 7. Photograph of the pitted gear teeth. Note, spalling and destructive pitting at one end of tooth at the pitch line.

area does not have a uniform diameter. A spalling cavity consists of a shallow wall and a steep wall. Both the shallow and steep walls have jagged surfaces. It originates below the surface, usually at or near the case/core transition zone. Spalling is usually caused by excessively high contact stresses. Usually, large pits are formed; because stress levels are high, the edges of the initial pits break away rapidly and large irregular voids are formed. Often these voids join together [3,4].

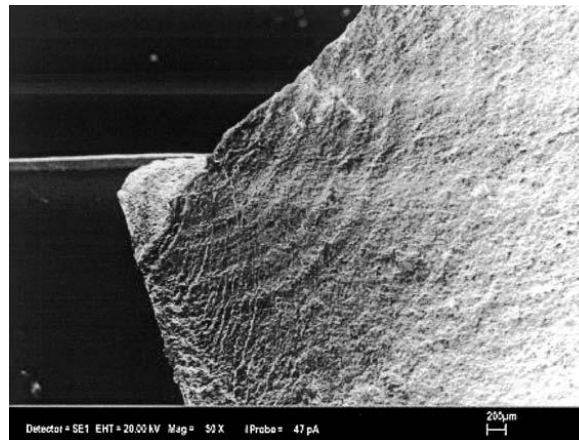
The fractured surfaces and tooth surface of the failed helical gear were examined with the help of a scanning electron microscope (SEM) in order to identify the cause of fatigue crack initiation and propagation. Fig. 8 shows crack initiation and propagation region. Beach marks can be observed clearly on the fracture surface, which is a typical feature of fatigue failure [3]. Beach marks indicate that the fatigue crack penetrated a large portion of the tooth before a piece broke off. The fracture surface is characteristic of a high cycle fatigue failure. River-like pattern could be seen in the propagation zone, which is a typical feature of fatigue failure, as shown in Fig. 9.

Fig. 8. SEM micrograph showing the crack initiation and propagation region.

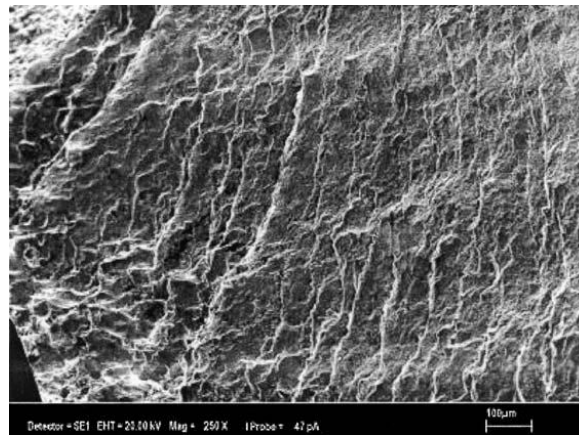
Fig. 9. SEM micrograph showing typical brittle fracture observed in the crack propagation region.

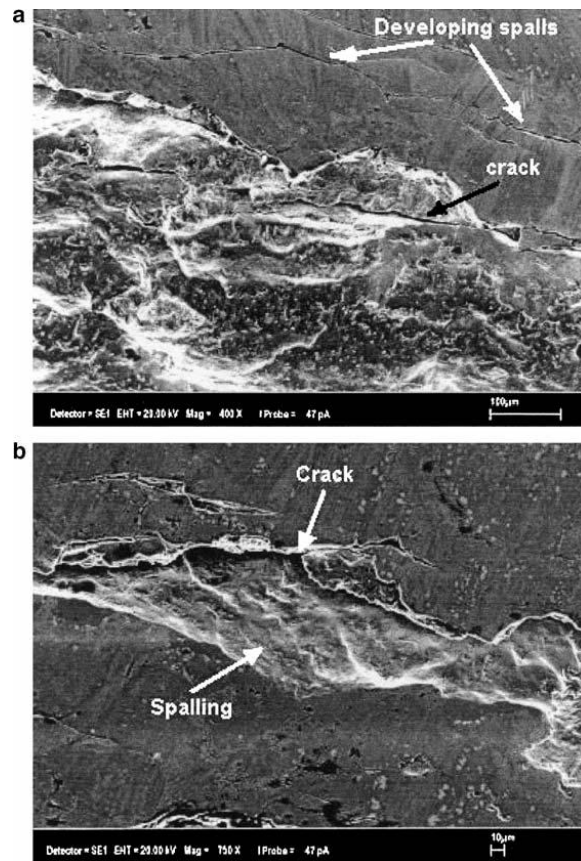
SEM examination indicated that although there were destructive pitting and spalling area on the active side of the gear tooth in the area of the pitch line (Fig. 10), there was micropitting in some areas in the dedendum section of the gear tooth (Fig. 11). The area immediately above or below the pitch line is very susceptible to pitting. Not only is the rolling pressure great at this point but sliding is now a real factor [1]. Spalling regions and fatigue cracks initiation sites from spalling region at the pitch line of the failed helical gear tooth can be seen clearly, as shown in Fig. 10. In addition, Fig. 10(a) shows top view of developing spalls in the vicinity of the pitch line.

Fig. 10. SEM micrograph showing two damaged area at the pitch line at the different magnification. Note, spalling areas containing cracks and developing spalls in the vicinity of pitch line.

SEM analysis showed that the destructive pitting and spalling area are located in the vicinity of the pitch line. Fatigue cracks originated from these damaged areas and propagated subsurface. In other words, it was proved that the tooth fracture is caused by destructive pitting and spalling and does not involve other damage processes. Why, in this situation, did destructive pitting and spalling occur along pitch line? Once the contact point moves into the vicinity of the pitch line, the number of gear pairs in contact becomes minimal, so that the normal Hertzian contact stresses is maximum on this region. Surface contact fatigue can occur when two surfaces slide against each other under high contact pressure and cyclic loading. This mode of failure leads to crack initiation at or near the contact surface, and may subsequently lead to damage varying in extent from microscopic pitting to severe spalling. Pitting is usually caused by gear tooth surfaces not properly conforming to each other or not fitting together properly. This can be a result of minor involute errors or local surface irregularities, but most often it occurs because there is not proper alignment across the full face width of the gear mesh [1,3].

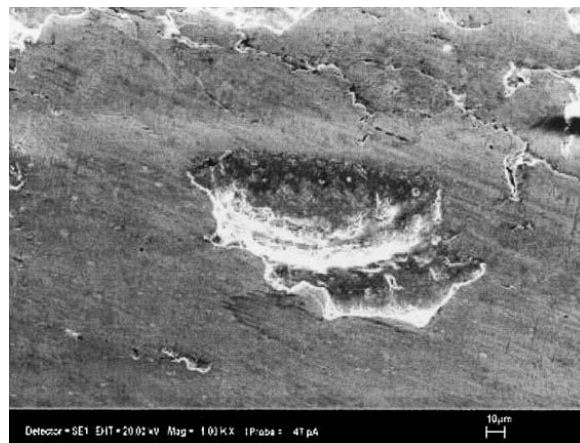
Fig. 11. SEM micrograph showing a typical pit caused by pitting on dedendum surfaces of the tooth.
