Engineering Failure Analysis 13 (2006) 1116–1125

# Fatigue failure of a helical gear in a gearbox

This paper presents a failure analysis of a helical gear used in gearbox of a bus, which is made from AISI 8620 steel. The helical gear had been in service about three years when several teeth failed. The failed helical gear had a number of adjacent teeth and random teeth breakage at one end of teeth. An evaluation of the failed helical gear was undertaken to assess its integrity that included a visual examination, photo documentation, chemical analysis, micro-hardness measurement, and metallographic examination. The failure zones were examined with the help of a scanning electron microscope equipped with EDX facility. Results indicate that teeth of the helical gear failed by fatigue with a fatigue crack initiation from destructive pitting and spalling region at one end of tooth in the vicinity of the pitch line because of misalignment.

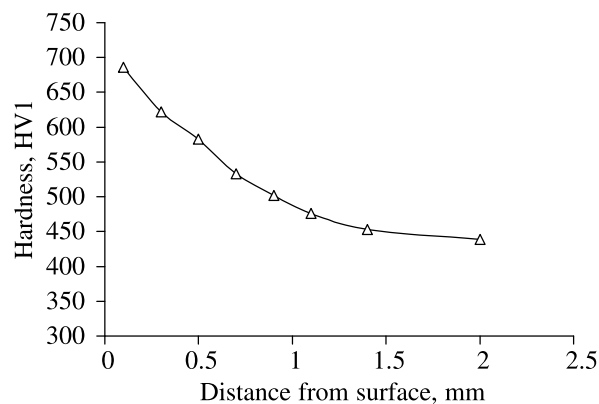
chemical composition. Spectrum analysis and micro-hardness measurement revealed that the failed helical gear material was AISI 8620 steel as carburised, which is usually used for gears in the surface-hardened conditions. The micro-hardness distribution across the helical gear tooth thickness at the pitch line was measured using a Vickers hardness tester with 1 kg load, and the results are given in Fig. 3. Also, the core and surface hardness were measured to be 439 and 686 HV, respectively. The carburized case depth was found to be about 0.63 mm. Carburized case depth is defined as the depth from surface where hardness reaches a value of 550 HV.

Fig. 3. Hardness distribution across the helical gear tooth thickness at the pitch line.

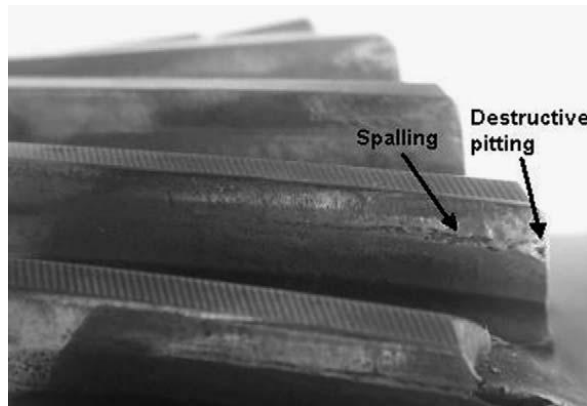
Destructive pitting and spalling were also noted on the active (i.e. loaded) side of each tooth at one end of tooth at the pitch line, as shown in Fig. 7. Destructive pitting appears as much larger pits than initial pitting. These larger craters usually are caused by more severe overload conditions. Spalling is similar to destructive pitting except that the pits are usually larger in diameter and quite shallow. Often the spalled

Fig. 7. Photograph of the pitted gear teeth. Note, spalling and destructive pitting at one end of tooth at the pitch line.

area does not have a uniform diameter. A spalling cavity consists of a shallow wall and a steep wall. Both the shallow and steep walls have jagged surfaces. It originates below the surface, usually at or near the case/core transition zone. Spalling is usually caused by excessively high contact stresses. Usually, large pits are formed; because stress levels are high, the edges of the initial pits break away rapidly and large irregular voids are formed. Often these voids join together [3,4].
