# **NextEra Energy Resources Generation Repair & Service Overview**

**November 15, 2013**

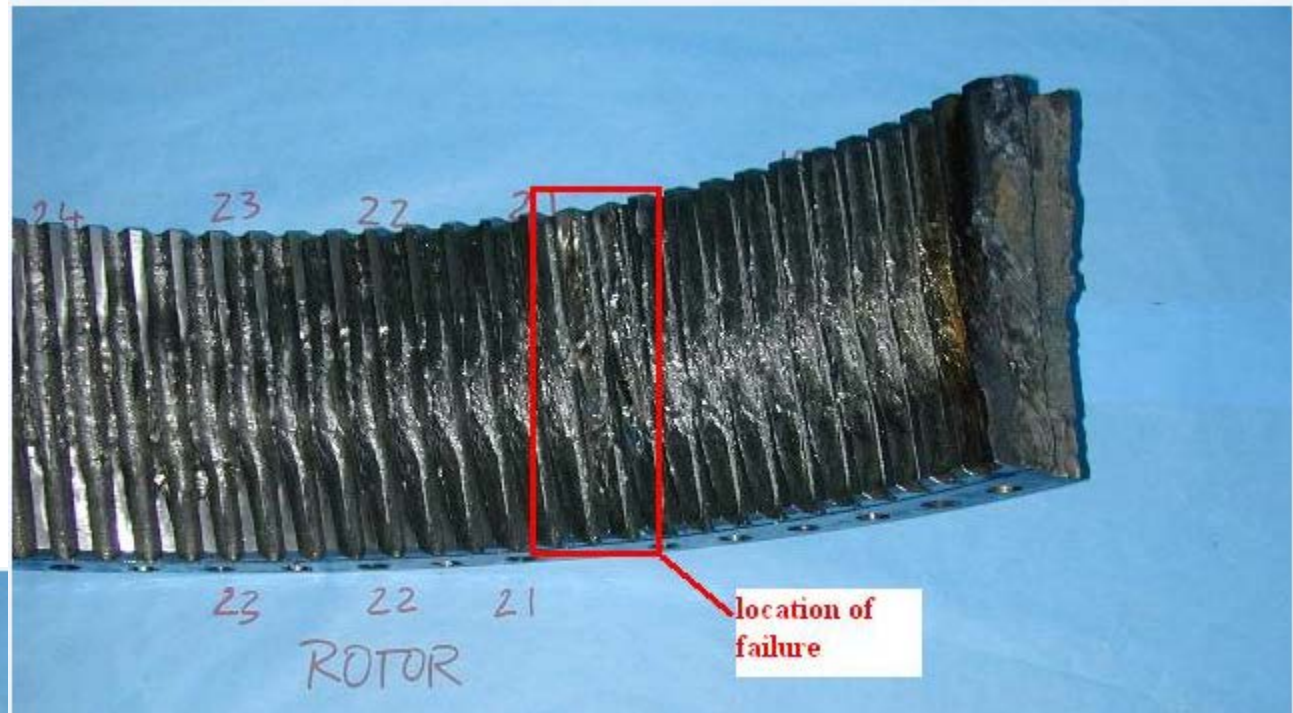
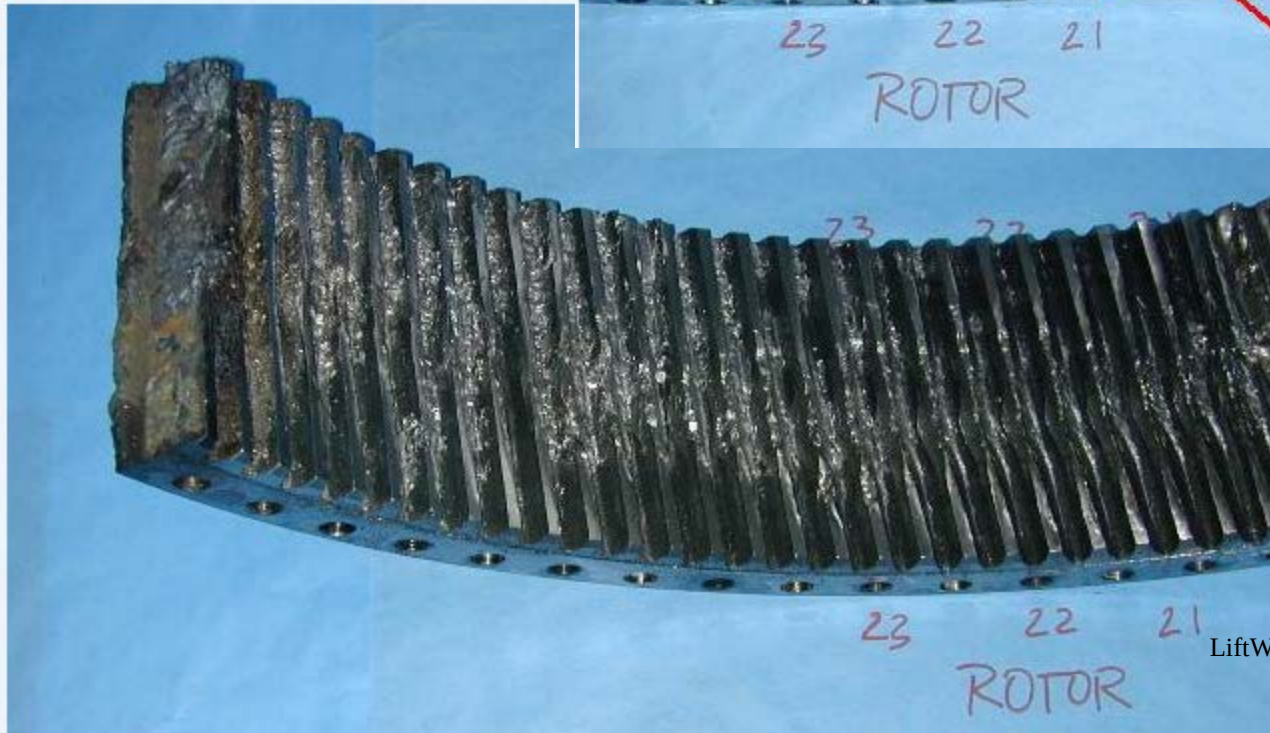
# Failure forensic analysis. Why did it fail?

Forensics of failures is caused by up 2,210 BHP of energy

Overloaded  
High cycle fatigue  
Low cycle fatigue  
Material inclusion  
Grind temper  
Heat treating error

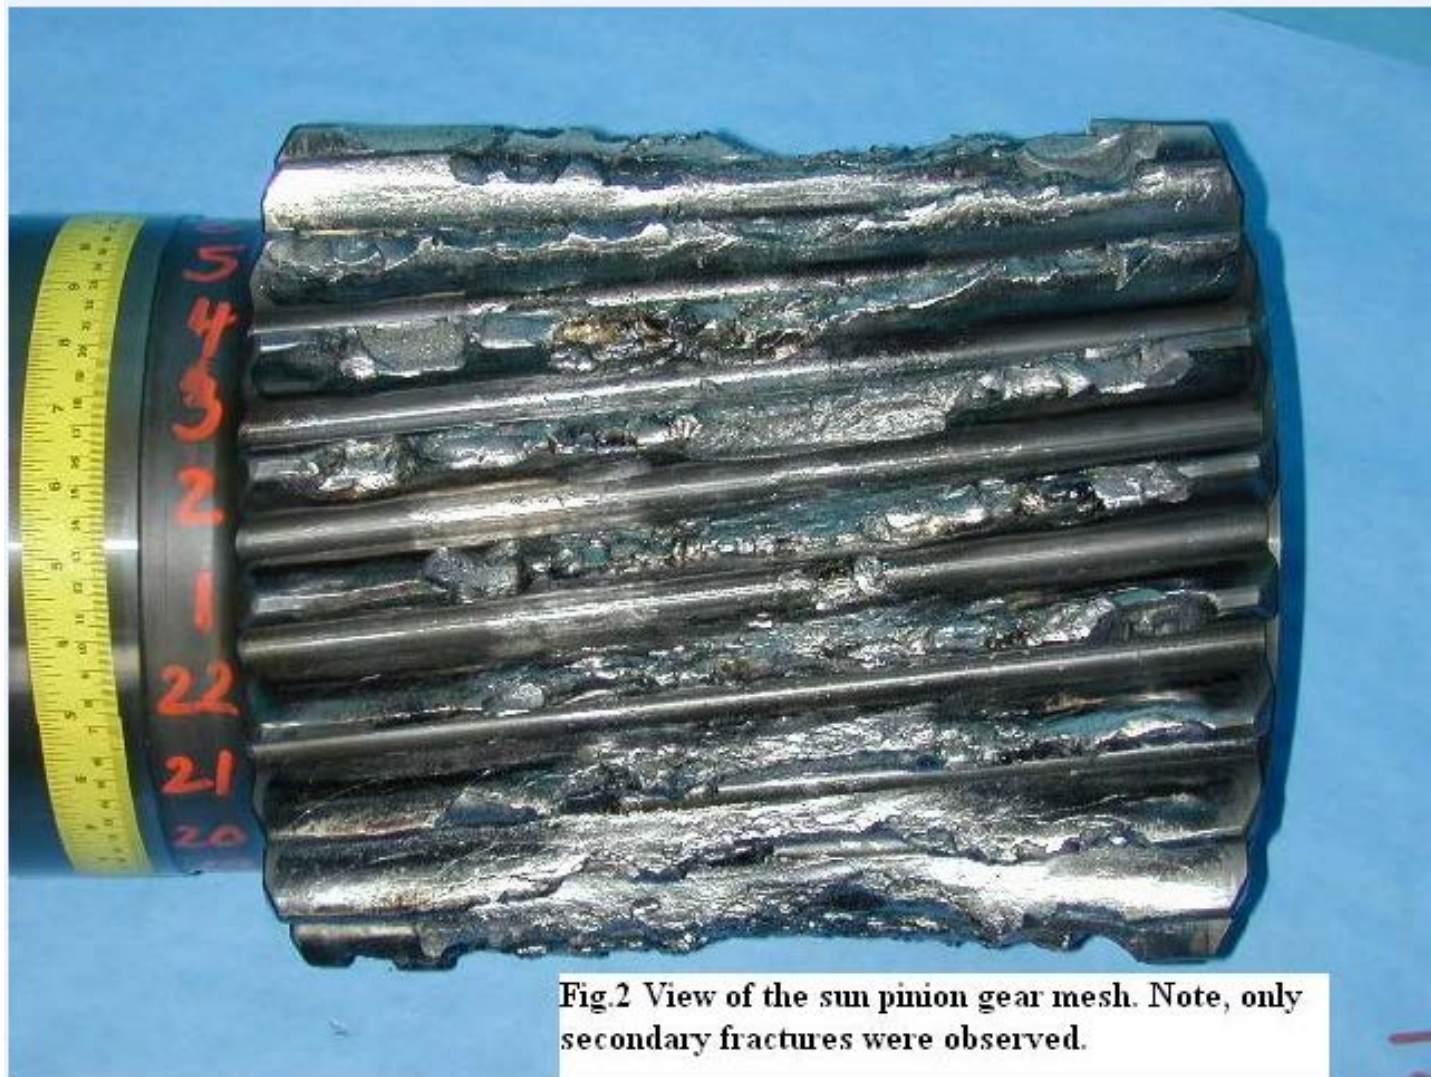
## Ring gear pinion secondary damage from previous slide

Fig.2 View of the sun pinion gear mesh. Note, only secondary fractures were observed.

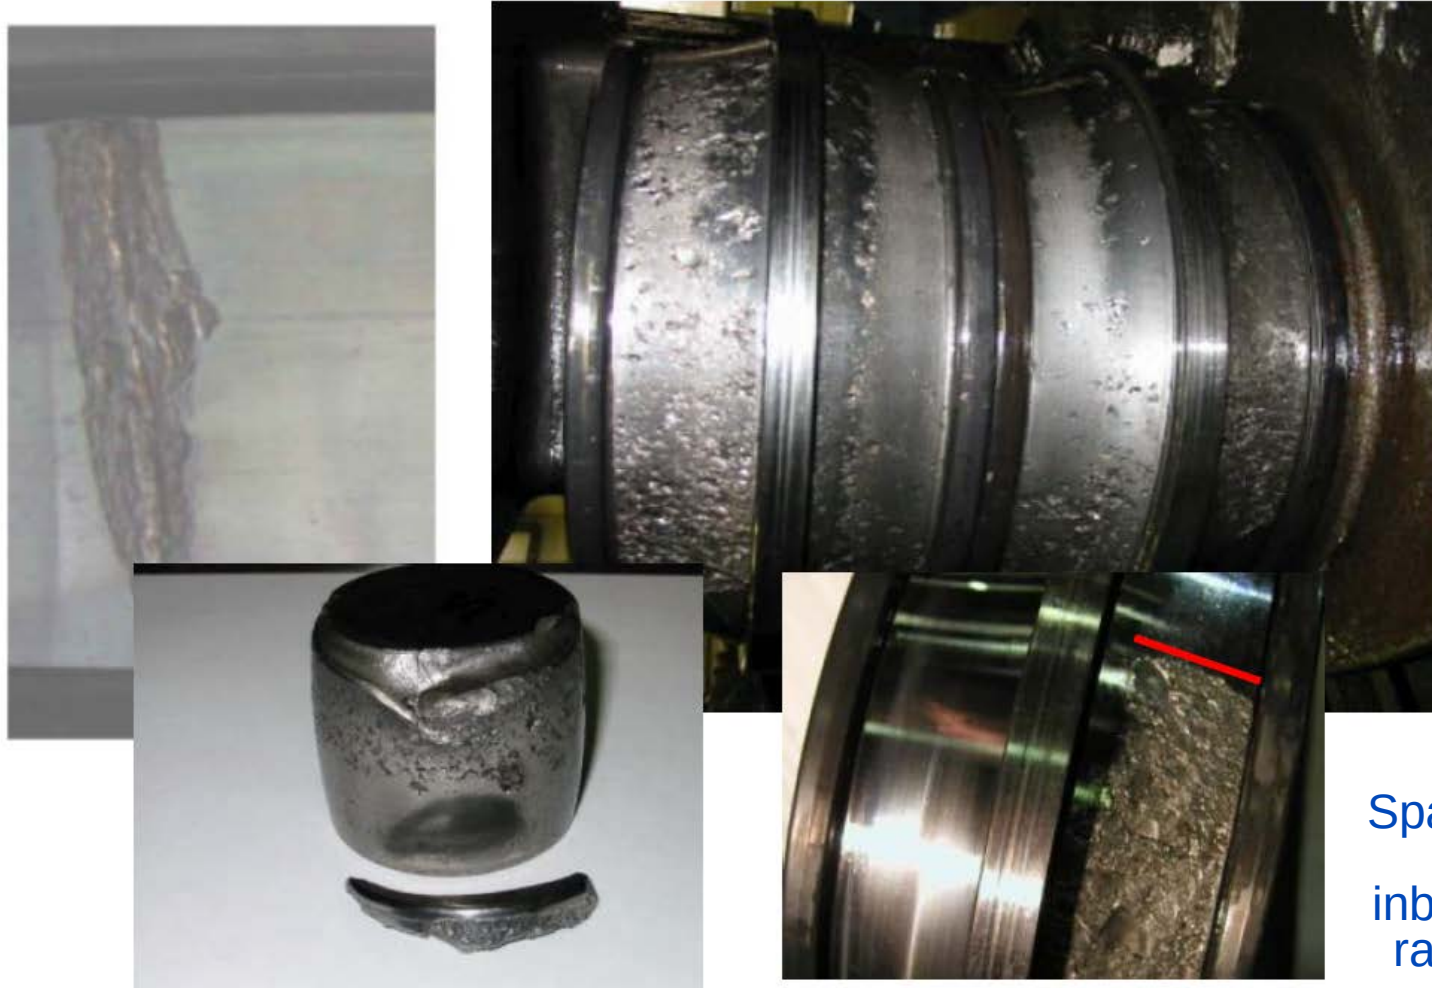
# Macro pitting of a spherical roller planet gear bearing race

Spalling  
of  
inboard  
races

Typical bearing analysis, indications of overloaded bearing due to higher loads than expected. Bearing selections that work in other industry do not work in wind.

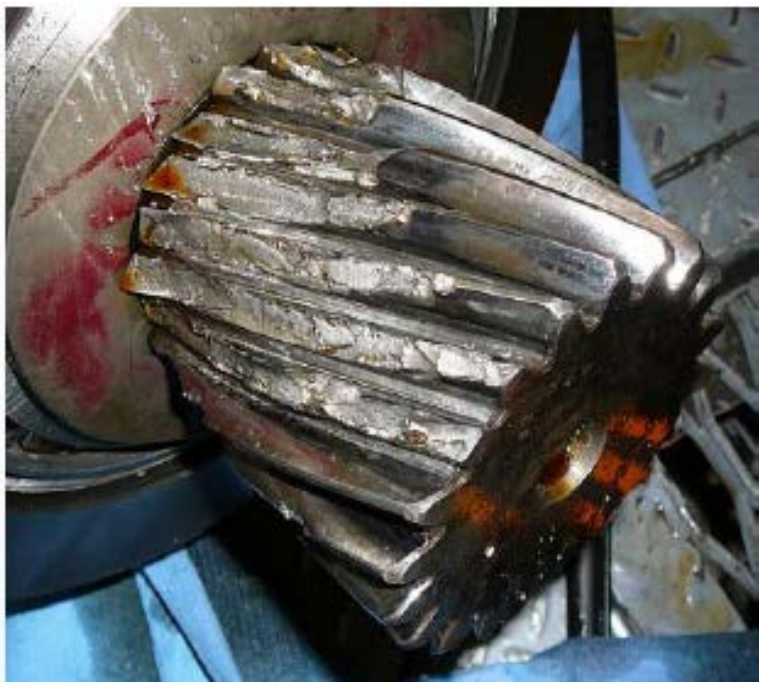
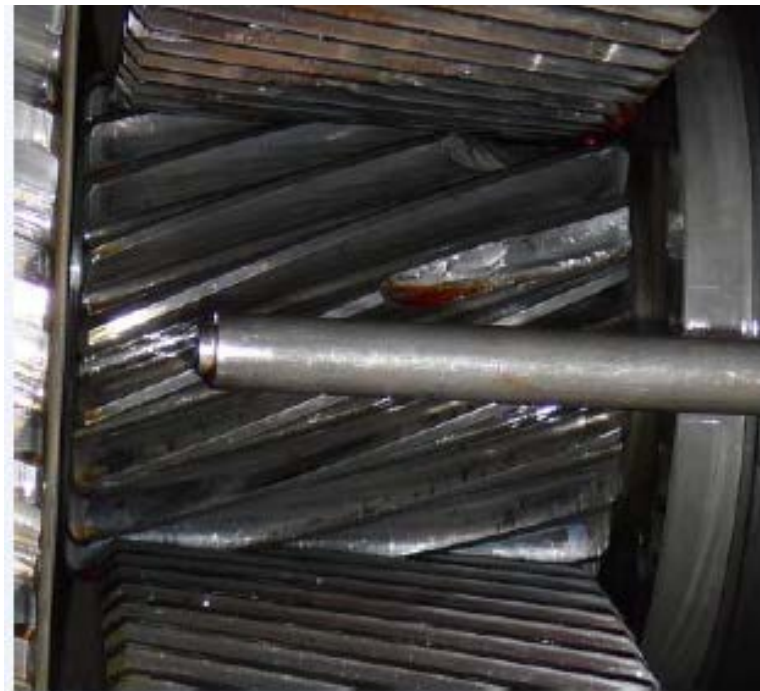
# Gear tooth overloading associated with a tolerance problem

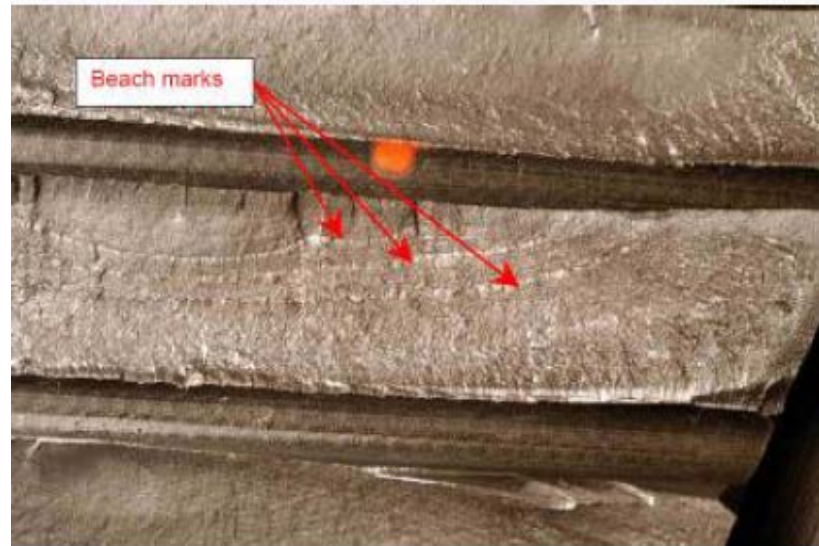
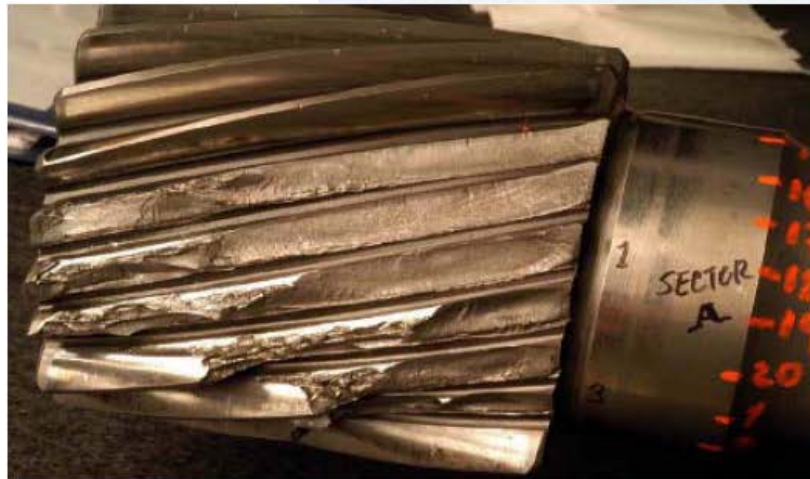
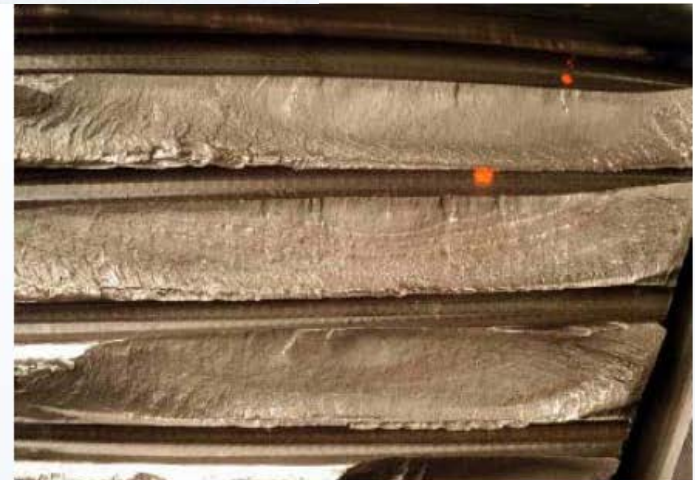
# High cycle fatigue – wear over life of the component

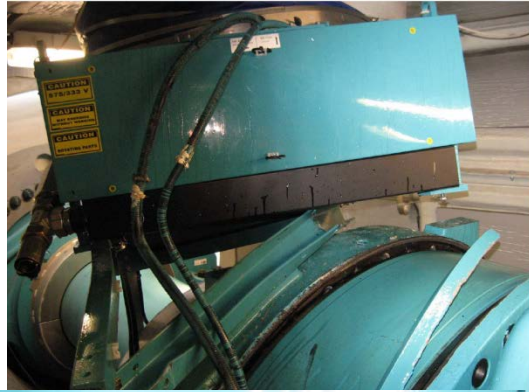
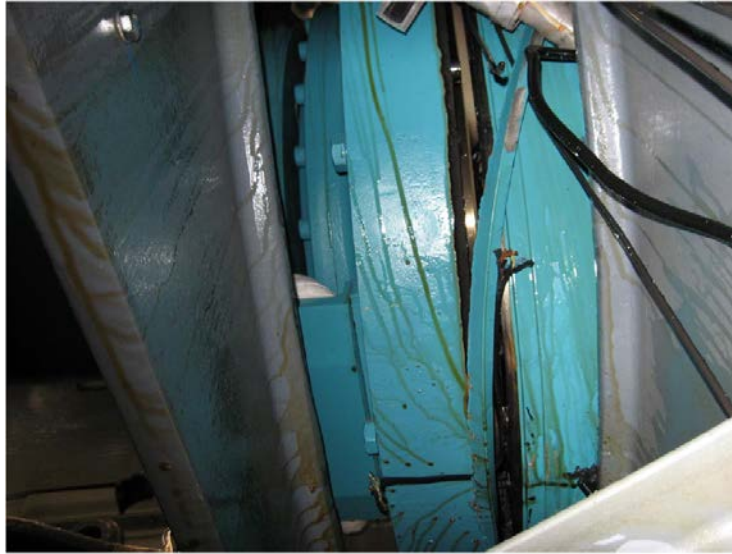
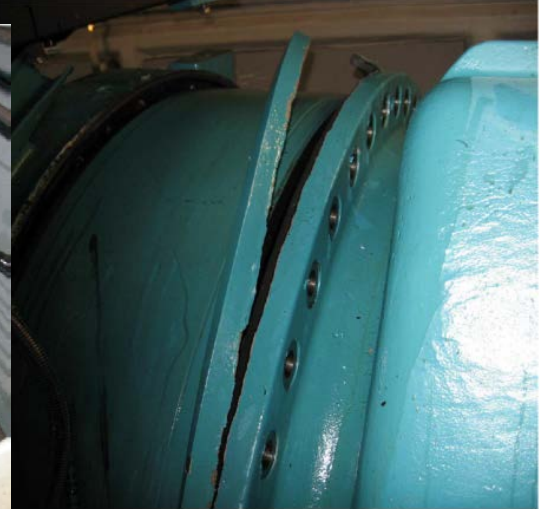
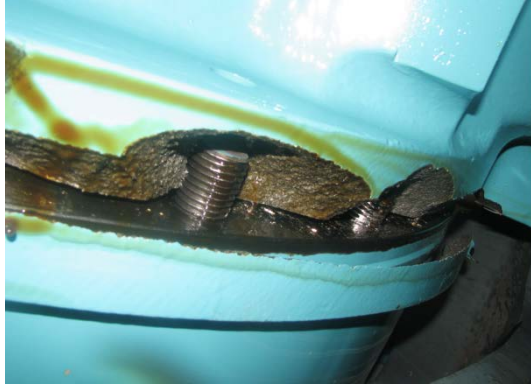
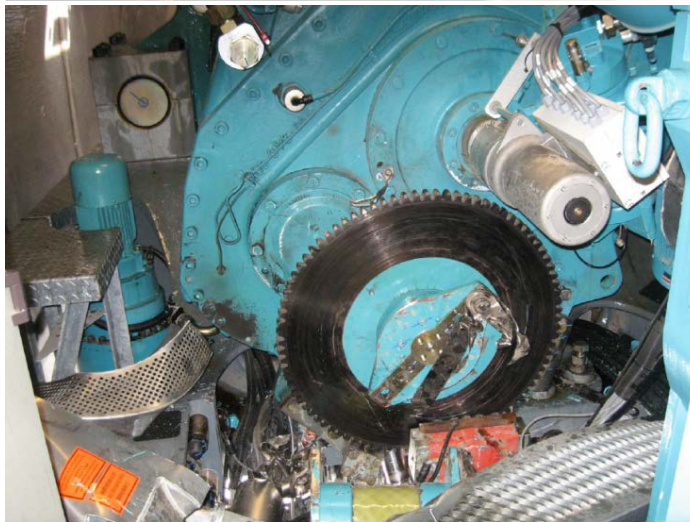
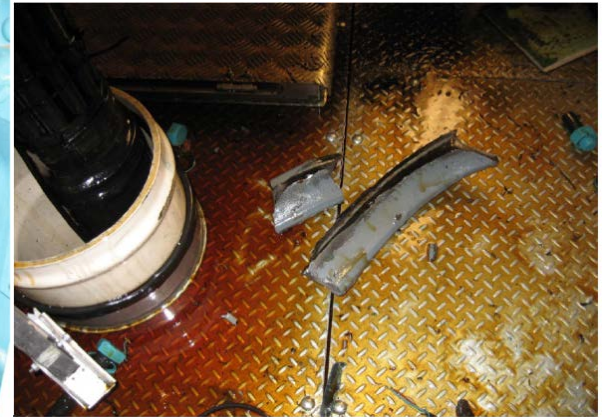
# Catastrophic Failure

Salvage some gearing and send gearbox to scrap vendor

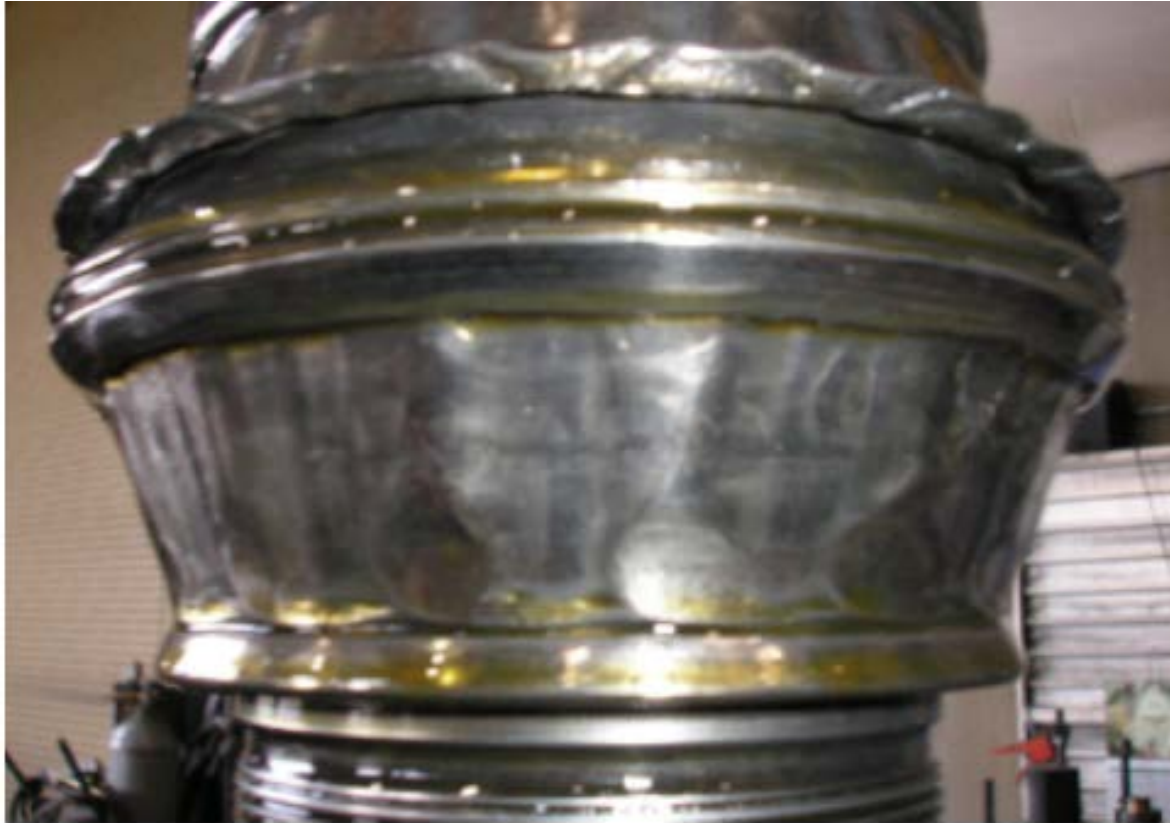
# Plastic deformation of a pair of tapered roller bearings

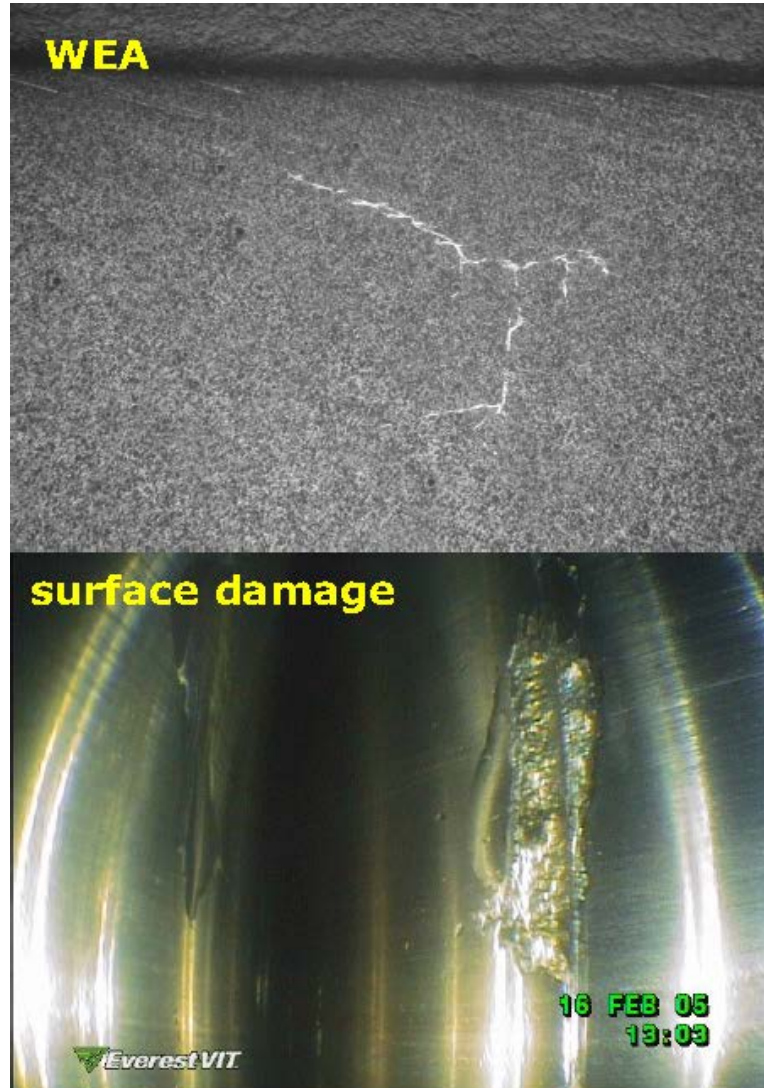
# Bearing race white etching prior to spalling of race

Root Cause is the transient vibrational loading seen in high speed bearings

Up tower repair was perfected in the GRS shop then deployed to the field

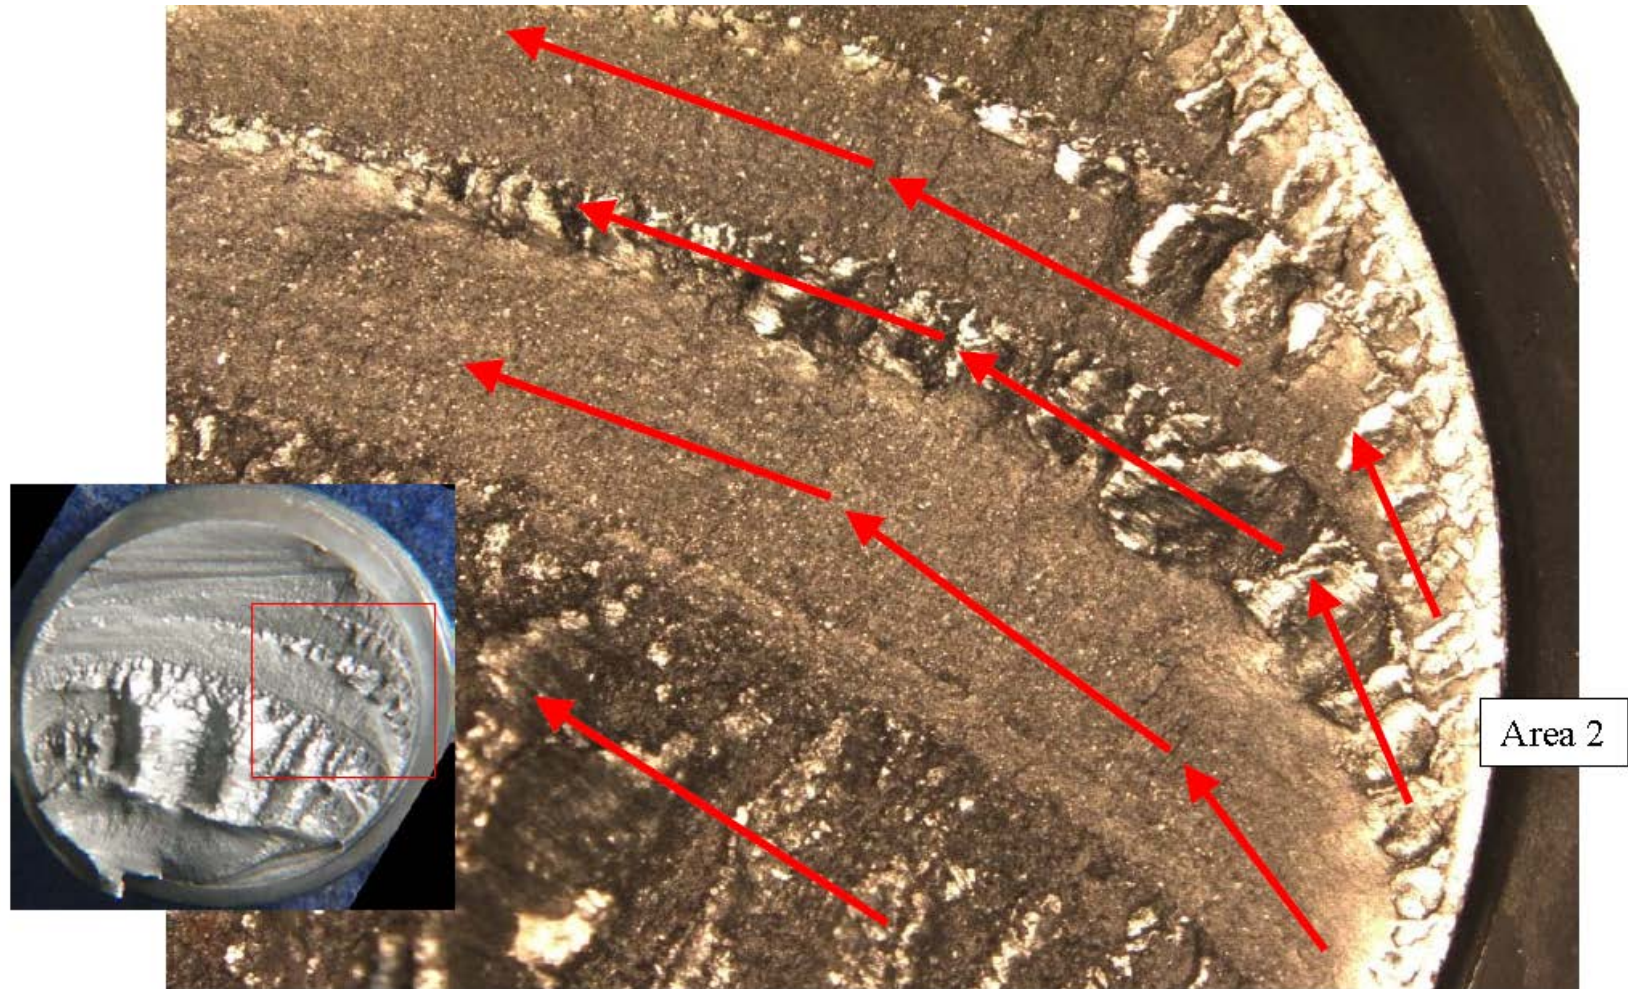
## Gearbox case bolt failure after about 50% of the diameter was cracked the bolt sheared off causing a failure

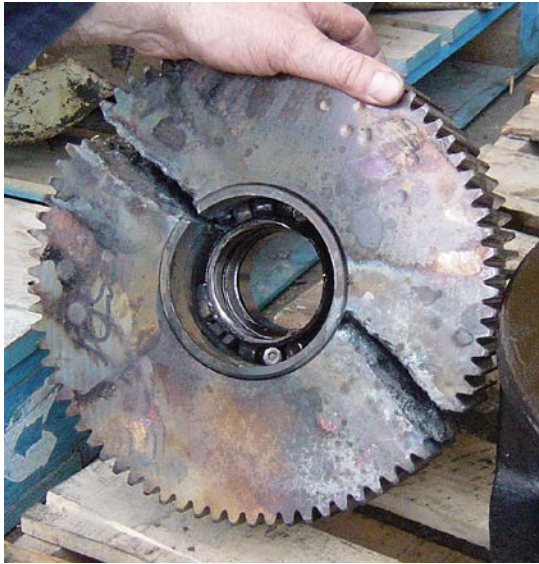
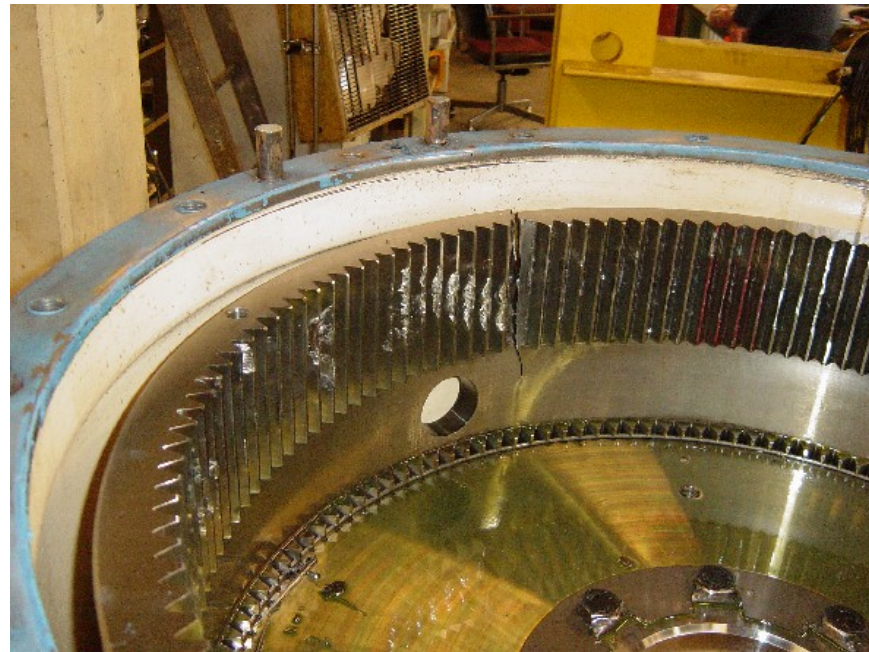
# Broken Gear and Ring Gear – cracked in two pieces

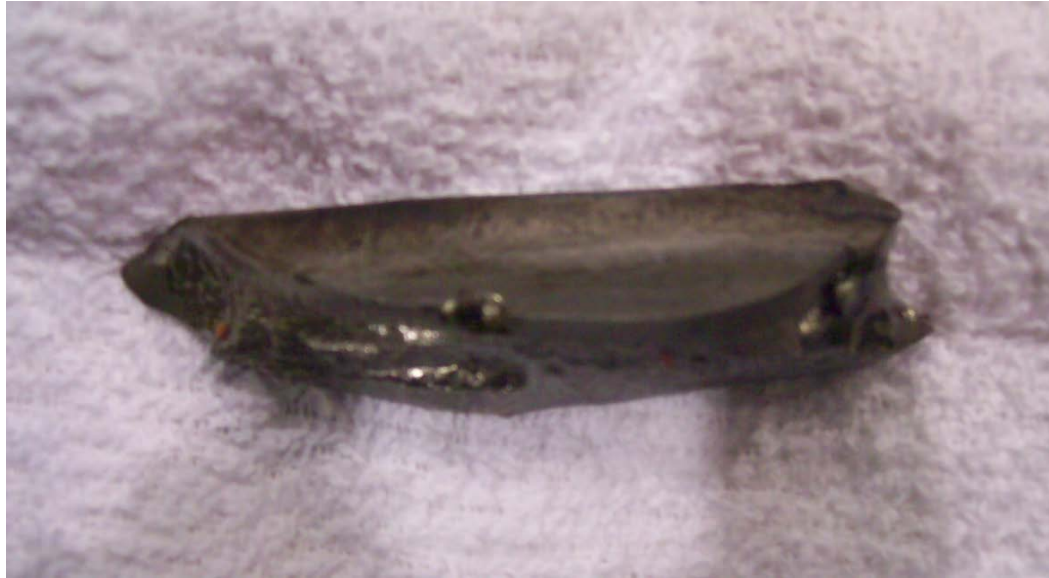
Planet gear tooth

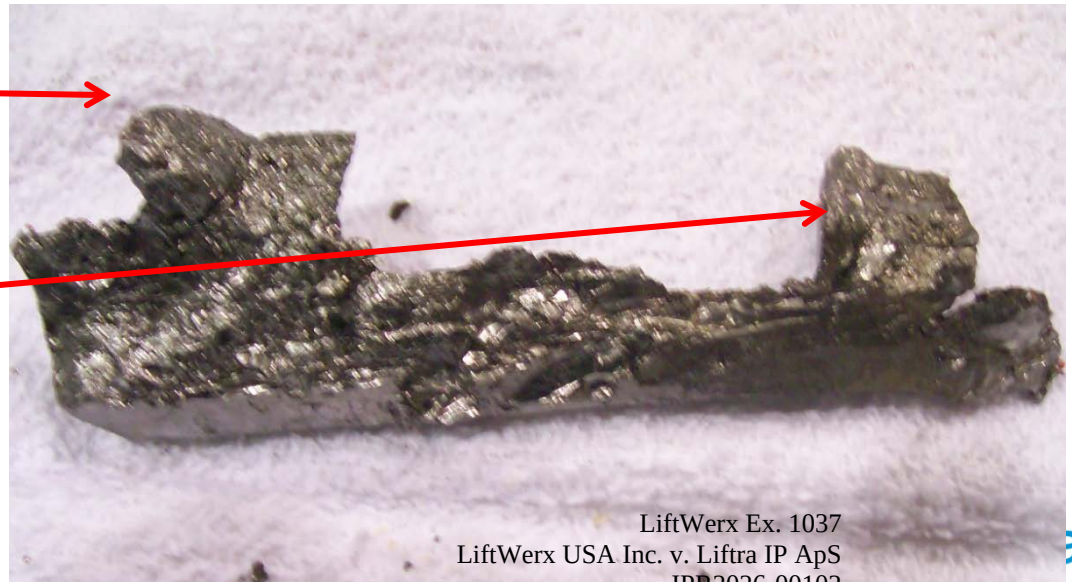
2 ring gear teeth  
cold welded  
together due to the  
energy of the failure

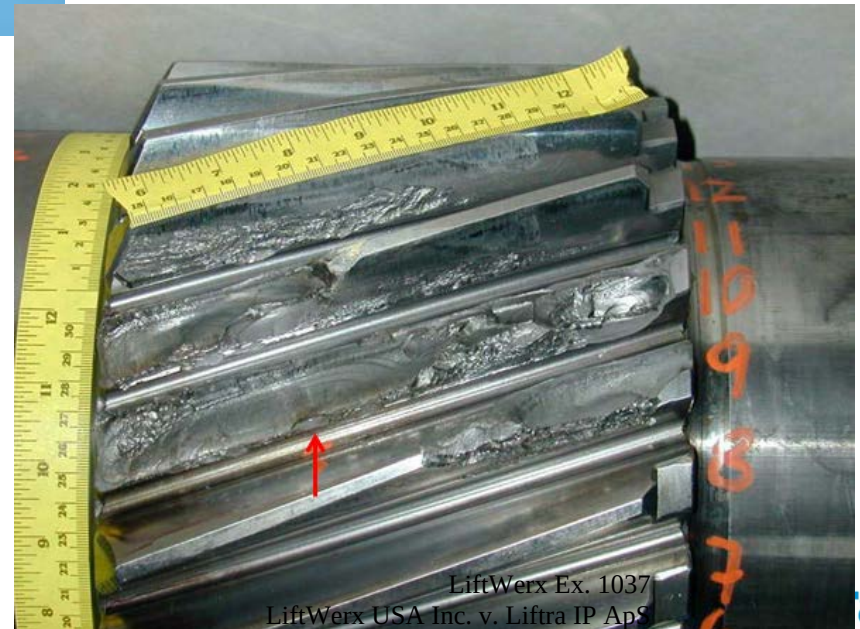
Overloading failure

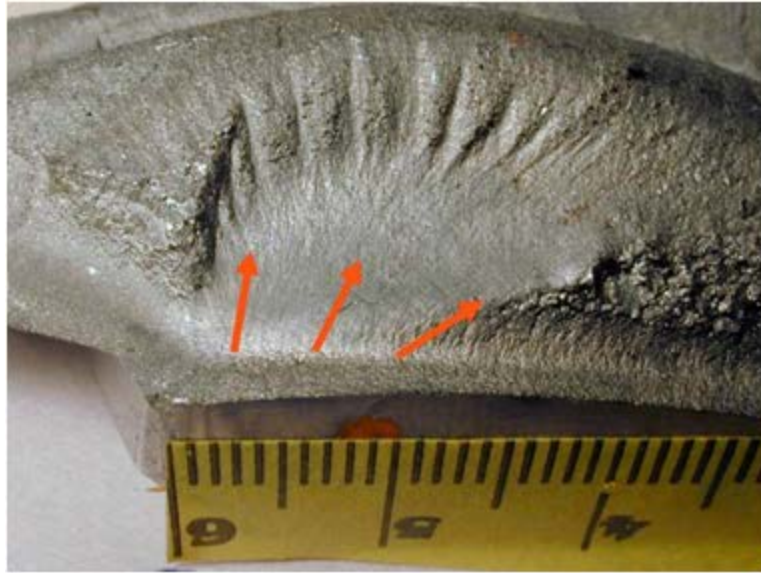
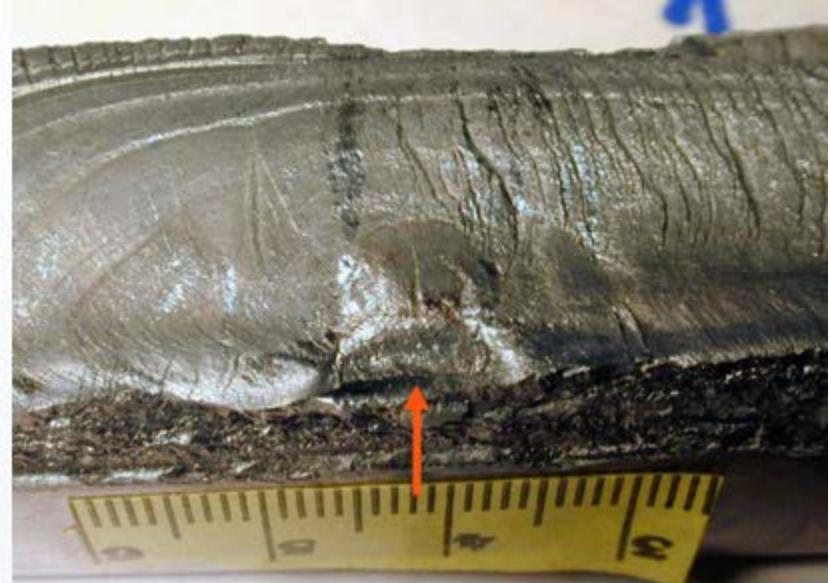
# Inclusion failure

Non metallic inclusion usually  
aluminum or silica

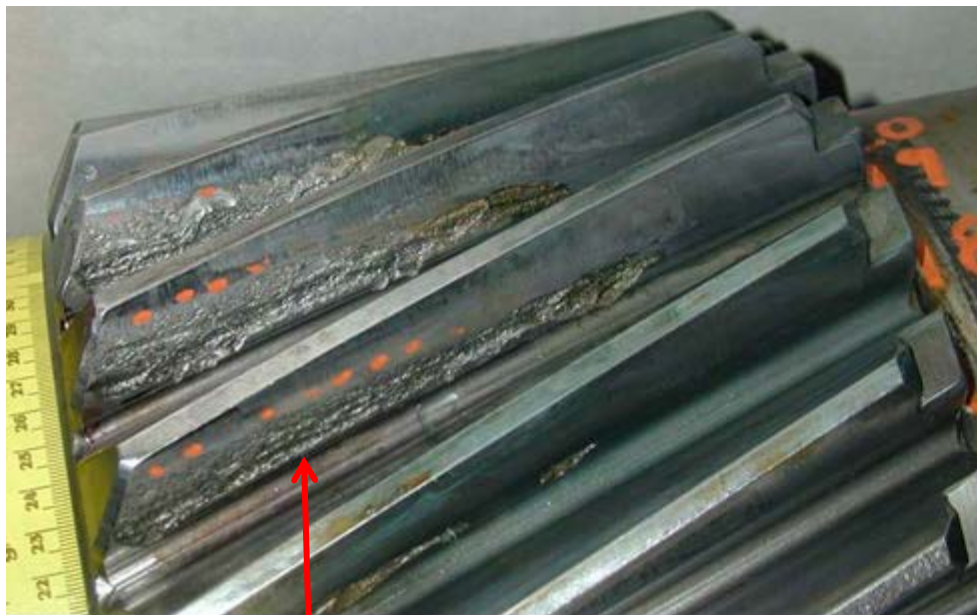
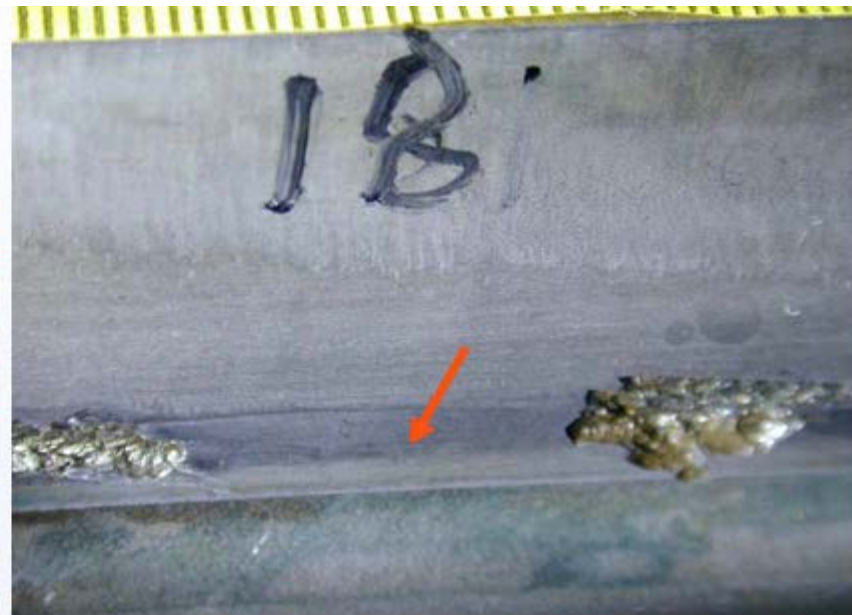
# Macro spalling

One sided spalling can suggest an alignment issue
