# Stick shaker

A **stick shaker** is a mechanical device designed to rapidly and noisily vibrate the control yoke (the "stick") of an aircraft, warning the flight crew that an imminent aerodynamic stall has been detected. It is typically present on the majority of large civil jet aircraft, as well as most large military planes.

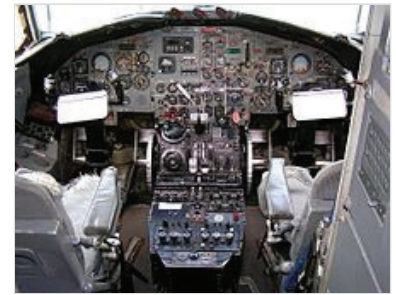
The BAC-111 cockpit includes a stick shaker/pusher following its 1963 crash

During 1963, a BAC One-Eleven airliner was lost after having crashed during a stall test. The pilots pushed the T-tailed plane past the limits of stall recovery and entered a deep stall state, in which the disturbed air from the stalled wing had rendered the elevator ineffective, directly leading to a loss of control and crash.<sup>[2]</sup> As a consequence of the crash, a combined stick shaker/pusher system was installed in all production BAC One-Eleven airliners. A wider consequence of the incident was the instatement of a new requirement related to the pilot's ability to identify and overcome stall conditions; a design of Transport category aircraft that fails to comply with the specifics of this requirement may be acceptable if the aircraft is equipped with a stick pusher.<sup>[3][4]</sup>
