## **Abrasion Study 2: The Effect of Tire Impacts on RPM Photometric Performance**

## 6. FEASIBILITY OF RPM RESTORATION

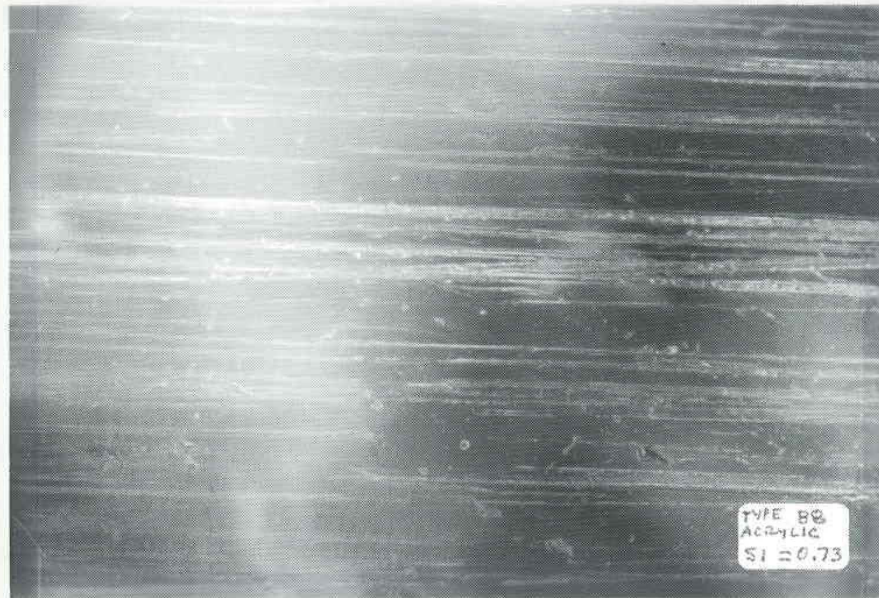
Figure 5-10. Photomicrograph of a plastic-faced Model 88 RPM subjected to 10 abrader passes.

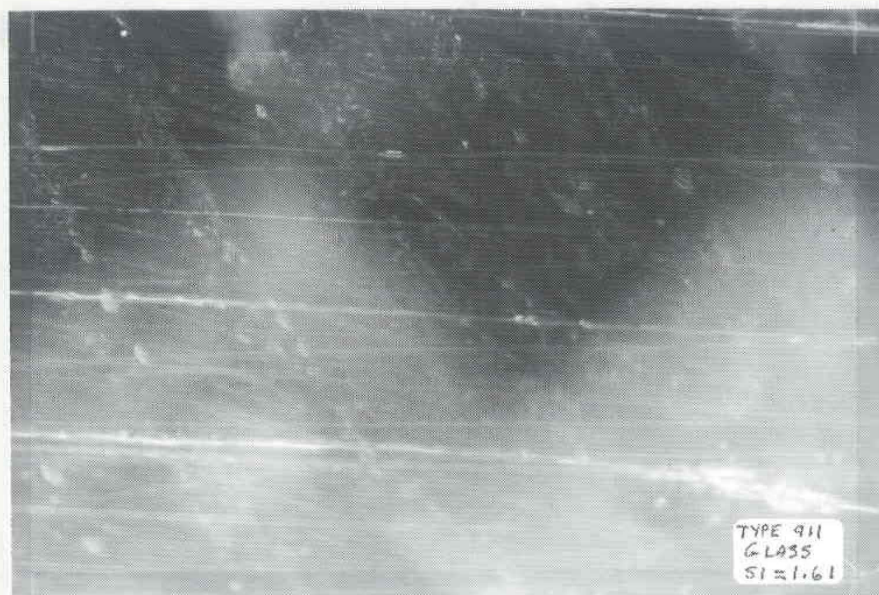
Figure 5-11. Photomicrograph of a glass-faced Model 911 RPM subjected to 10 abrader passes.

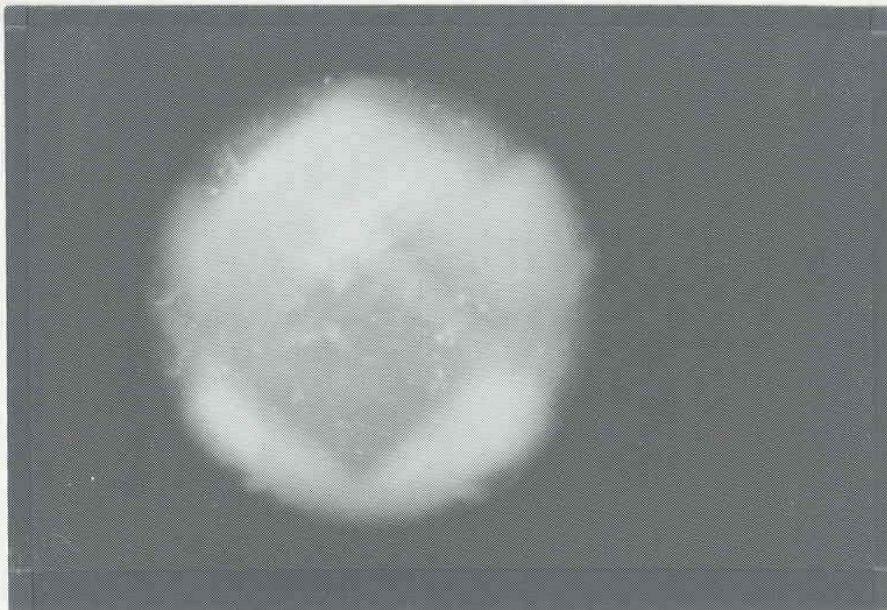
Figure 5-17. Photomicrograph of glass-faced Model 911 RPM (ID# 37) after 4400 tire impacts.

Unlike the plastic RPMs, the glass markers reveal more obvious physical damage to the naked eye. Typically, pitting, chipping or cracking of the glass superstrate is evident along the top margin of the glass. This phenomenon, shown in Figure 5-16, is much more pronounced on the 4 x 4 inch Model 911 markers than on the low profile 948s. In addition, on a few of the larger glass markers, small pieces of the glass face were completely missing after testing. Viewed under 40 power magnification, the glass markers showed some evidence of the small scratches typical of the plastic-faced RPMs, but at a clearly much lower frequency. A typical photomicrograph of a glass RPM is provided as Figure 5-17. Whereas the scratches on the plastic faces were often sufficient to obscure the cube corner substrate, this was not the case with the glass markers.
