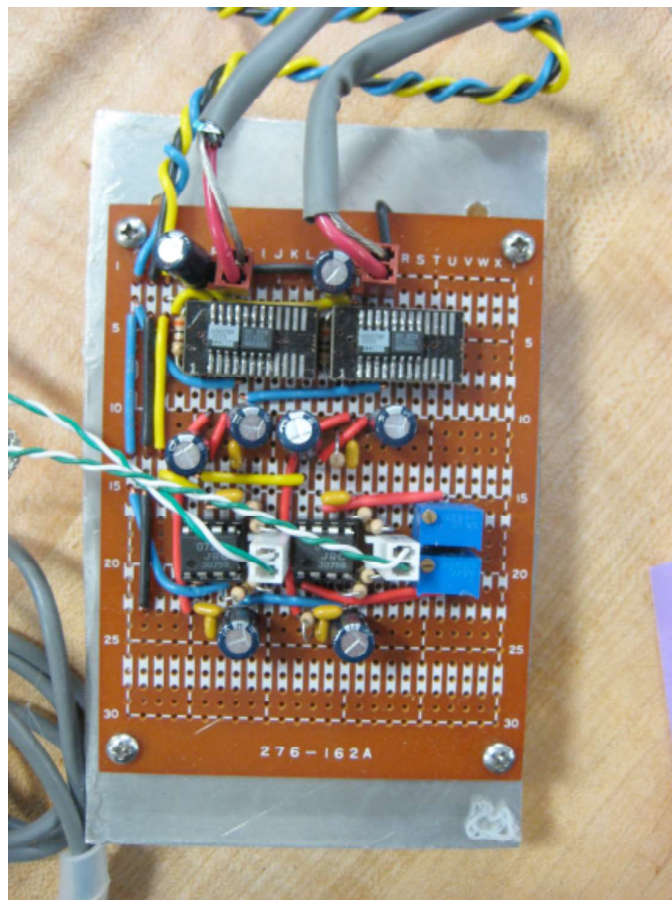
**Figure 3-15: Filtration and amplification circuit for instrumentation**

Because the amplification stages are not exact due to slight variances in component values of the electronics, it was necessary to calibrate the load and torque sensors. This was done through the National Instruments Measurement and Automation Explorer application using known masses for the load cell, and a calibrated torque wrench for the torque sensor.

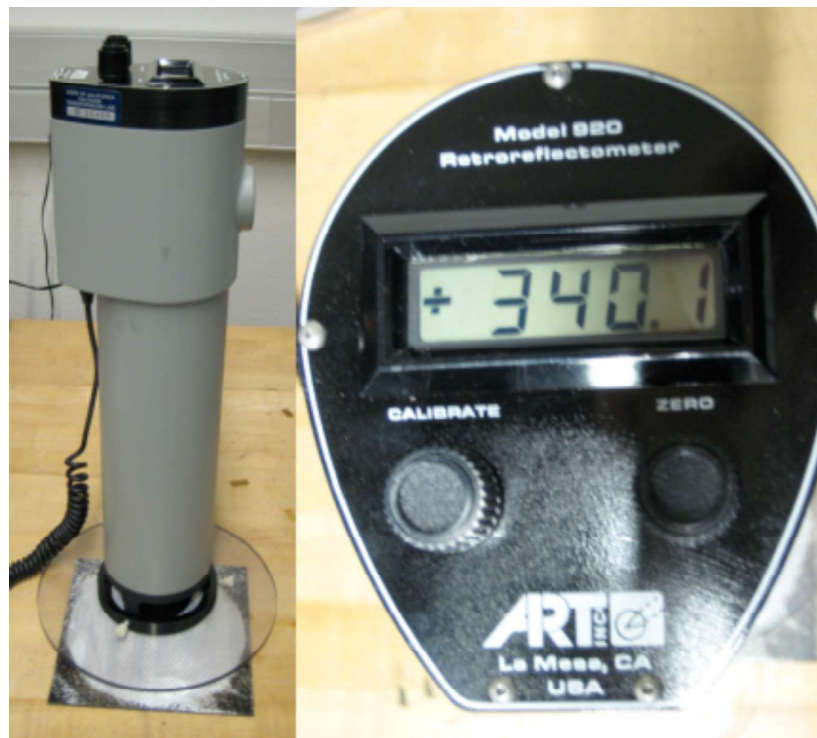
Once all replicates of the test were run, the resulting coefficients of retroreflectivity ( $R_A$ ) were measured for each sign, to be later compared against control values. The  $R_A$  values were taken using a Model 920L field retroreflectometer manufactured by Advanced Retro Technology, Inc. First, the retroreflectometer was calibrated using two different materials of known  $R_A$ , by using the two knobs on the end of the retroreflectometer (Figure 3-16). The first material was a flat black felt surface with an  $R_A$  of zero, by which the retroreflectometer was zeroed out. The other material was a small piece of encapsulated glass bead retroreflective film with a known  $R_A$  of 308.

**Figure 3-16: Retroreflectometer; Detail of calibration knobs and readout**

Once the retroreflectometer was calibrated, the  $R_A$  values of the control samples were taken. The standard method for taking the readings, as dictated by the manufacturer, was to take a measurement at roughly  $0^\circ$  orientation, another at the same spot but with the retroreflectometer rotated roughly  $90^\circ$ , and then to average these two measurements. This average value counts as one reading.

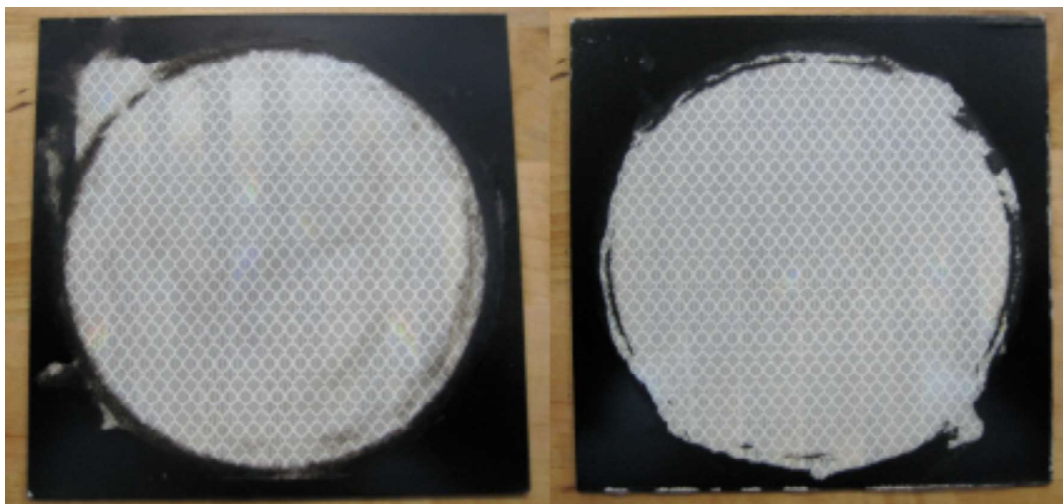
cleaning fluid, which could not be removed even with vigorous rubbing. This residue can be seen in Figure 3-20 as a mottled appearance in the cleaned area. Initially this was thought to be due to the paint adhering to signs with the 1160 film better than to those without, but further testing revealed that this was probably not the case. Instead, it was probably due to a lack of sufficient cleaner being used to remove the paint. Also, it appeared partway through the test that the paint seemed to be removed from the sign before the 40 cycles had passed, meaning that the runs could be of a much shorter duration. Thus, for future tests, the number of cycles was reduced from 40 to 20.

**Figure 3-20: Comparison of cleaned signs; Left with 1160, Right without.**

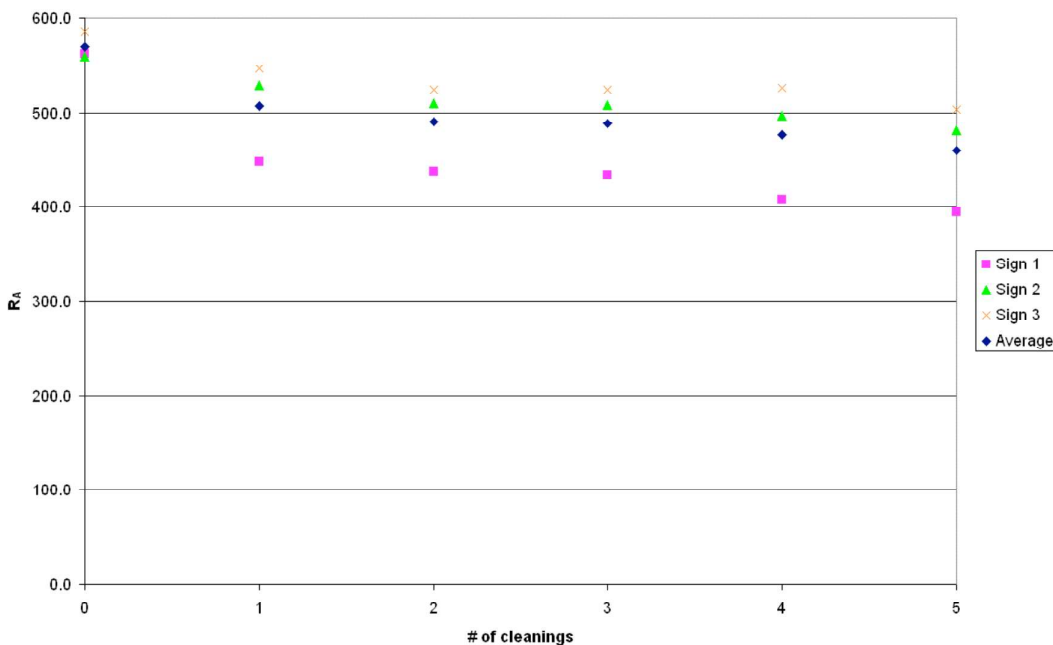
rougher than a used one. Figure 3-21 shows the change in  $R_A$  for the signs without the 1160 film, and Figure 3-22 shows the change for those signs with the film.

**Figure 3-21: Results from multiple runs w/o 1160 film**

These results were somewhat surprising. With the results from the factorial experiment, it was thought that the  $R_A$  would degrade steadily over several cleanings. Instead, what happened is the reduction in  $R_A$  leveled off, and in the case of the signs with the 1160 film actually began to improve dramatically. Visual inspection of the signs after the initial tests showed a fair amount of scratching on the surface from the new pad, but over time the samples began to regain a shiny surface again. It is thought that the reason for these results was probably a combination of pad wear and the characteristics of the cleaner. After the first few uses, the surface of the pad took on a noticeably softer feel which seemed to reduce its abrasive qualities. Additionally, once the SEI Graffiti Remover was applied and the solvent allowed to evaporate, the cleaner that was left behind had a waxy consistency which may have aided in "polishing" the sign. At any rate, it appeared that it was possible to clean the signs multiple times without significant damage, as the  $R_A$  levels never approached the minimum levels mandated by the FHWA.

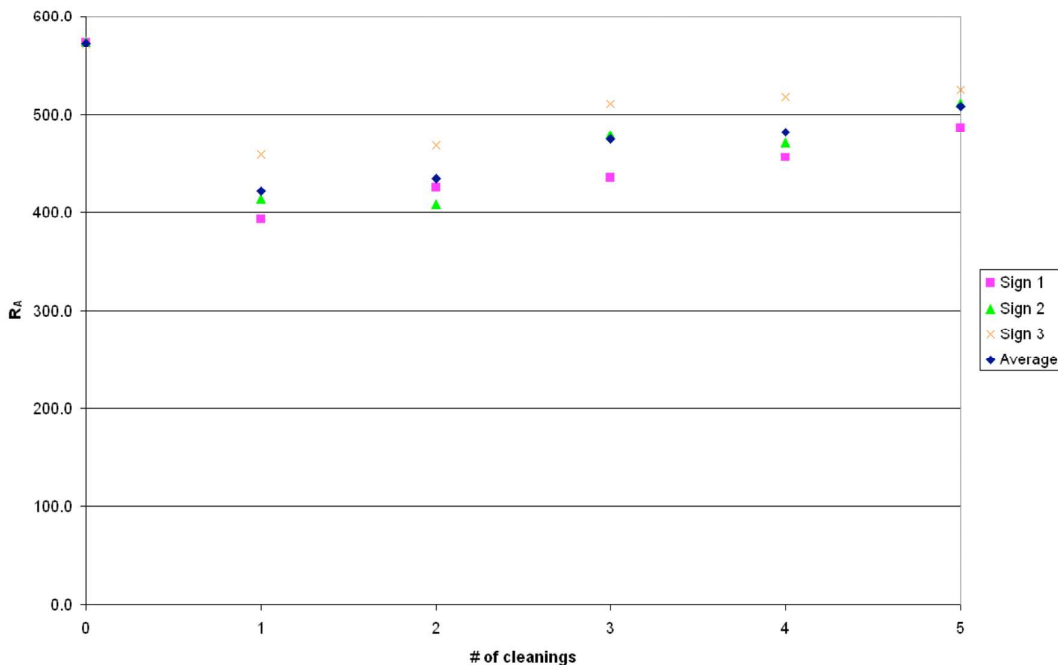
**Figure 3-22: Results from multiple runs with 1160 film**

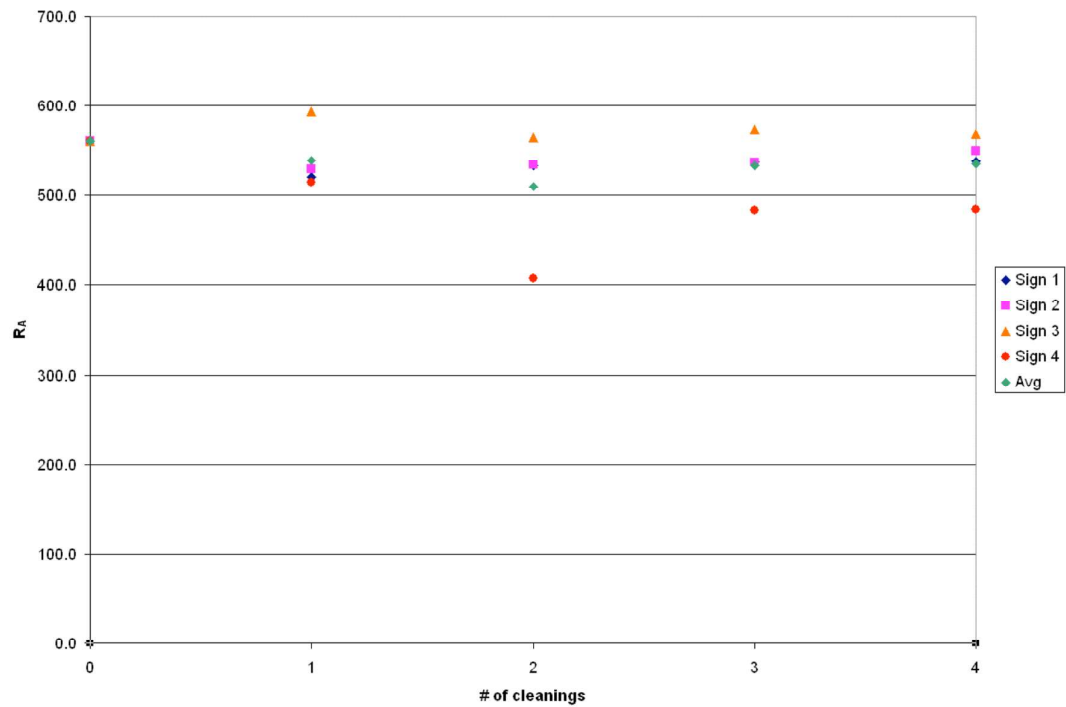
For the last test in the series, attempts were made to simulate a situation likely to be faced by maintenance workers: cleaning a sign that has been painted multiple times. The paint used was the same flat black spray paint used in the single-run test, was applied the same way and allowed to cure for at least 48 hours each time. Due to time constraints, only four cleanings were possible. Again, both signs with and without the 1160 film were tested, and the tests were run for 20 cycles. The pad used was the same one from the previous test, indicating that initial damage should not be a problem. Figure 3-23 shows the results from the signs without the 1160 film, and Figure 3-24 shows the results from those with the film.

Figure 3-23: Multiple cleanings on painted signs w/o 1160

While these results are not as dramatic as those from the previous test since none of the signs improved over several cleanings, it is notable that the  $R_A$  never really got close to the FHWA minimum levels. This indicates that it is probably possible to use the proposed design of a motorized pad and chemicals to clean a sign.

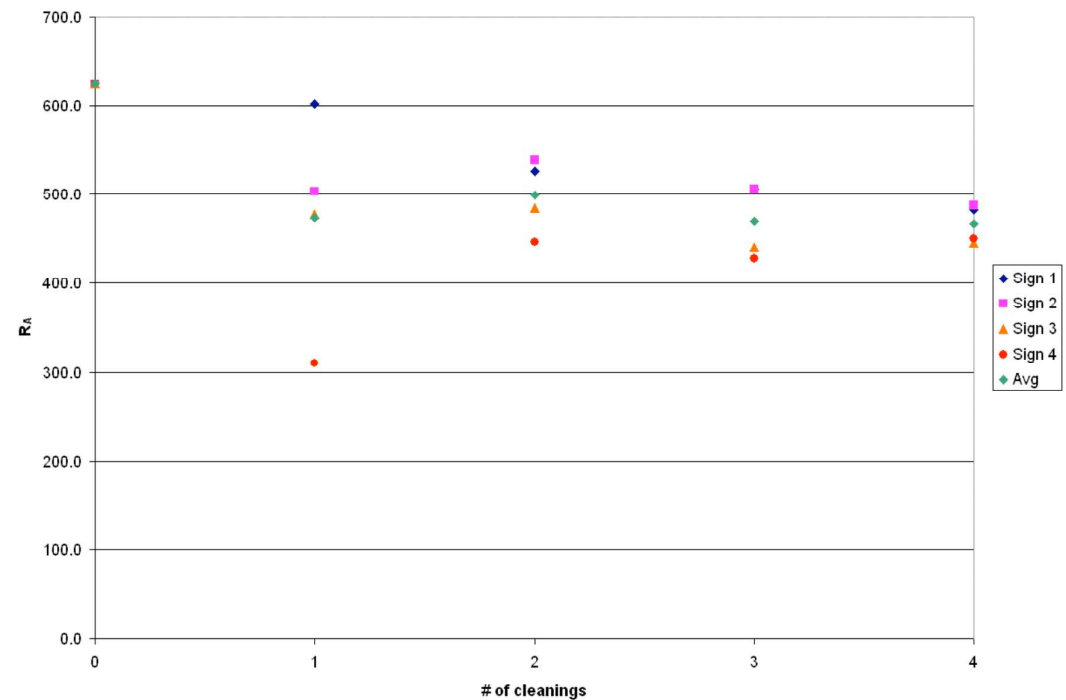
Figure 3-24: Multiple cleanings on painted signs with 1160

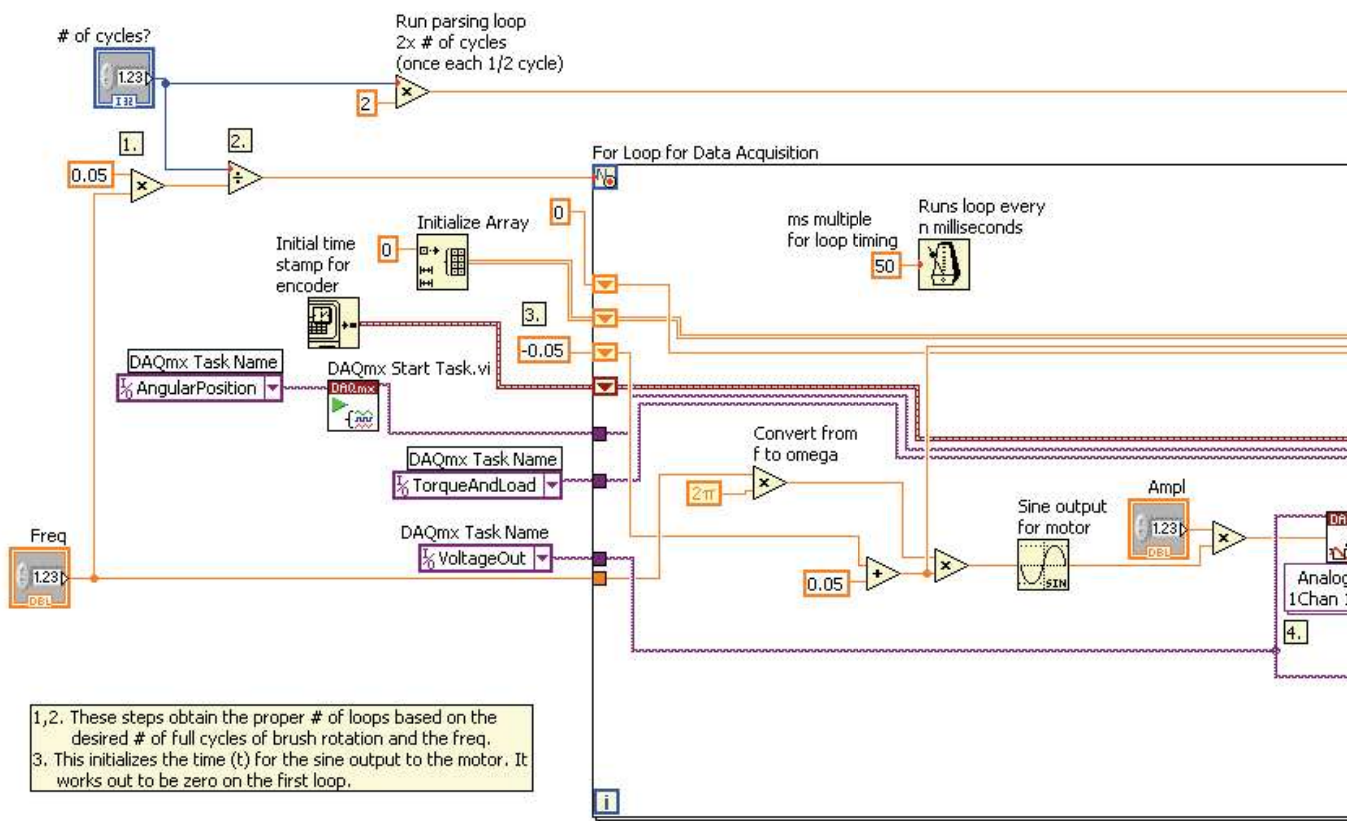
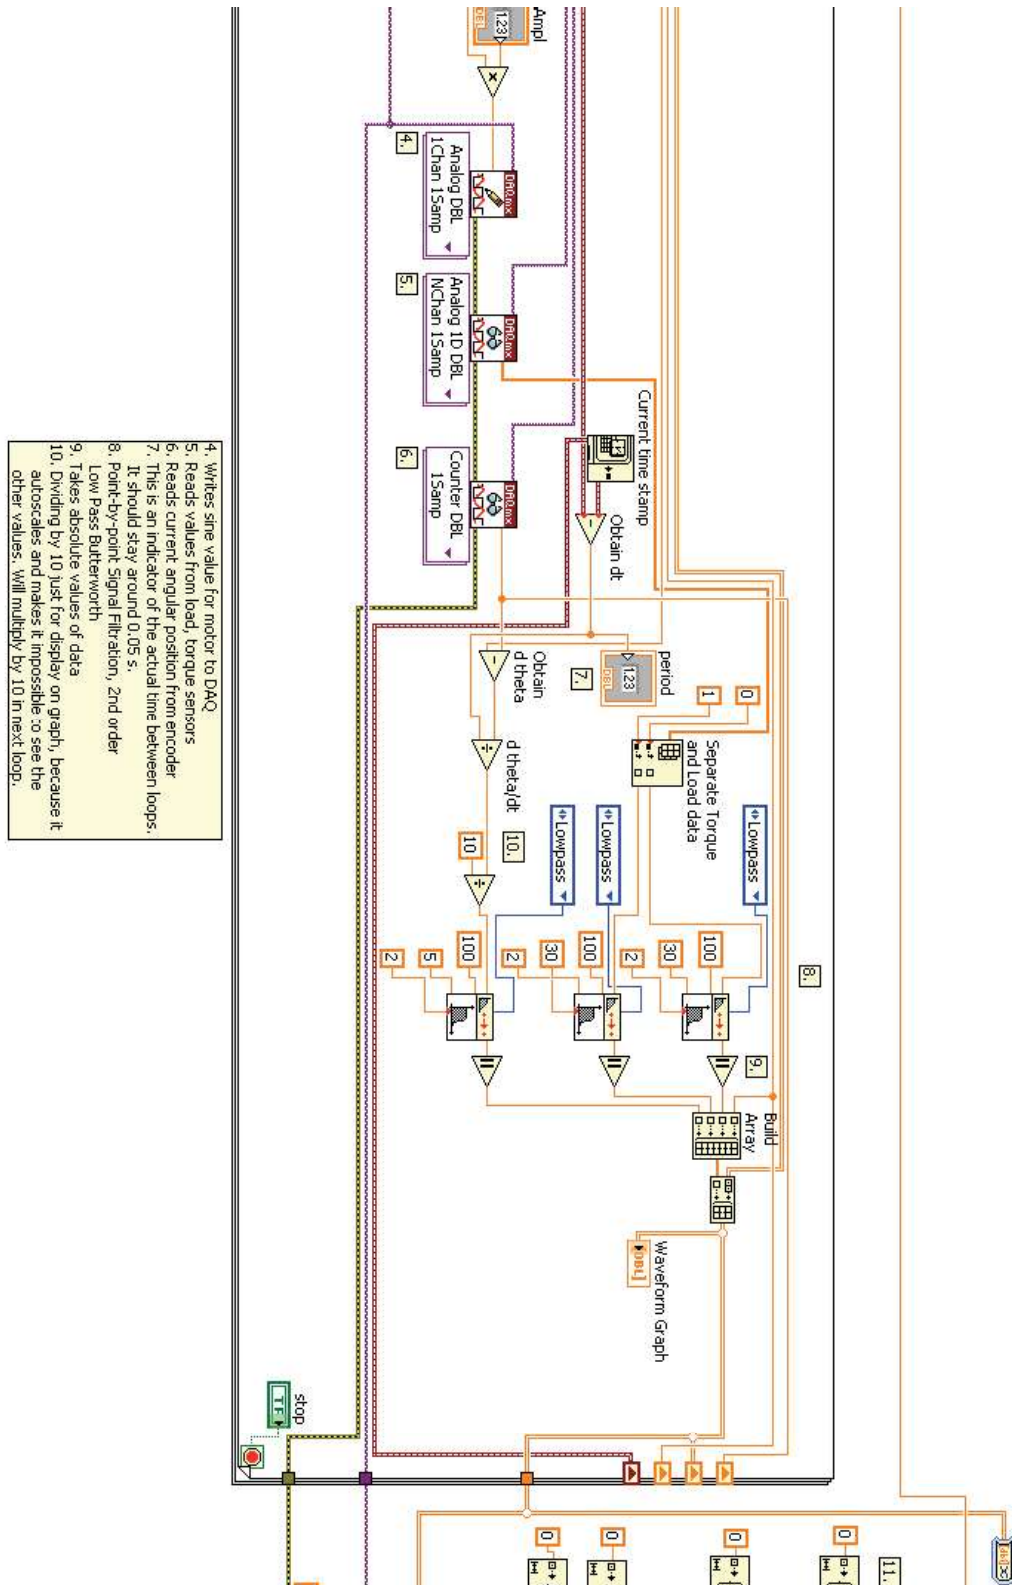
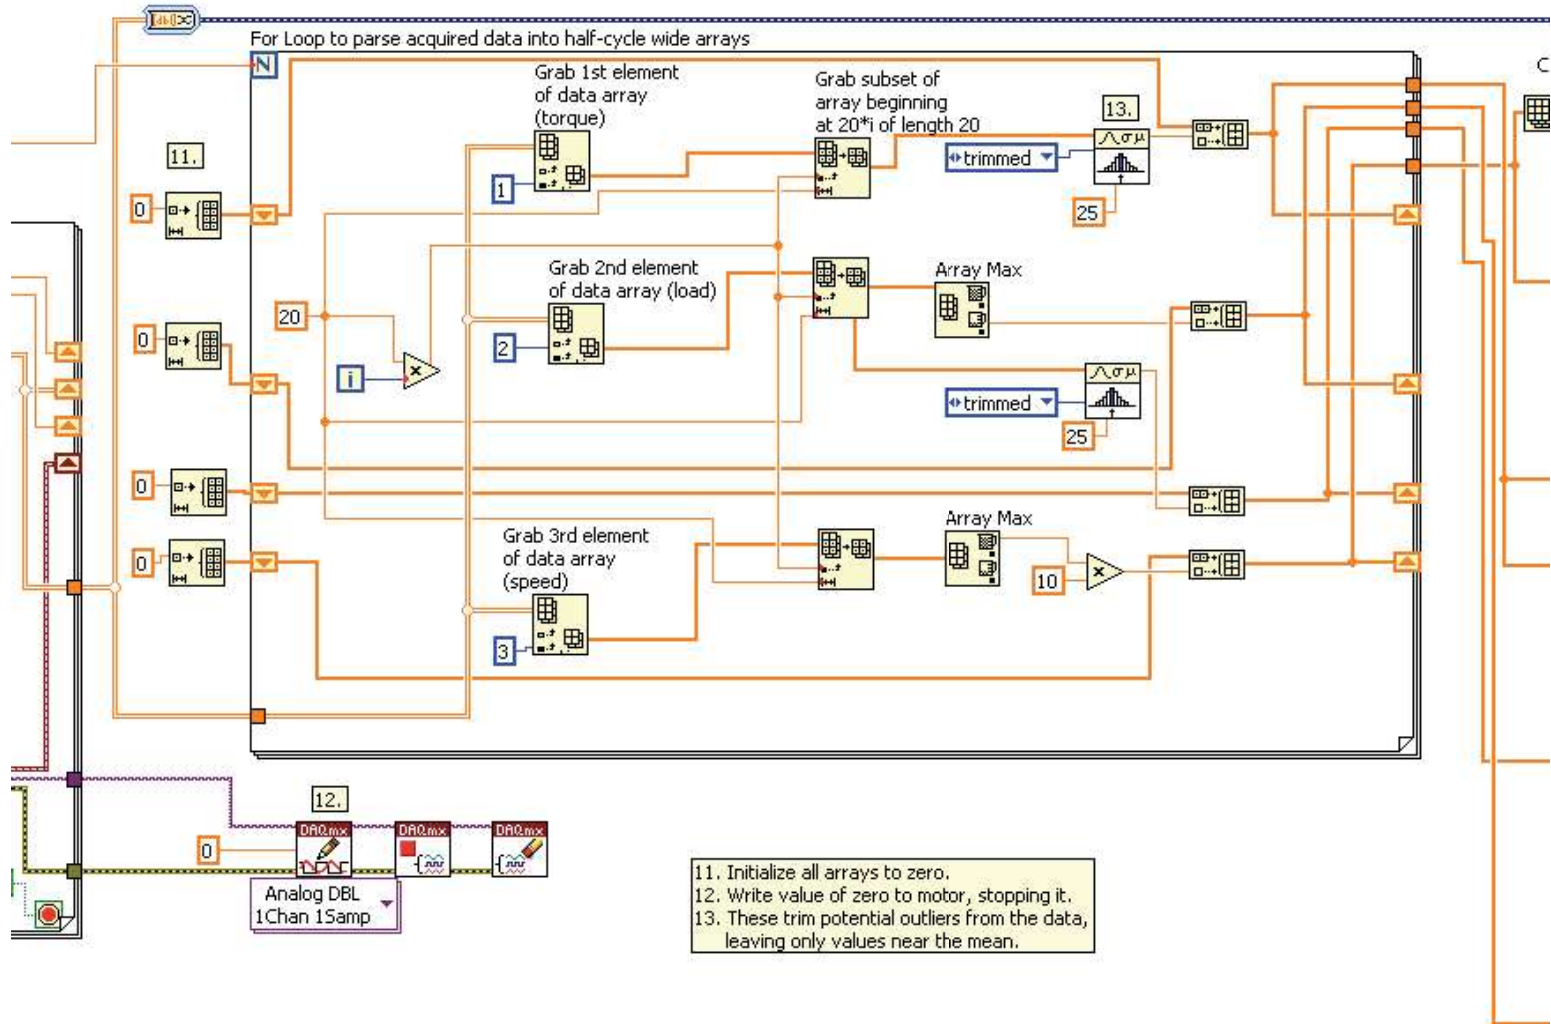
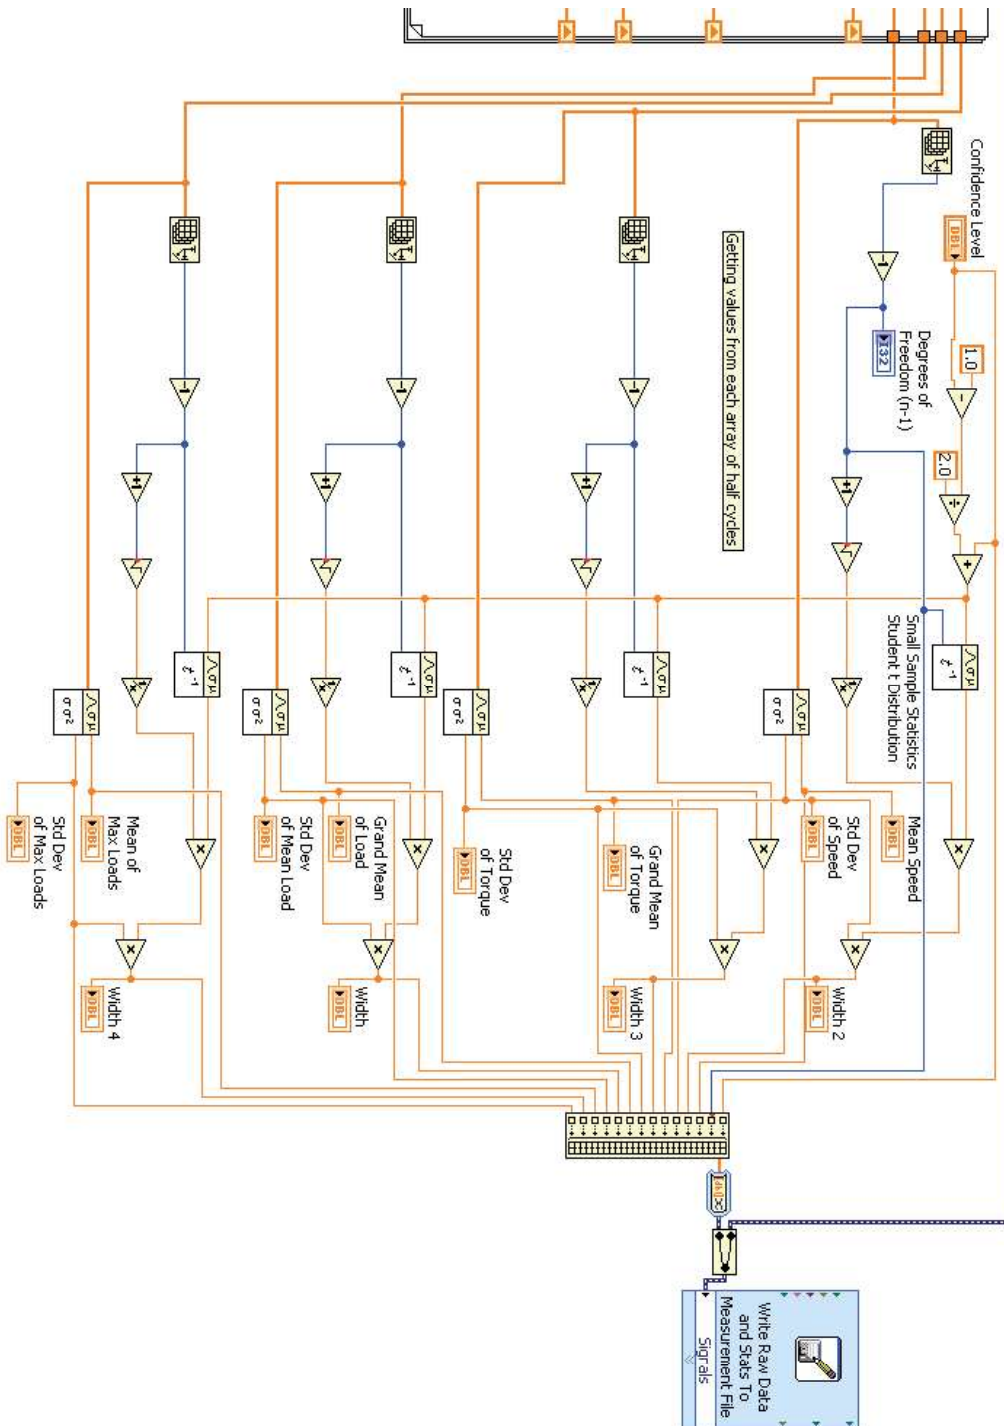
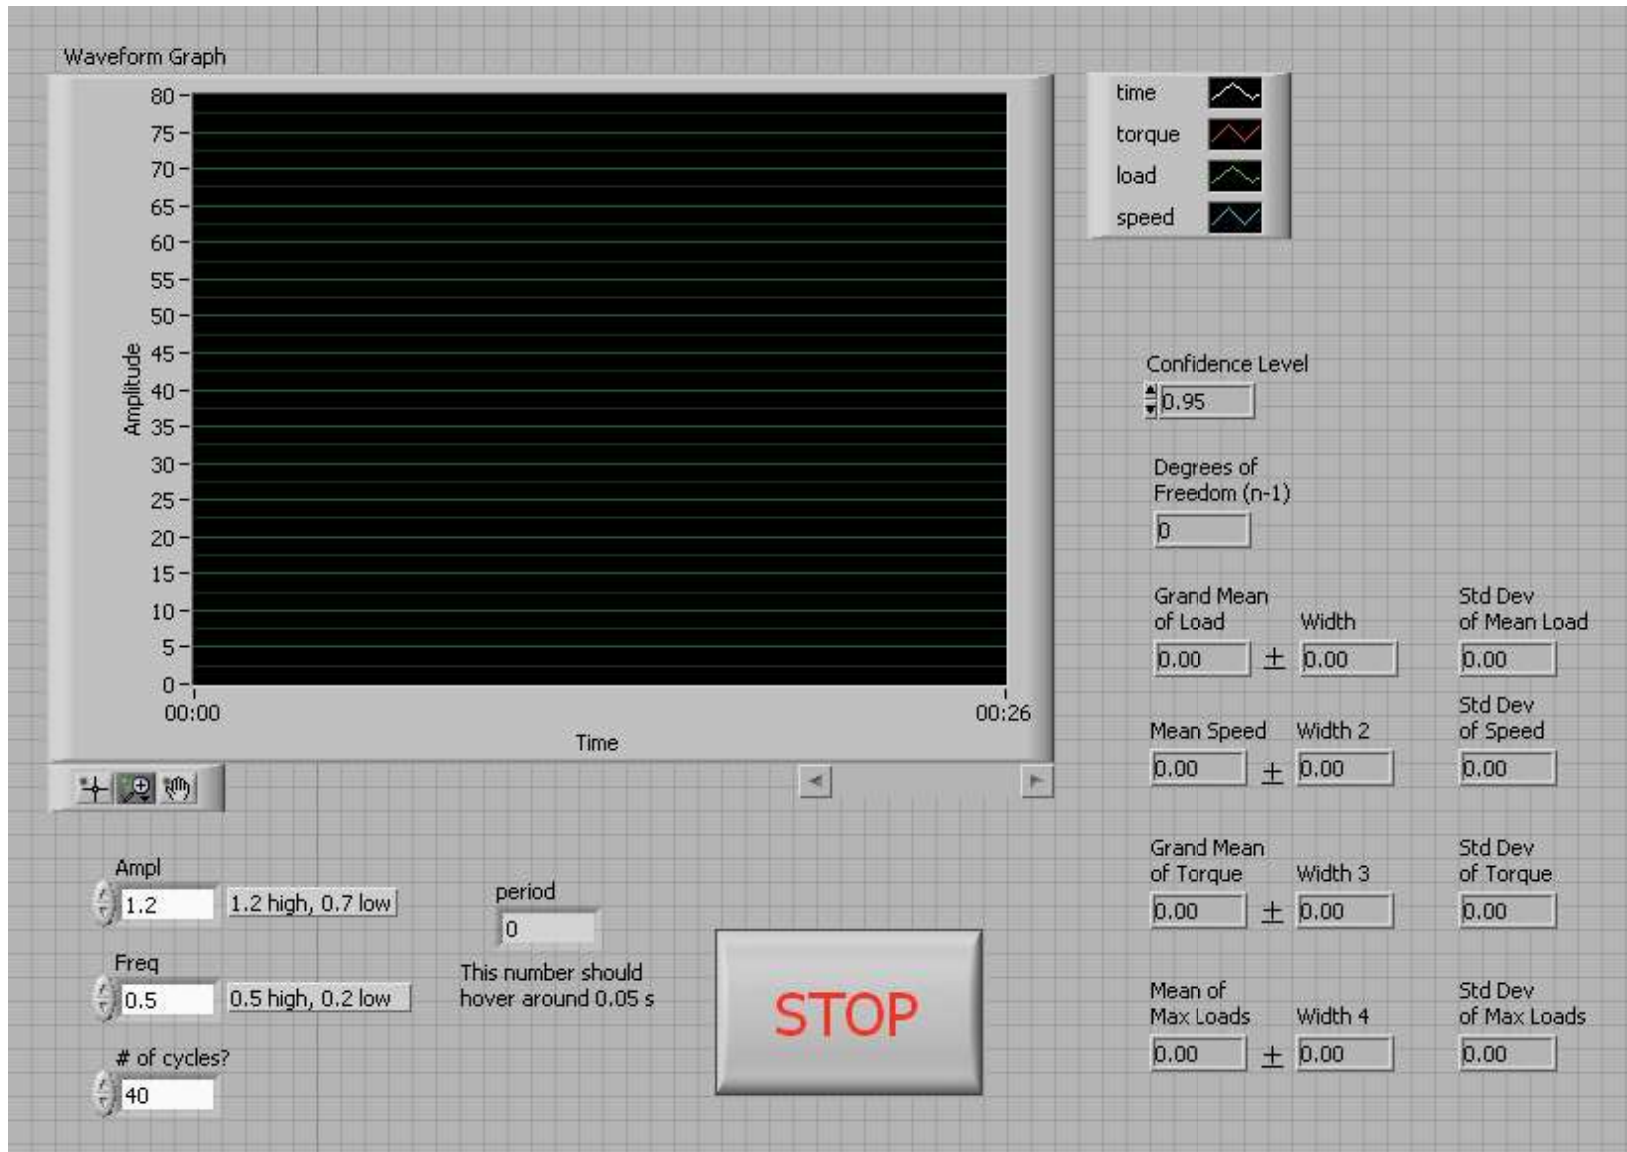
Figure 0-1

The following images show the LabVIEW Virtual Instrument that was written for the factorial experiment. The images should be tiled from left to right to obtain an image of the entire program. The final image shows the front panel of the VI.
