ZHUHAI COSMX BATTERY CO., LTD.,  
Petitioner

NINGDE AMPEREX TECHNOLOGY LIMITED,  
Patent Owner

Case IPR2023-00587  
Patent No. 10,964,987

**DECLARATION OF SAMUEL P. GIDO, PhD**

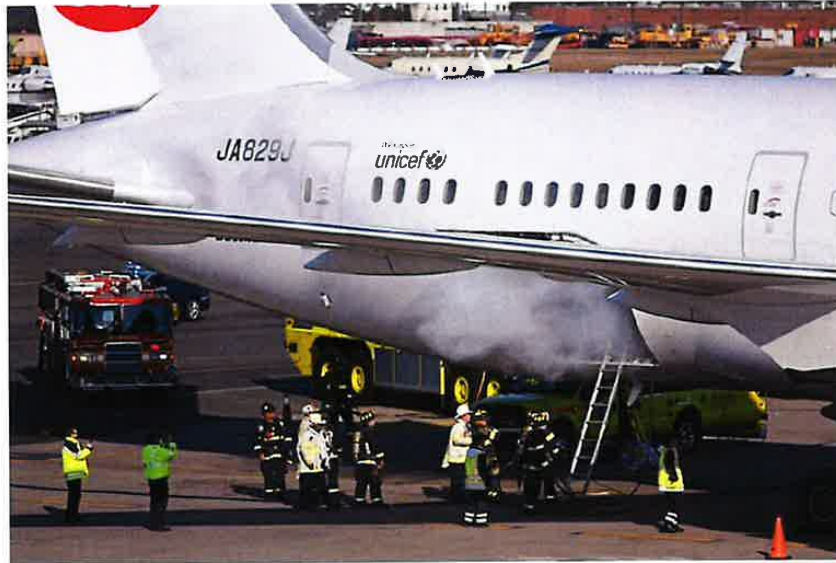
still present but was less intense than before. The airport security camera video showed smoke coming out of the airplane, as shown in figure 1, at 1040:26.

**Figure 1.** Photograph of smoke emanating from the incident airplane's aft E/E bay.

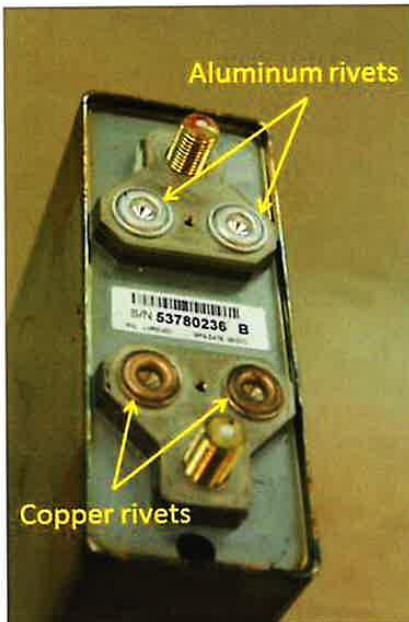
Each current collector attaches to two rivets that connect a collector plate with the respective terminal plate on a cell's exterior. Two aluminum rivets are installed at the positive terminal, and two copper rivets are installed at the negative terminal. The rivets provide electrical

continuity between the cell's exterior and interior. Figure 5 shows a photograph of a riveted header assembly. Section 1.5.5 discusses the postincident examination of riveted assemblies.

**Figure 5.** Riveted header assembly.

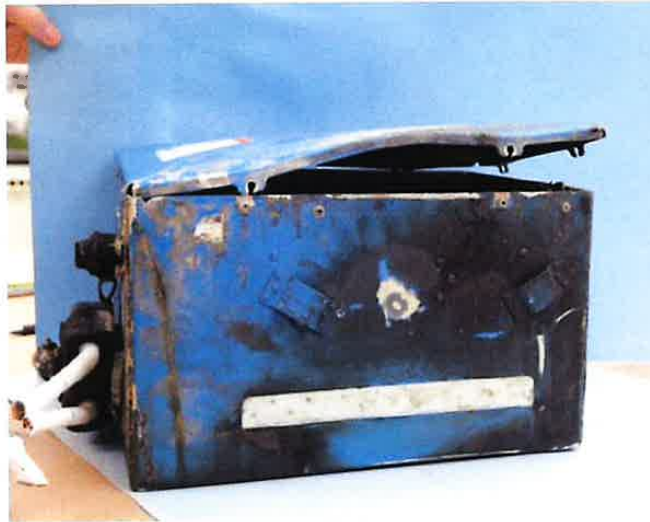
The lid on the battery case was bulged and creased. The right aft lid corner (as viewed from the front of the battery case) exhibited more soot, charring, and residue than the rest of the lid and the most damage to the lid fastening points.<sup>33</sup> Figure 6 shows the bulged battery case lid and side 4 of the battery case.

**Figure 6.** Right aft corner of the battery lid and side 4 of the battery case.

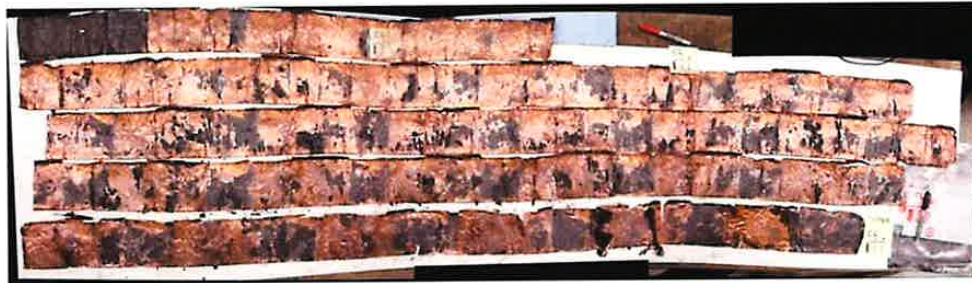
**Figure 14.** Cell 6 winding closest to cell 5.

The current collector sides of the winding assemblies (cell sides 2 and 4) appeared blackened and charred and had no remaining insulation material. The copper current collectors were intact and attached to the windings. The aluminum current collectors exhibited fractures with areas of missing material, and two of the three pairs of aluminum current collectors (those in the winding closest to cell 5 and the center winding) had fused and were disconnected from the header assembly. The other pair of aluminum current collectors were intact.
