## **Chapter 4. Conclusions and Recommendations**

### **4.2. Feasibility of Proposed Design of the End Effector**

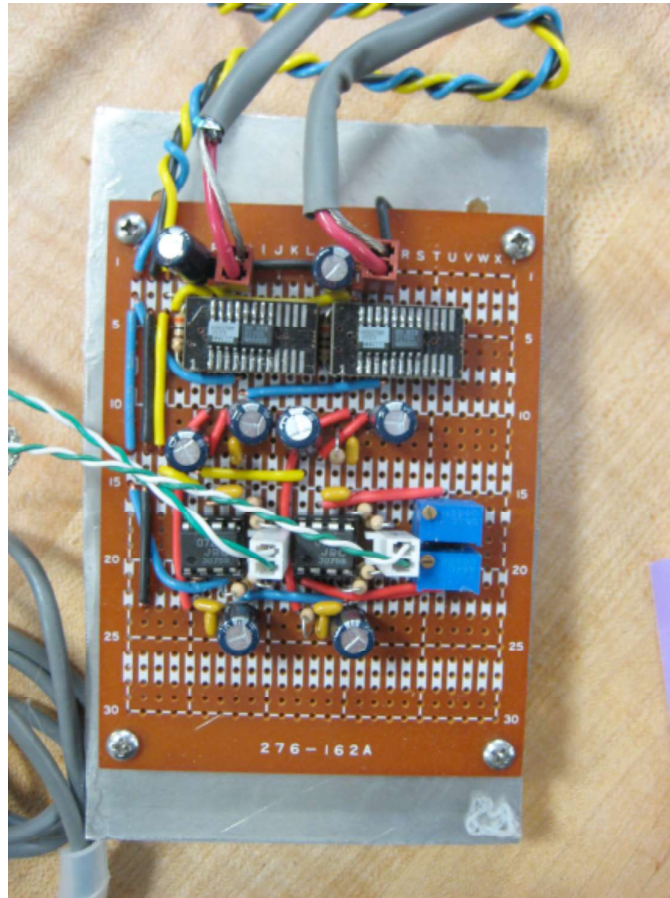
**Figure 3-15: Filtration and amplification circuit for instrumentation**

Because the amplification stages are not exact due to slight variances in component values of the electronics, it was necessary to calibrate the load and torque sensors. This was done through the National Instruments Measurement and Automation Explorer application using known masses for the load cell, and a calibrated torque wrench for the torque sensor.

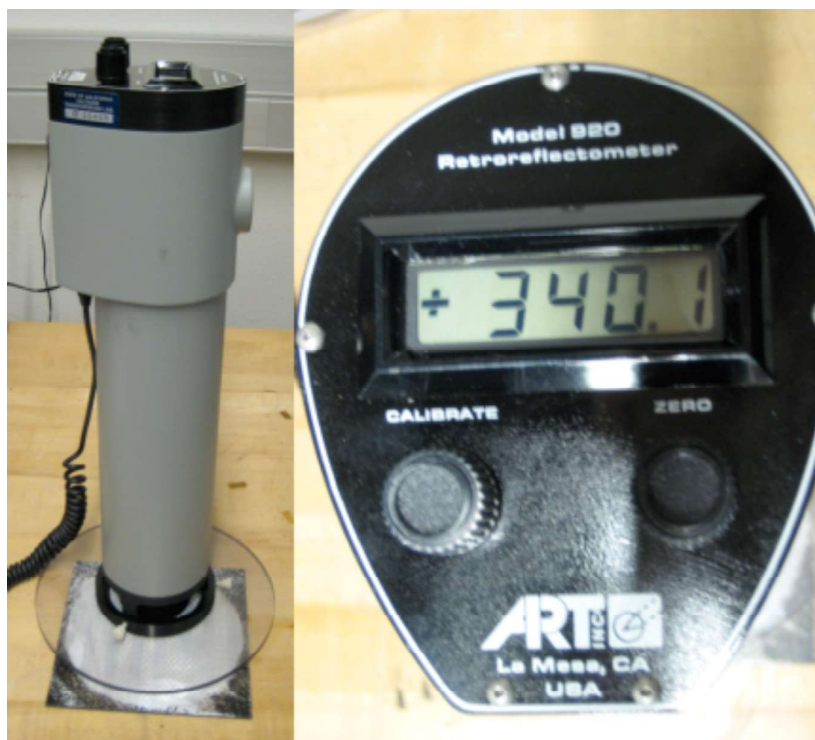
**Figure 3-16: Retroreflectometer; Detail of calibration knobs and readout**

Once all replicates of the test were run, the resulting coefficients of retroreflectivity ( $R_A$ ) were measured for each sign, to be later compared against control values. The  $R_A$  values were taken using a Model 920L field retroreflectometer manufactured by Advanced Retro Technology, Inc. First, the retroreflectometer was calibrated using two different materials of known  $R_A$ , by using the two knobs on the end of the retroreflectometer (Figure 3-16). The first material was a flat black felt surface with an  $R_A$  of zero, by which the retroreflectometer was zeroed out. The other material was a small piece of encapsulated glass bead retroreflective film with a known  $R_A$  of 308.

Once the retroreflectometer was calibrated, the  $R_A$  values of the control samples were taken. The standard method for taking the readings, as dictated by the manufacturer, was to take a measurement at roughly  $0^\circ$  orientation, another at the same spot but with the retroreflectometer rotated roughly  $90^\circ$ , and then to average these two measurements. This average value counts as one reading.

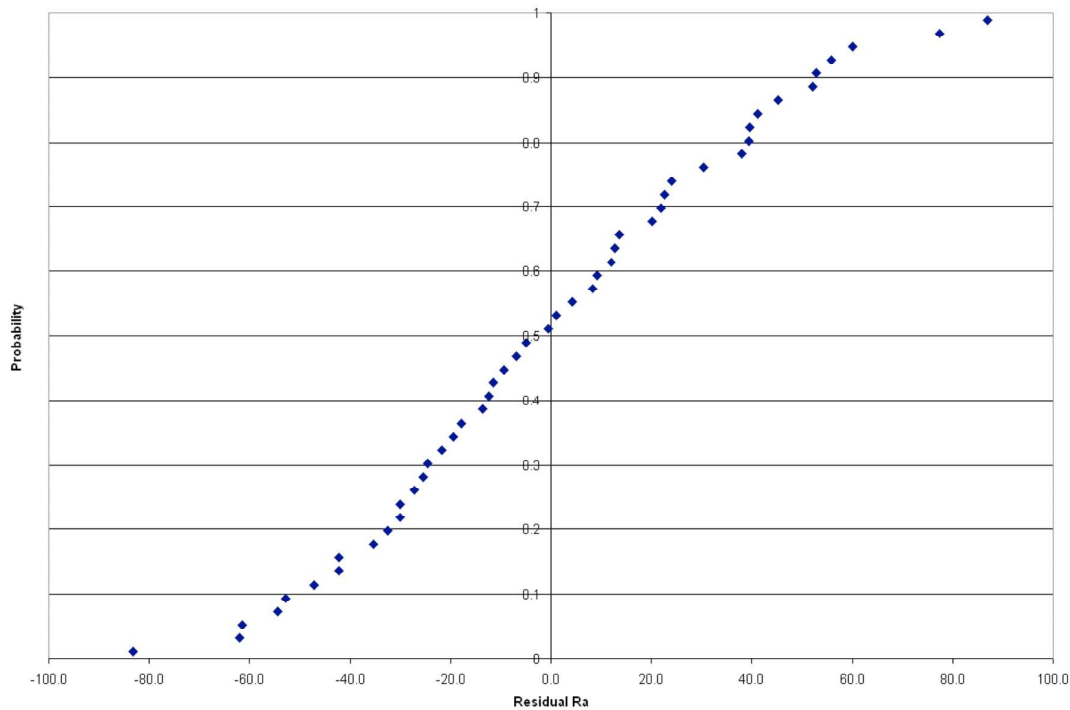
**Figure 3-17: Probability plot of residuals for  $R_A$  data**

In order to show that the data are distributed normally, thus making this analysis relevant, the residuals were calculated and used to generate a normal probability plot. The residuals are calculated by

which is the difference between the actual data point and the grand mean over all data points. Figure 3-17 shows the plot. Although the data are somewhat spread out, they appear to be normally distributed, and so the following analysis methods are most likely relevant.

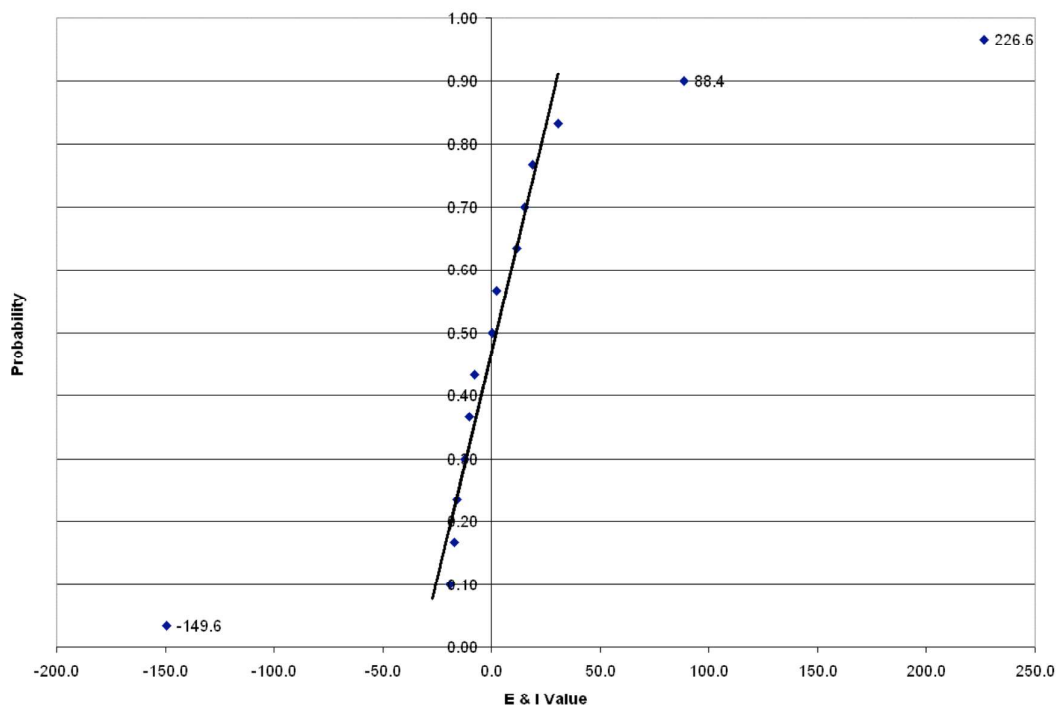
**Figure 3-18: Probability plot of ordered effects and interactions**

Knowing the factors that influence the amount of damage caused to the sign, a fitted model can be created from the calculated effects, as follows:

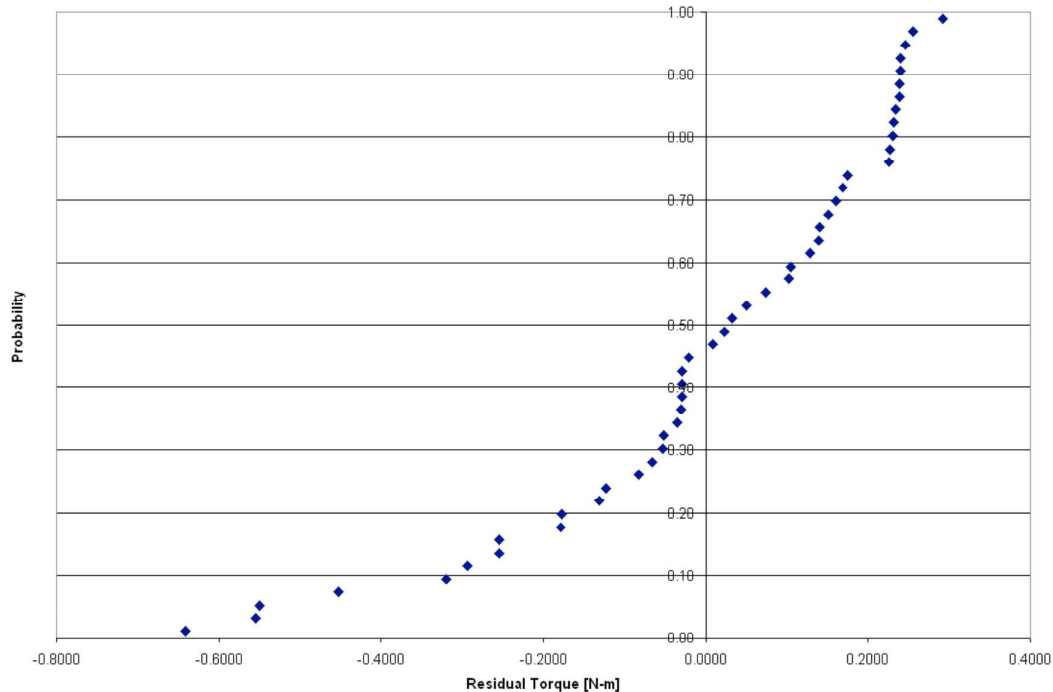
**Figure 3-19: Probability plot of torque residuals**

However, if the residuals are calculated and plotted in a fashion similar to Figure 3-17, the result is Figure 3-19. Note that the residuals do not appear to be distributed normally about the mean, which indicates that further investigation of the effects and interactions of the factors may not be accurate. However, it should be enough, looking at the raw data, to notice that the highest levels of torque appear in the runs which used the scouring pad on the 1160 film at high load (runs 14 and 16). The next highest levels of torque appear in the runs which used the scouring pad without the 1160 film at high load (runs 6 and 8). This may be enough information to suggest a motor size, given a particular brush choice and axial load.

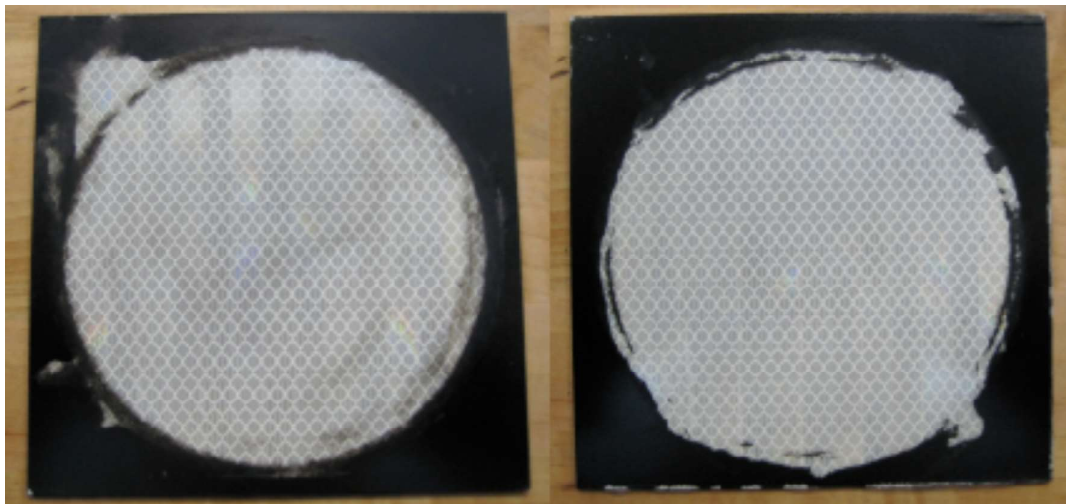
**Figure 3-20: Comparison of cleaned signs; Left with 1160, Right without.**

cleaning fluid, which could not be removed even with vigorous rubbing. This residue can be seen in Figure 3-20 as a mottled appearance in the cleaned area. Initially this was thought to be due to the paint adhering to signs with the 1160 film better than to those without, but further testing revealed that this was probably not the case. Instead, it was probably due to a lack of sufficient cleaner being used to remove the paint. Also, it appeared partway through the test that the paint seemed to be removed from the sign before the 40 cycles had passed, meaning that the runs could be of a much shorter duration. Thus, for future tests, the number of cycles was reduced from 40 to 20.

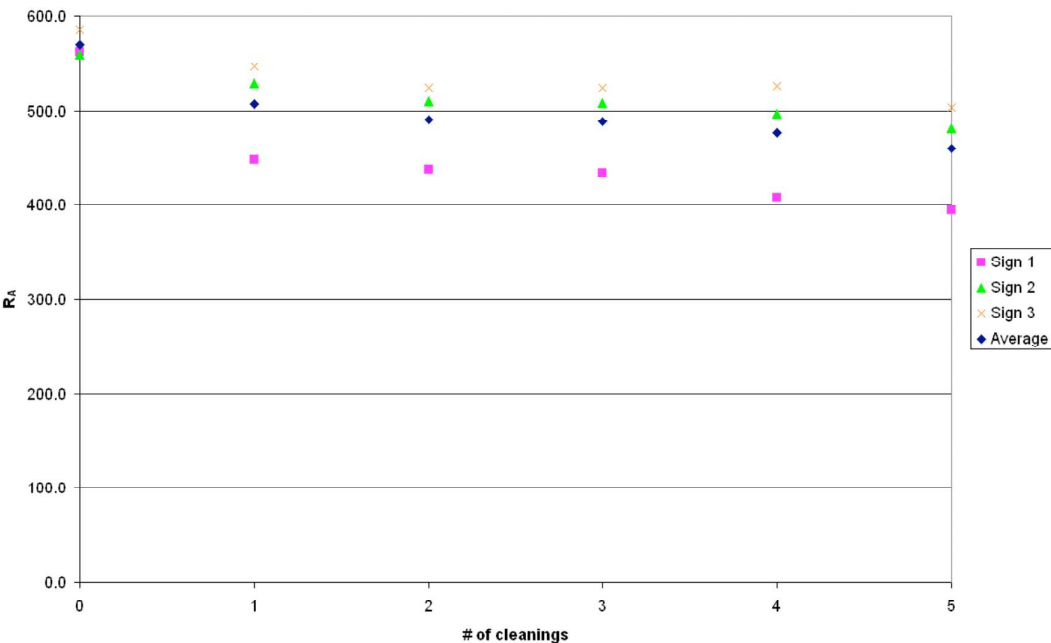
Figure 3-21: Results from multiple runs w/o 1160 film

rougher than a used one. Figure 3-21 shows the change in  $R_A$  for the signs without the 1160 film, and Figure 3-22 shows the change for those signs with the film.

These results were somewhat surprising. With the results from the factorial experiment, it was thought that the  $R_A$  would degrade steadily over several cleanings. Instead, what happened is the reduction in  $R_A$  leveled off, and in the case of the signs with the 1160 film actually began to improve dramatically. Visual inspection of the signs after the initial tests showed a fair amount of scratching on the surface from the new pad, but over time the samples began to regain a shiny surface again. It is thought that the reason for these results was probably a combination of pad wear and the characteristics of the cleaner. After the first few uses, the surface of the pad took on a noticeably softer feel which seemed to reduce its abrasive qualities. Additionally, once the SEI Graffiti Remover was applied and the solvent allowed to evaporate, the cleaner that was left behind had a waxy consistency which may have aided in "polishing" the sign. At any rate, it appeared that it was possible to clean the signs multiple times without significant damage, as the  $R_A$  levels never approached the minimum levels mandated by the FHWA.

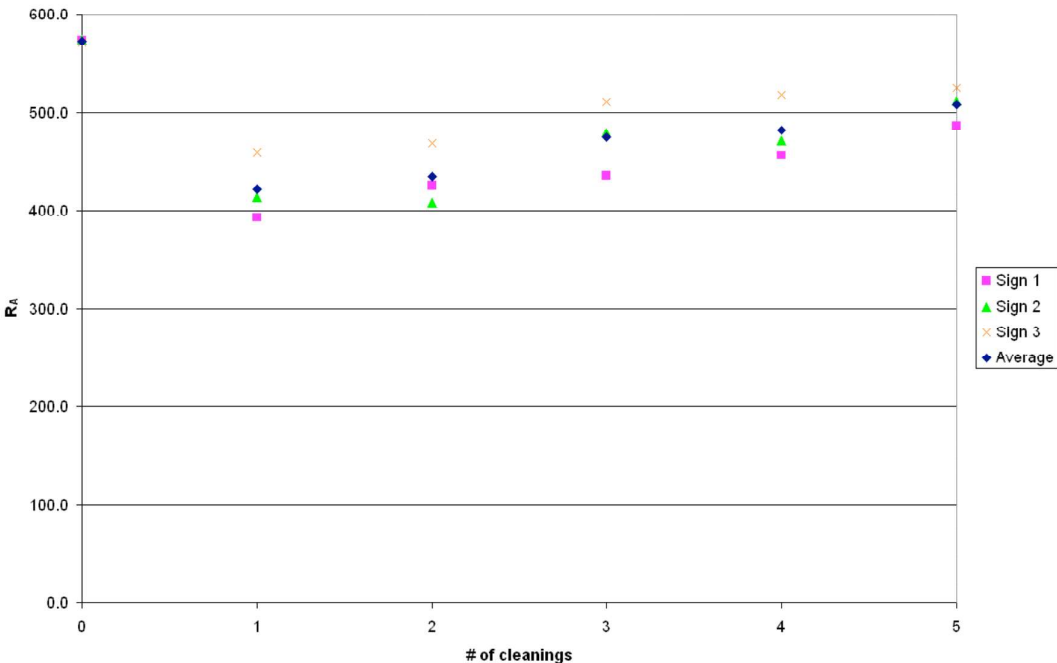
Figure 3-22: Results from multiple runs with 1160 film

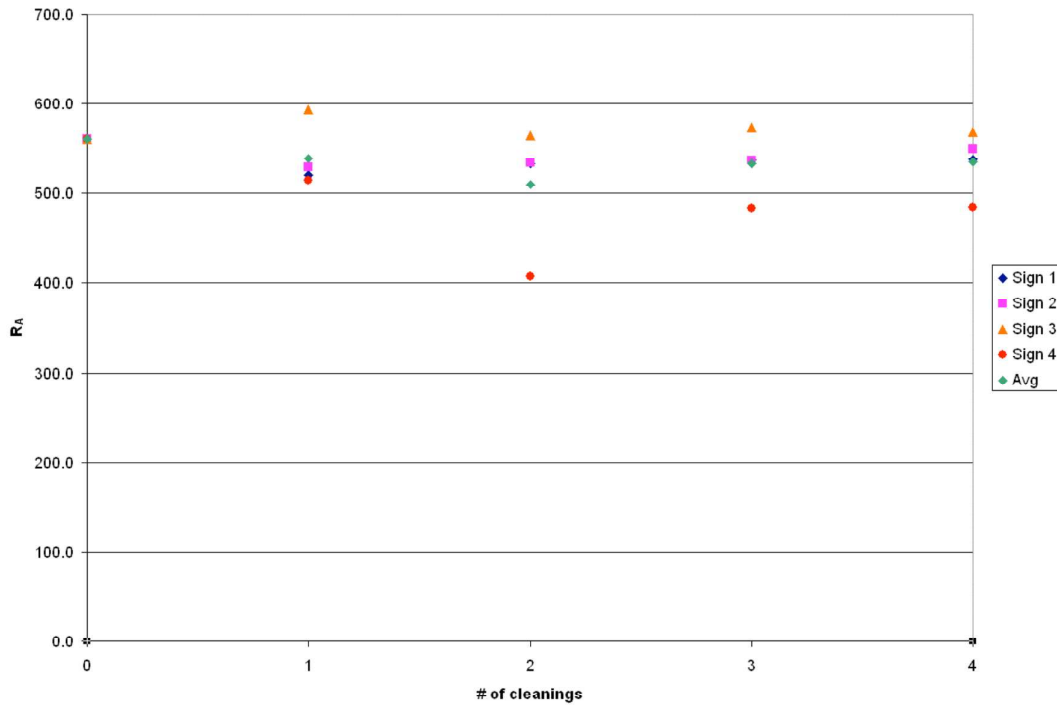
Figure 3-23: Multiple cleanings on painted signs w/o 1160

For the last test in the series, attempts were made to simulate a situation likely to be faced by maintenance workers: cleaning a sign that has been painted multiple times. The paint used was the same flat black spray paint used in the single-run test, was applied the same way and allowed to cure for at least 48 hours each time. Due to time constraints, only four cleanings were possible. Again, both signs with and without the 1160 film were tested, and the tests were run for 20 cycles. The pad used was the same one from the previous test, indicating that initial damage should not be a problem. Figure 3-23 shows the results from the signs without the 1160 film, and Figure 3-24 shows the results from those with the film.

While these results are not as dramatic as those from the previous test since none of the signs improved over several cleanings, it is notable that the  $R_A$  never really got close to the FHWA minimum levels. This indicates that it is probably possible to use the proposed design of a motorized pad and chemicals to clean a sign.

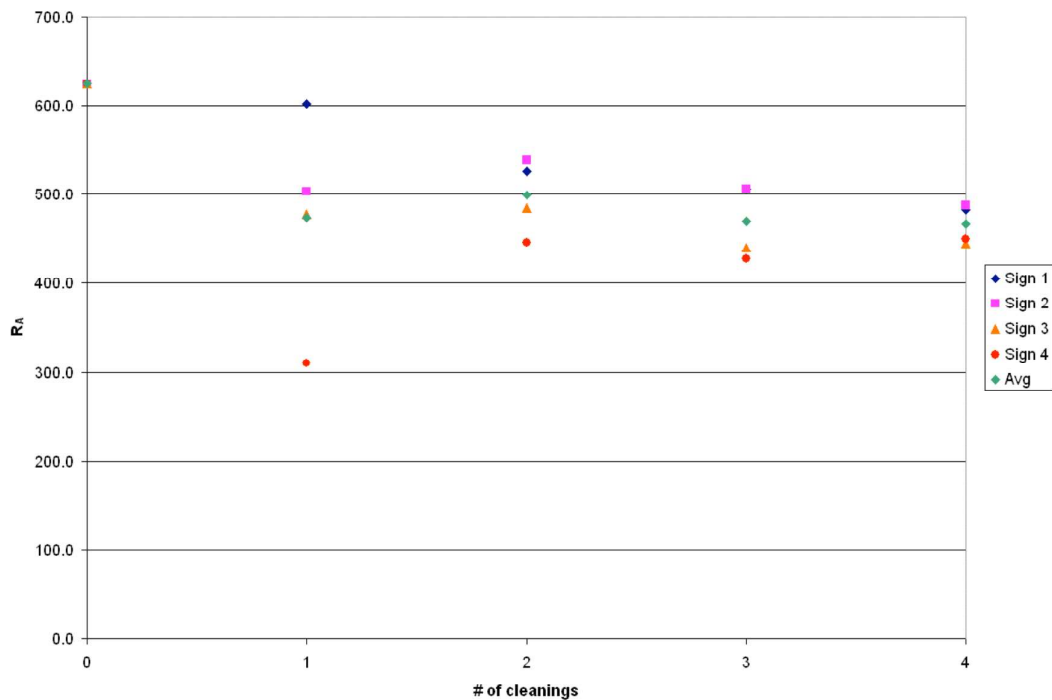
Figure 3-24: Multiple cleanings on painted signs with 1160

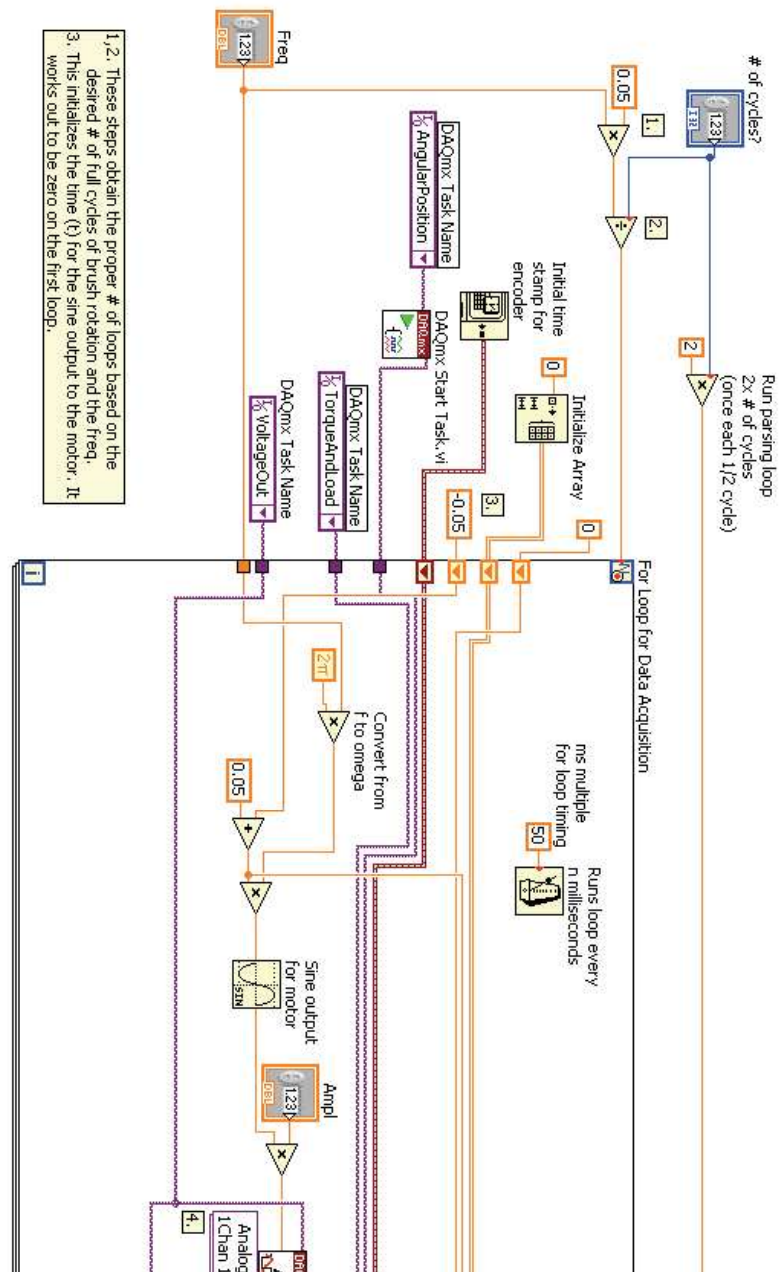
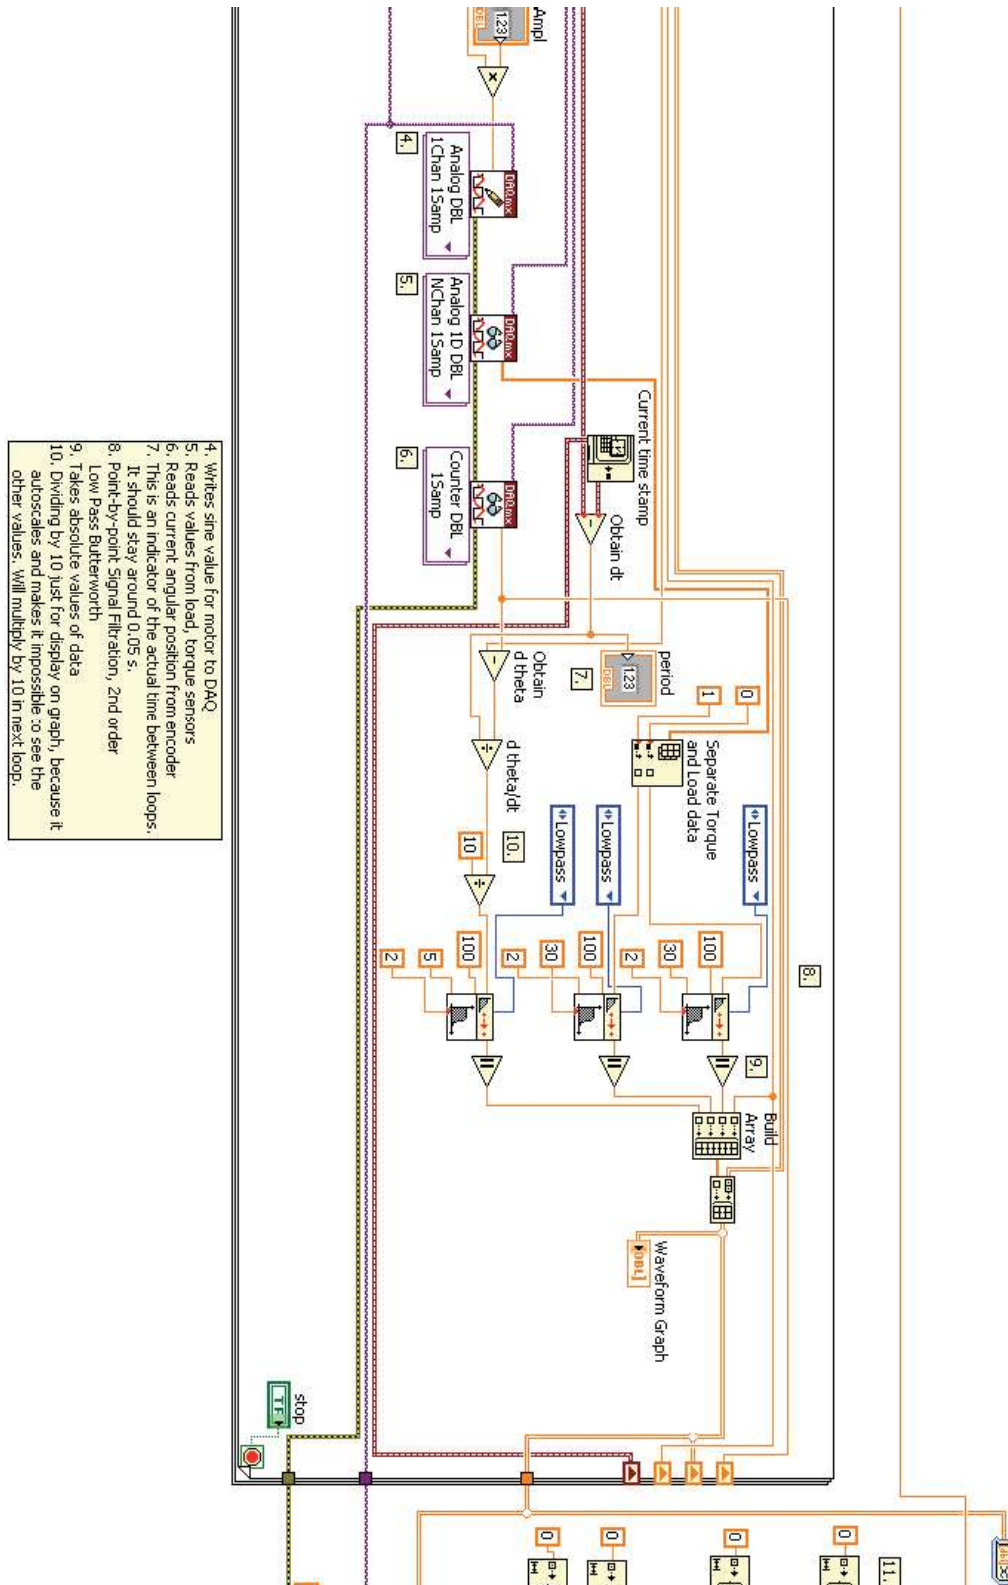
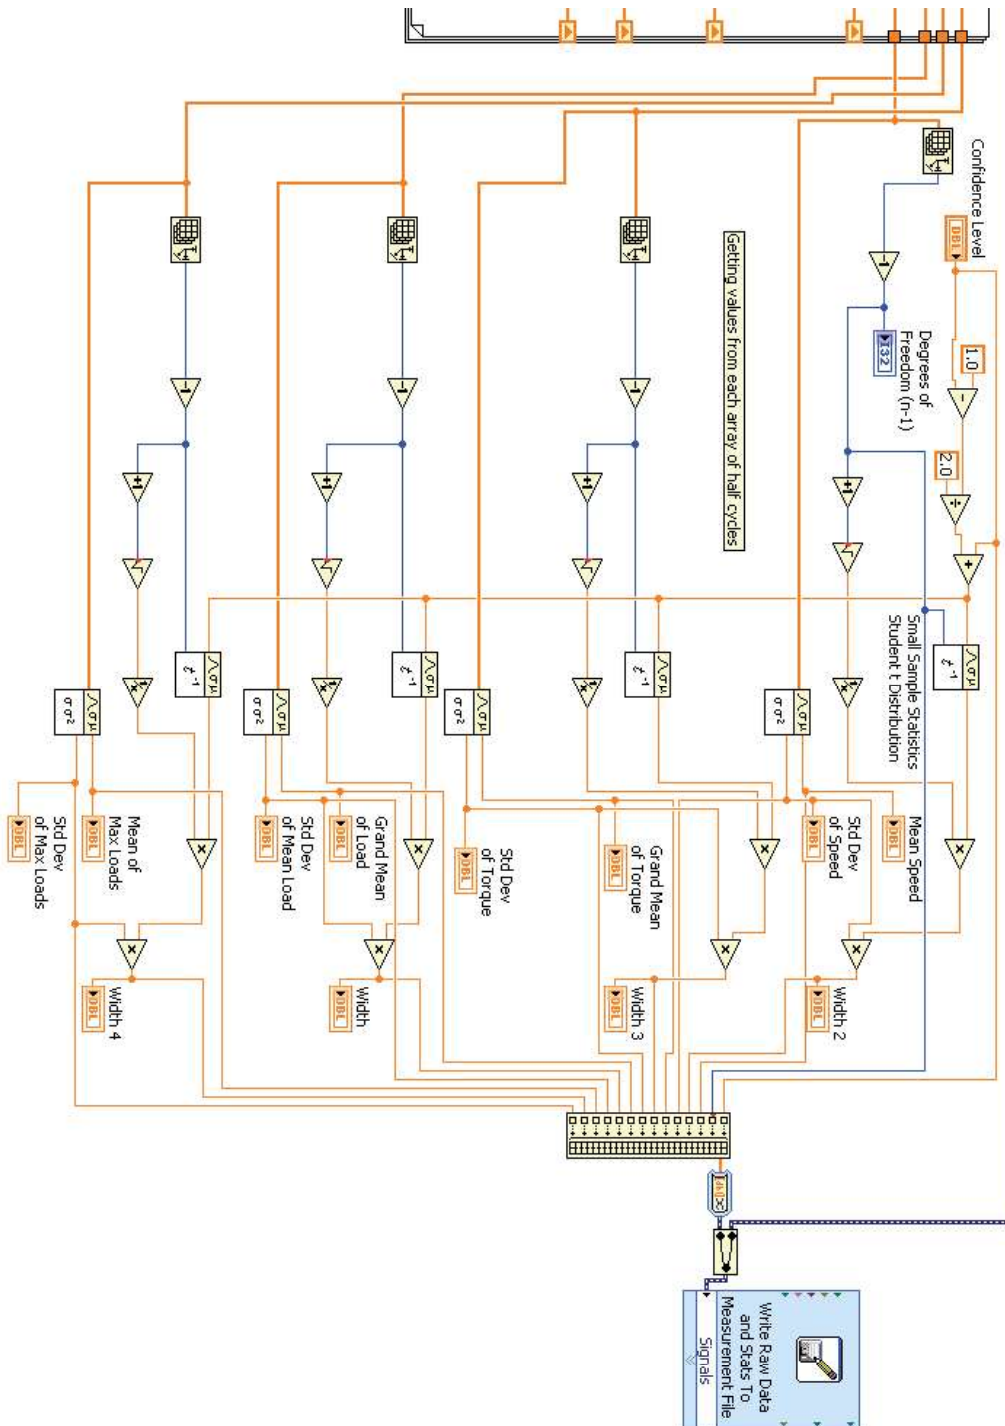
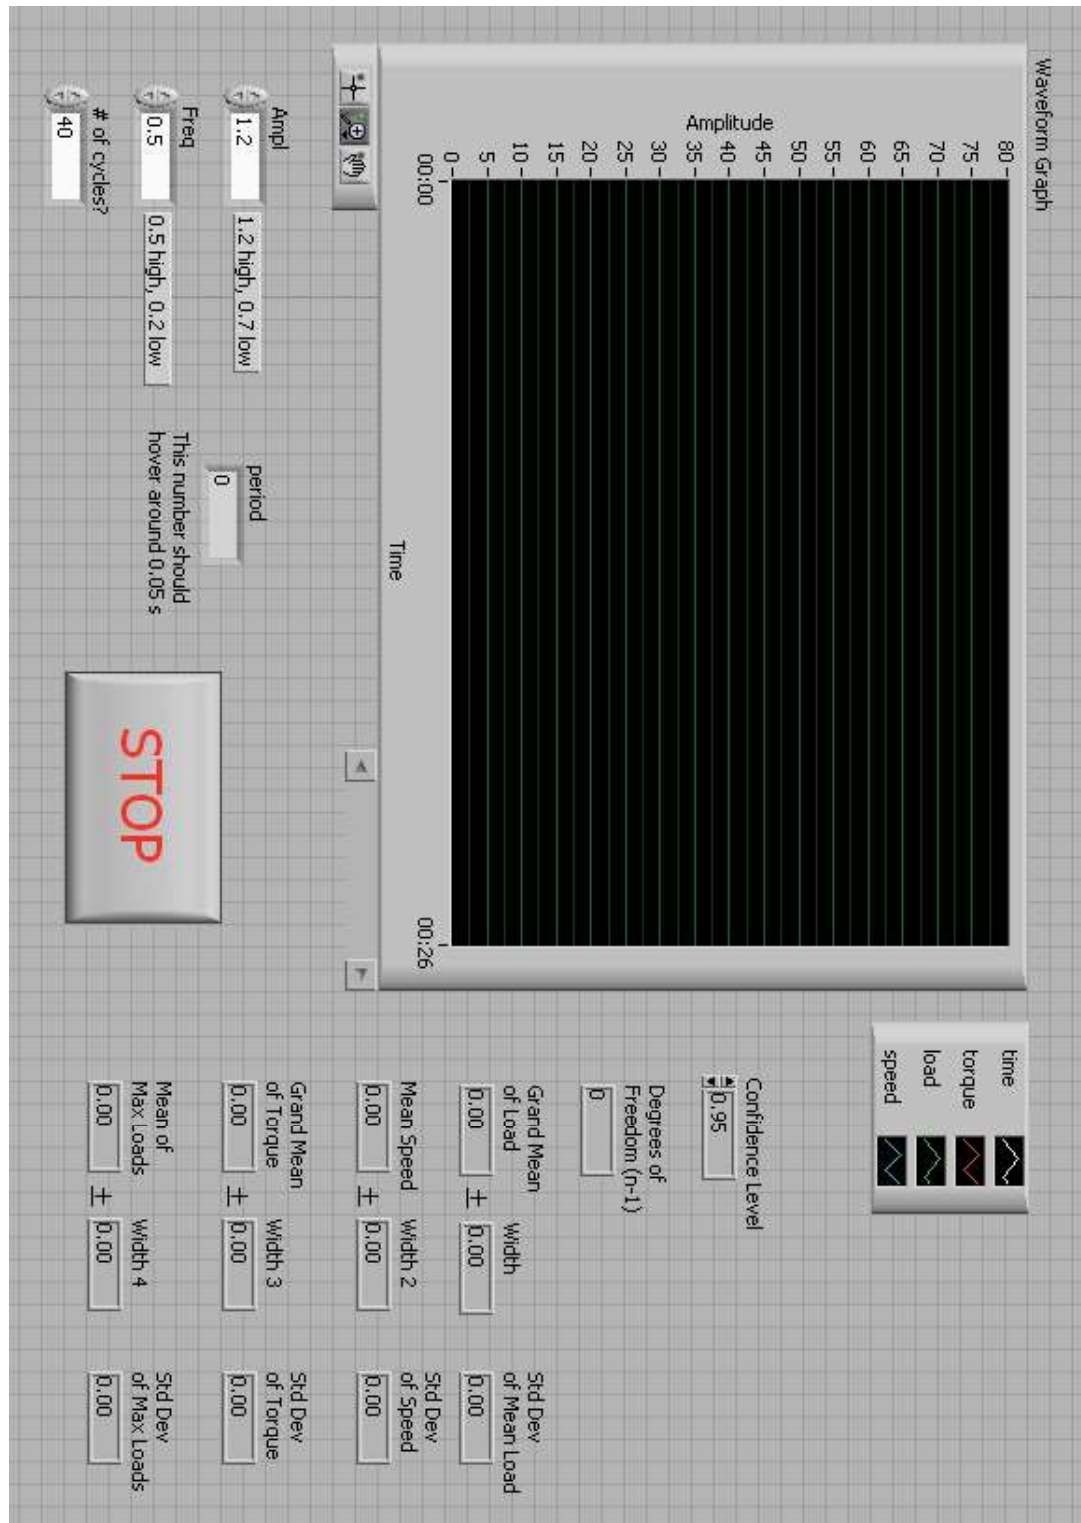
Figure 0-1

The following images show the LabVIEW Virtual Instrument that was written for the factorial experiment. The images should be tiled from left to right to obtain an image of the entire program. The final image shows the front panel of the VI.
