Hydrate Formation in Chevron Mabee Unit for NGL Recovery and CO_2 Purification for EOR

Submitted to Gas Processors Association 2017 by:

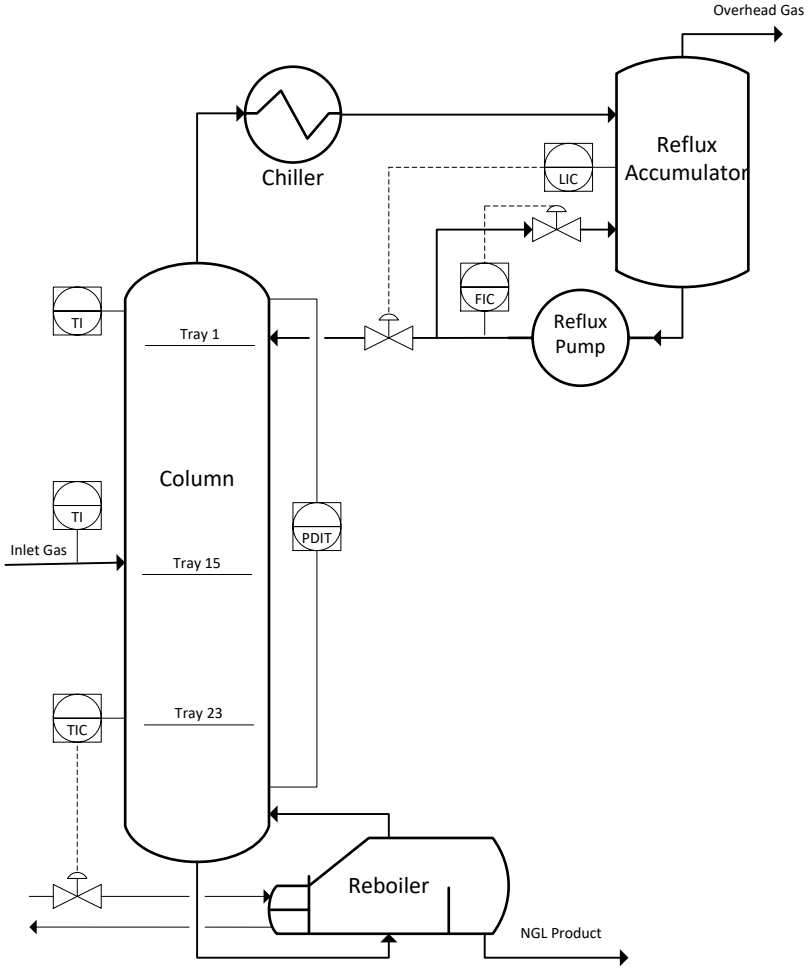
Figure 1: Process Flow Diagram of Distillation Column and Reflux

The distillation column is a 26-tray tower equipped with a partial condenser and reboiler, as shown in Figure 1. A pressure differential transmitter spans from tray 1 through tray 26. Temperature transmitters are equipped at the column overhead, column inlet located at tray 15, tray 23, and column bottoms. Propane is used as the refrigerant in the partial condenser. The reflux accumulator level is maintained through the use of continuously operating pumps along with a level control valve feeding the reflux back into the column and a flow control valve recycling reflux back to the accumulator.

After deployment, the distillation tower experienced what plant operations coined as "reflux events." During these events, the reflux level in the reflux accumulator would suddenly rise at a rapid rate. The level would remain high and overwhelm the tower reflux system. Corrective action involved warming up the chiller outlet temperature to stop liquid generation until the reflux accumulator level fell within the normal operating range. This pattern is shown in Figure 2. These corrective measures disrupted the temperature profile across the column, reduced NGL production, increased H_2S content in the NGL product, and required continuous involvement from plant operators.

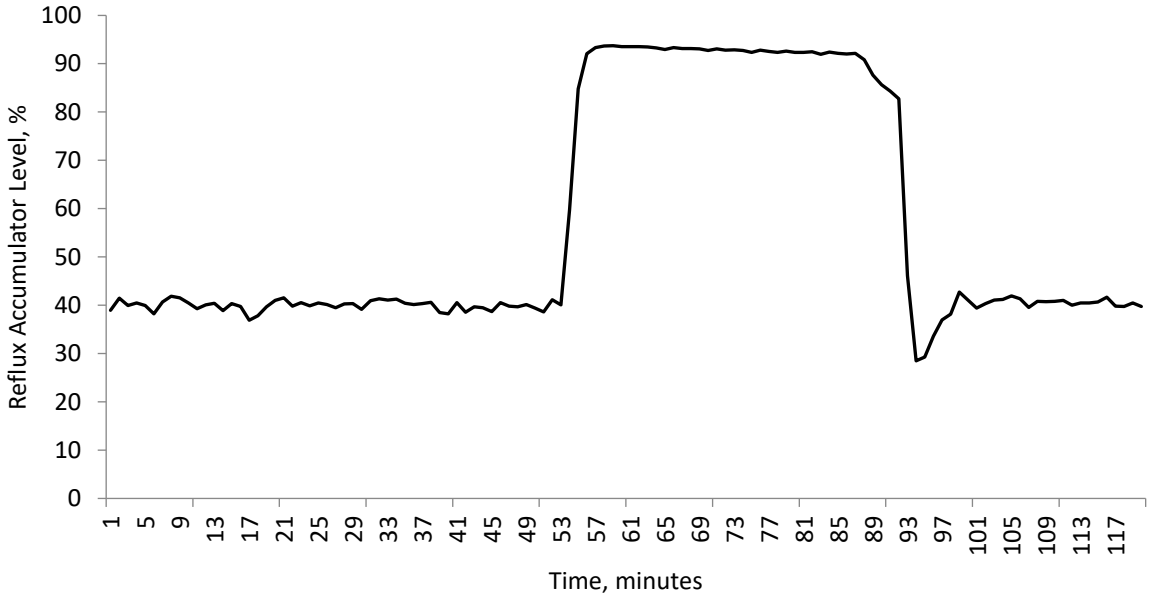
Figure 2: Example of Reflux Accumulator Level Versus Time During a Reflux Event

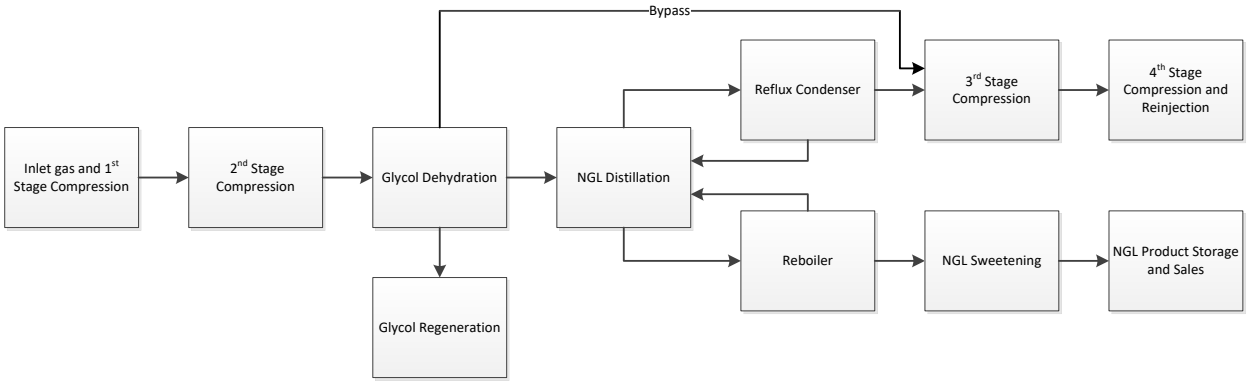
Figure 3: Mabee Gas Plant Block Flow Diagram

To thoroughly diagnose the abnormal conditions, the team reviewed the operations upstream of the NGL Recovery Unit. As shown by Figure 3, upstream of the distillation tower, glycol dehydration removes water from the process gas in preparation for NGL extraction. If water exceeds certain thresholds in the NGL recovery column, the water can become trapped in the tower trays, leading to blockages and, if conditions allow, hydrate formation.

Initially, it was thought that the reflux events were not a result of hydrate formation or trapped water as field instrumentation indicated very low water content in the feed gas. When modeled with an inlet feed water content below 3 lbs/MMscf, the process simulation model predicted no hydrate formation in the NGL recovery column. Additionally, the pressure differential transmitter across the tower spanned 0 to 1 psi across the tower trays, offering little insight as to the tray loading both leading up to and during the events. Figure 4 illustrates data collected in the facility where reflux events were observed despite data indicating moisture content to the tower well below the design requirement of 3 lb/MMscf.

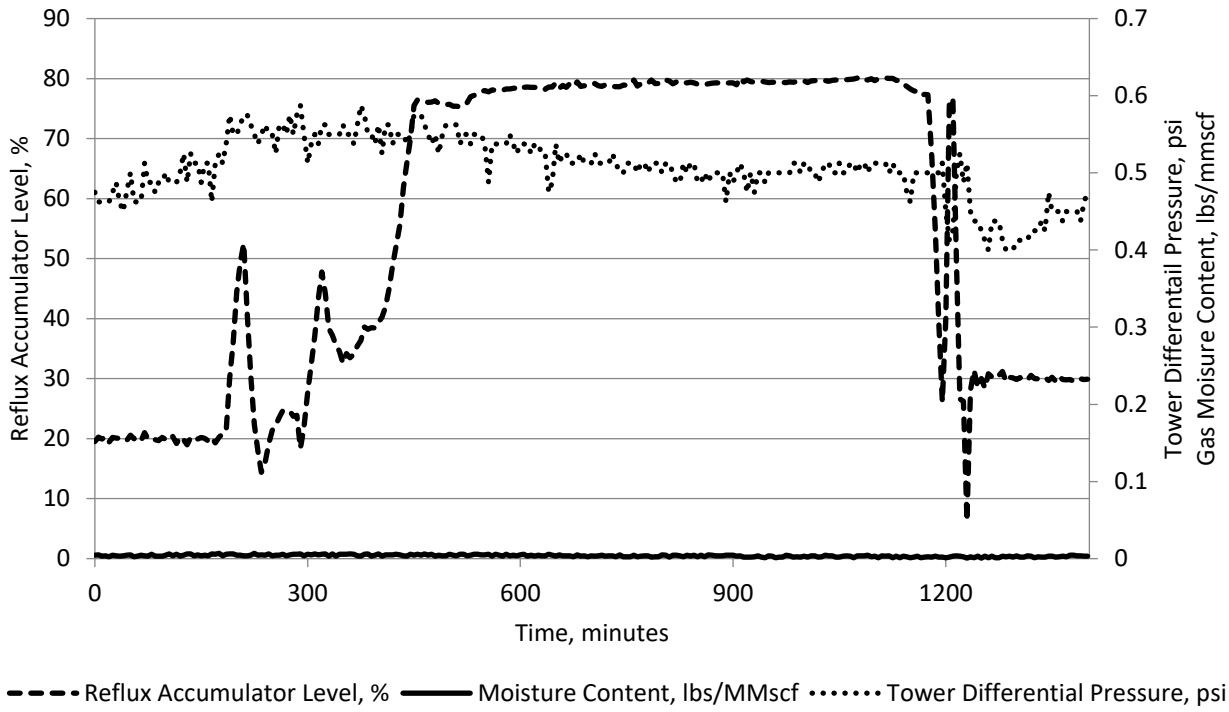
Figure 4: A Typical Reflux Event as Shown Through Reflux Accumulator Level, Inlet Moisture Content, and Tower Differential Pressure

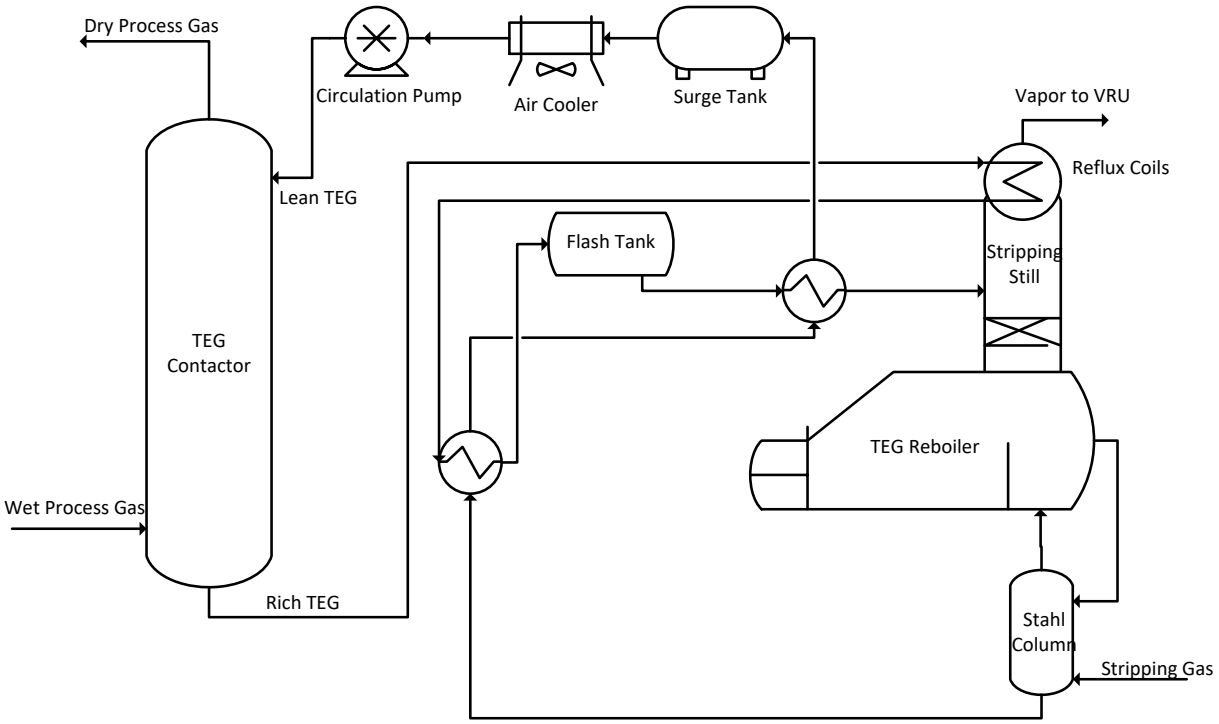
Figure 5: Process Flow Diagram for Gas Dehydration and Glycol Regeneration

Improvements to the operation of the existing facility were required to be fully aligned with pre-deployment expectations for the performance of the integrated NGL recovery unit. The team focused on reducing water content to the NGL recovery unit through process optimization. The dehydration system, in place before the addition of the NGL recovery unit, uses triethylene glycol as a solvent to physically absorb water. The water rich glycol is then regenerated and returned to the contactor to start the process all over again as shown in Figure 5.

The solvent circulation rate, reboiler temperature, stripping gas flowrate and process gas inlet temperature were all considered during optimization. At the time of troubleshooting, the reboiler temperature was 375 ^{o}F while circulating 25 sgpm of TEG without stripping gas.

While the optimum TEG circulation rate was found to be near 3 sgpm, pump constraints prevented the TEG rate from being less than 12 sgpm. Therefore, the TEG circulation rate was reduced from 25 sgpm to 12 sgpm. Optimizing the circulation rate in and of itself would not reduce the dry gas water content to hydrate free levels in the NGL recovery unit. The addition of stripping gas was needed to accomplish this goal. At a constant glycol circulation rate of 12 sgpm, the dry gas water content was studied at various reboiler temperatures and stripping gas rates in Figure 7.

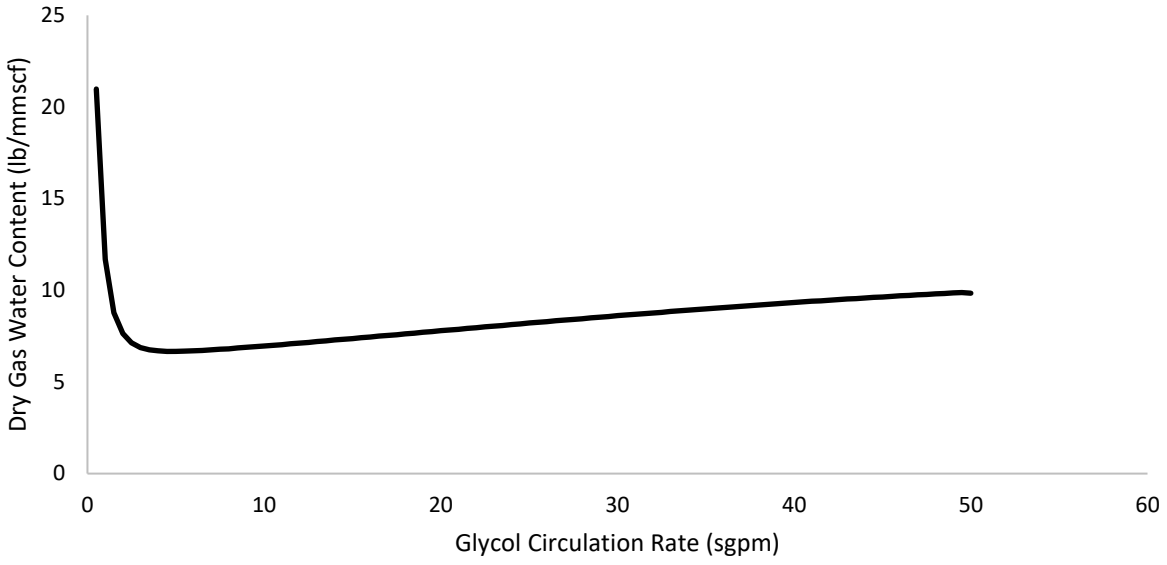
Figure 6: TEG Circulation Effect on Dry Gas Water Content Without Stripping Gas

The trend may counter previously held understandings that more glycol circulation results in a dryer gas, but is easily explained when looking at the temperature effect the solvent circulation has on the dry gas. The lean TEG will have a higher temperature than the wet gas. Typically, the lean TEG temperature effect on the dry gas temperature is negligible due to the significantly lower flowrate when compared to the high flowrate of the gas, as it is common to maintain a 3:1 ratio of glycol being circulated to water being removed. The Mabee plant was operating at about 25 gallons of glycol per pound of water being removed. If the lean glycol flowrate is increased, it increases the temperature of the column, which shifts the water equilibrium point in the gas. A warmer gas holds more water [2]. At low flowrates of TEG, the temperature effect is insignificant. Having knowledge of this trend prevents the temptation to circulate more TEG. Keeping the circulation rate low ensures the gas stays as cool as possible through the contactor.

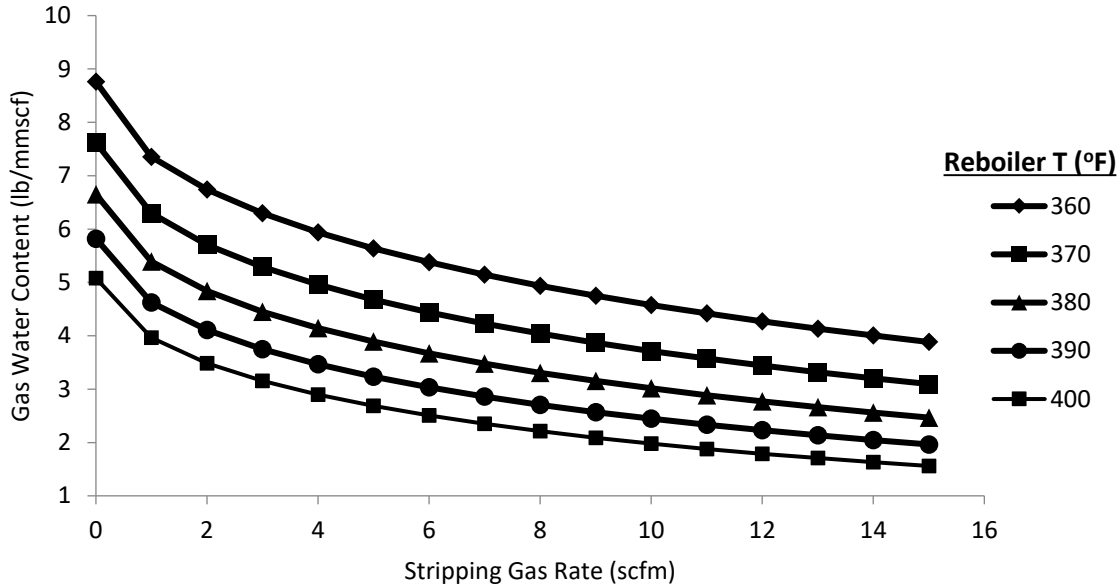
Figure 7: The Effect of Stripping Gas and Reboiler Temperature on Dry Gas Water Content

With no stripping gas to the dehydration unit, Figure 7 shows that even a reboiler temperature of 400 °F is not sufficient to reduce feed gas moisture content below 3 lbs/MMscf [4]. As glycol is known to degrade at temperatures higher than 400 °F, it is necessary to introduce some stripping gas to the system in order to achieve the desired water content [4]. Since multiple combinations of reboiler temperature and stripping gas rate can achieve the desired result, operational costs can be calculated and compared across the probable cases to determine the most cost effective solution. In this case, the reboiler temperature and stripping gas rate were increased to 390 F and 6 scfm, respectively, in order to achieve a moisture content averaging around 3 lbs/MMscf to the tower.

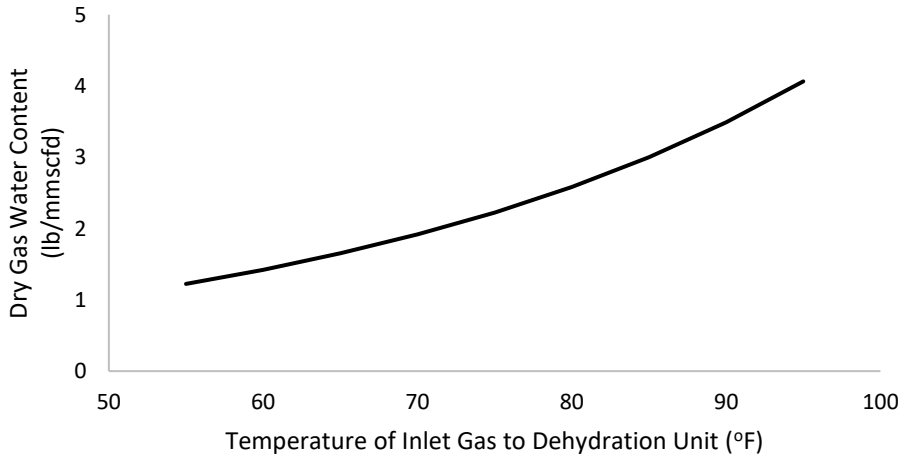
Figure 8: Effect of Inlet Temperature on the Dry Gas Water Content for 390 °F Reboiler and 6 scfm Stripping Gas

As expected, the trend shows lower dry gas water content at lower inlet gas temperatures [2]. By reducing the inlet gas temperature, the dry gas water content could be reduced well below the design limit. Based on the optimization study, the dehydration plant operating conditions were changed to the conditions summarized in Table 2.

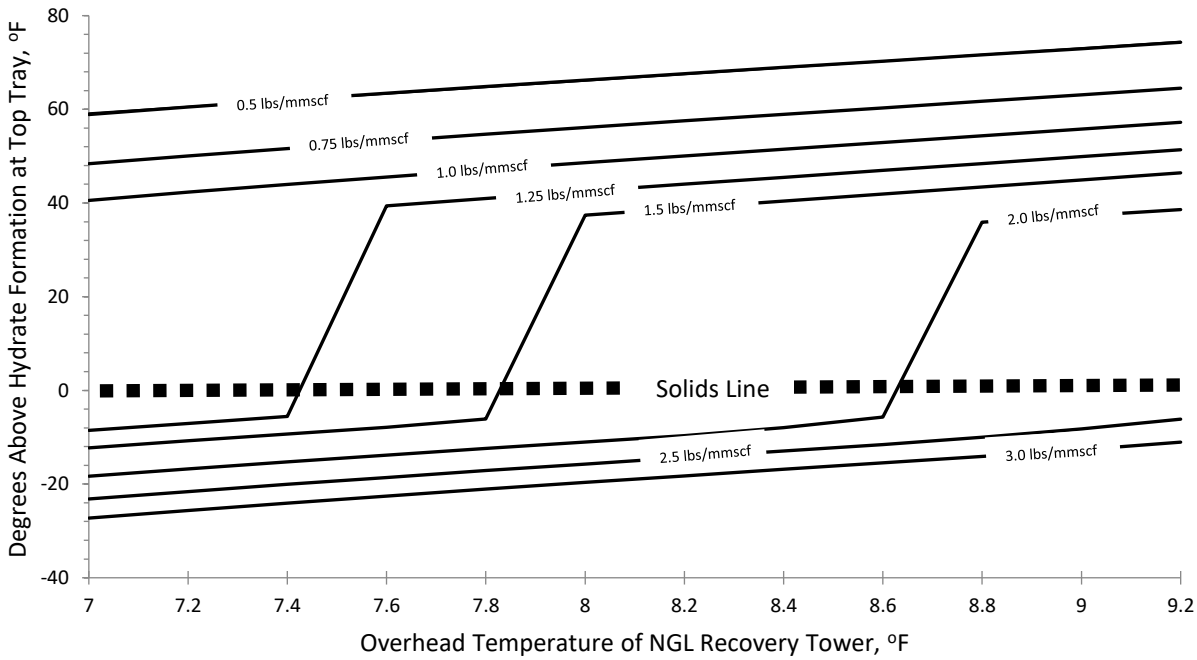
Figure 9: Operator Reference Guide to Avoid Hydrate Formation at Various Inlet Water Contents

While operating the dehydration unit at its optimum is important, operators need to know what temperature to operate the NGL distillation tower in order to mitigate the risk of hydrate formation. Figure 9 was created to give clear recommendations for operation of the tower temperatures at various inlet water contents. Although the margin is thin, Figure 9 shows operational flexibility.
