Accused product examinations

June-August 2023

Serendia, LLC
Exhibit 2088
Jeisys v. Serendia
IPR2024-00386
Ex. 2088-001

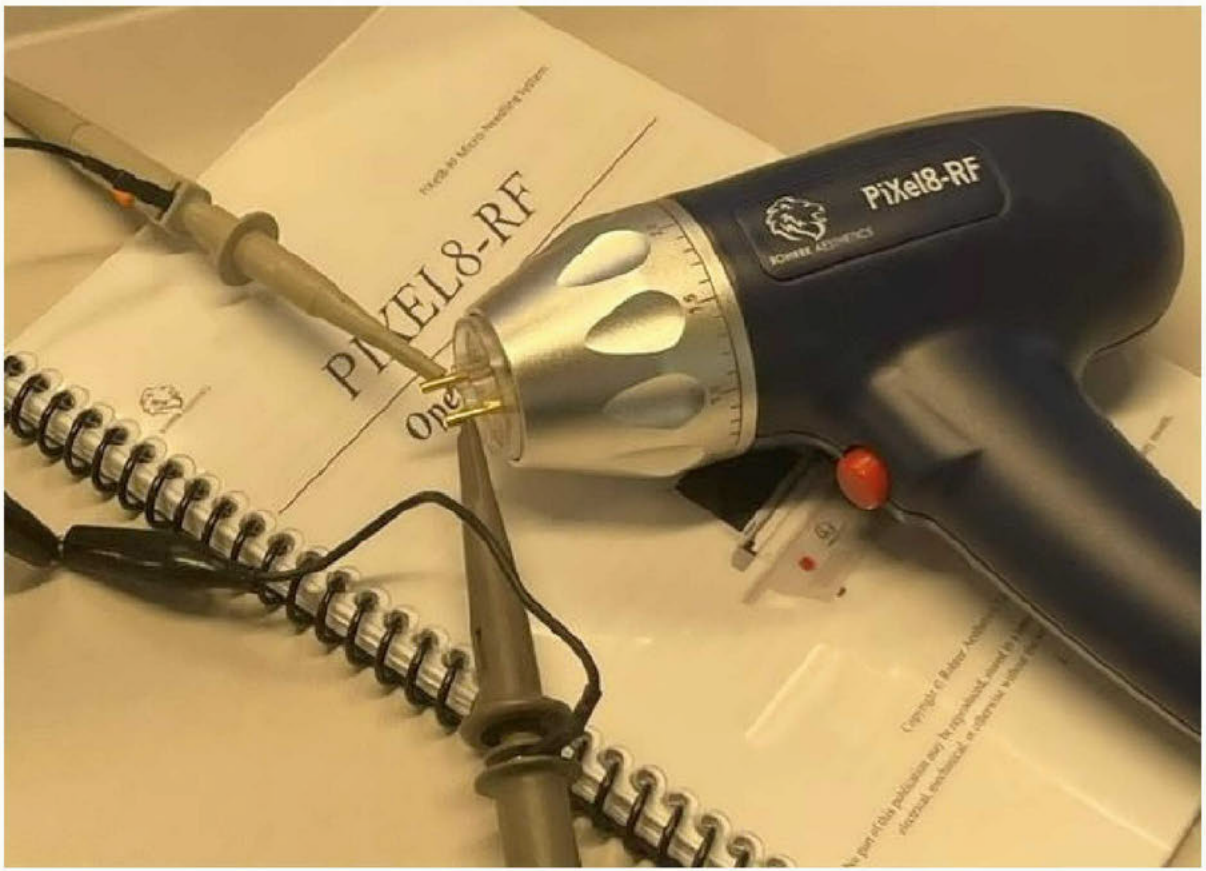
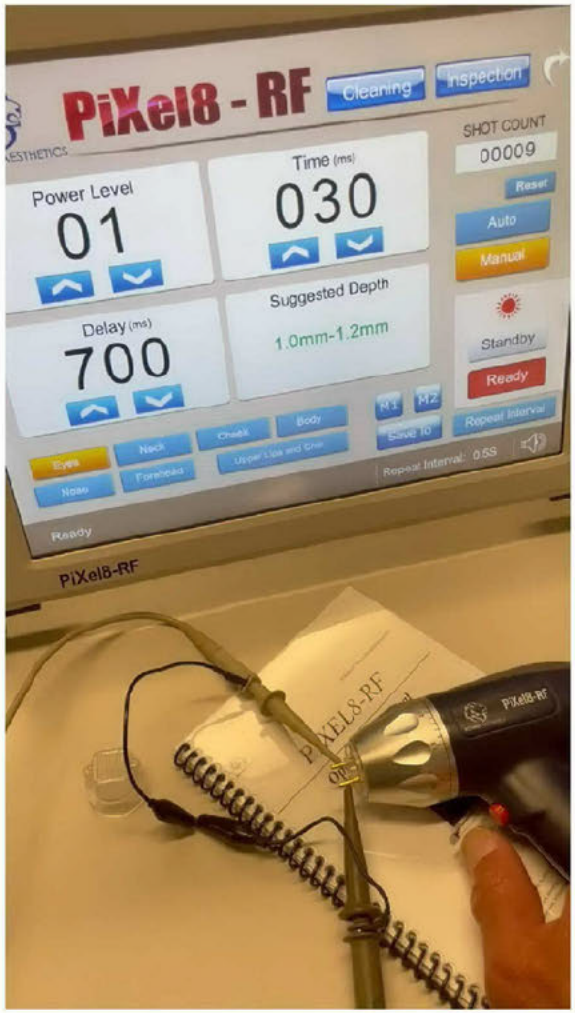
As shown on the following slide, the handpiece lacked an interlock, so I was able to simply probe both electrodes, one per channel. Above left is each channel and the sum waveform; above right is just the sum waveform.

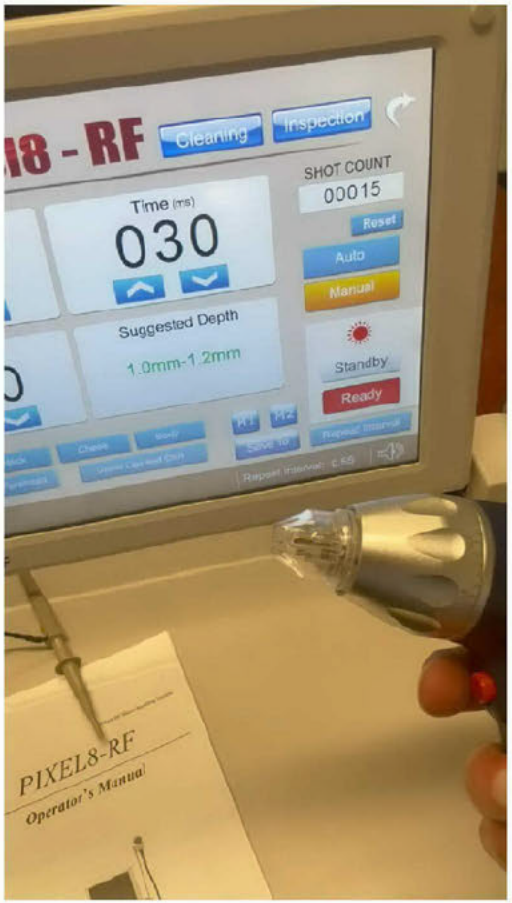
Lines of pins are all wired together, then they alternate conductivity. There was no ground pad, so RF current will only flow between lines of pins.
