## INSPECTION PROGRAM MISSION STATEMENT

# Annual Hydrant Inspection Procedures

© 2001 Capt. Willis Lamm, Water Supply Officer, Moraga-Orinda (CA) Fire District

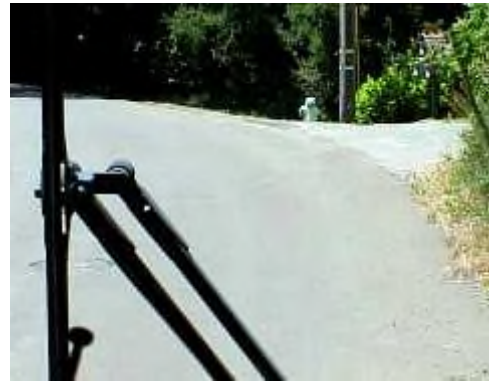
**Making note of the  
hydrant's location on approach**

The hydrant location actually witnessed in the field should match the address given on the checklist. The hydrant should also be plotted correctly on District maps. Occasionally new hydrants are not picked up by

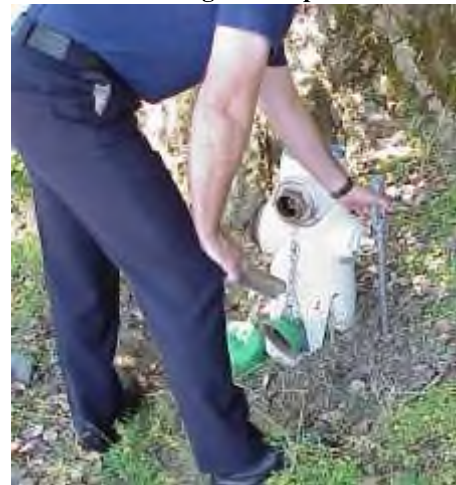
**Ground sloughoff prevents full turning of the spanner**

Crews should make minor corrections such as pruning and minor digging. More significant work such as heavy brush removal, significant digging, placing of retaining walls to prevent hillside soil sloughoff or the raising of bodies which are set too low should be referred for correction by submitting a repair request.

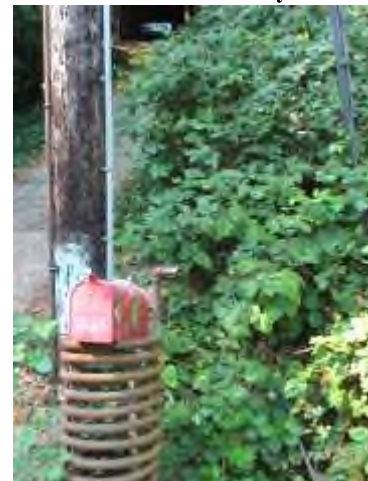
**There is a hydrant somewhere behind those blackberry bushes**

There should be no obstructions, including the ground, preventing easy coupling of hoses or turning of spanners. The hydrant should be visible from all approaches. There should be no brush or tree limbs that could interfere with anyone approaching the hydrant and attempting to connect to it or operate it.

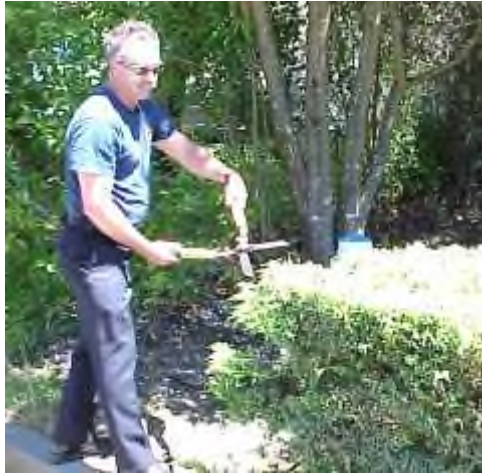
### Pruning back an encroaching hedge

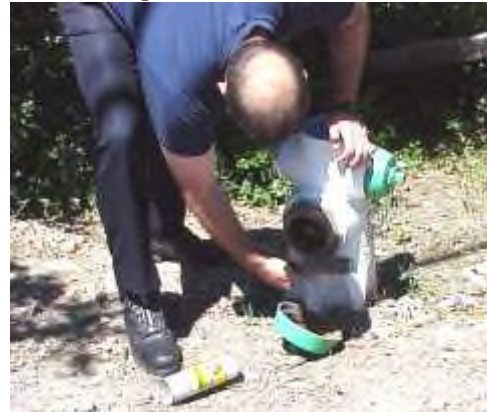
Cleaning threads with a wire brush

Crews should clean and lubricate threads and lubricate the chain race on the cap as needed. Missing caps should be replaced.

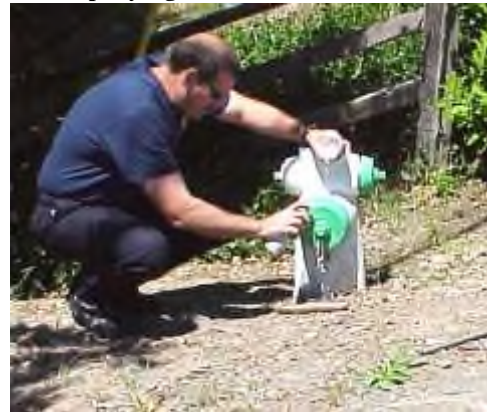
Spraying silicone on chain race

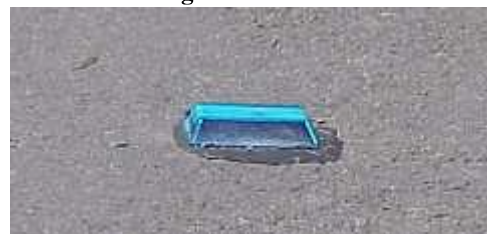
The blue reflector should be in good condition

The blue reflector should be relatively clean and reflective. At least 2/3 of its reflective surface should be intact and in good condition. Severely damaged or missing reflectors should be reported.

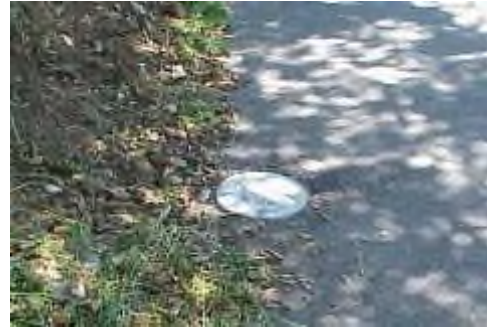
The street shutoff should be visible whether on the roadway or

**over on the shoulder**

The gate pot for the street shutoff valve should be accessible and readily discernible from water main zone valves. All hydrant gate pots should be painted white in order to be easily spotted under water if a hydrant gets knocked off. Any gate pots which cannot be located should be reported.

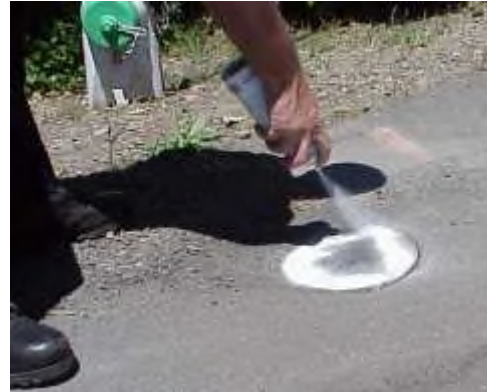
**Painting a gate pot which  
had been covered with "slurry seal"**
