## Deformation induced degradation of hot-dip aluminized steel

Hot-dip aluminizing  
Intermetallics  
Post-processing  
Aluminium  
Iron  
Deformation

In this work the fracture and corrosion behaviour of hot-dip aluminized steels is investigated in controlled dipping experiments which allowed to separately study the effects of Si in the Al bath (1–10 wt%) and the intermetallic phase thickness (5–30 µm). The addition of Si had no direct influence on the performance of the coating system for similar thickness values of the IMP seam, which in turn showed to be the dominant factor independent from the amount of Si. Thin intermetallic phase seams (< about 10 µm) exhibited more (about 5–10 per 100 µm interfacial length) but smaller cracks with a fishnet pattern on the outer Al-Si coating, which remained intact and interconnected until a tensile deformation of 15–20%. Thicker intermetallic phase seams resulted in less (about 2 per 100 µm interfacial length) but broader cracks perpendicular to the tensile direction, giving rise to a lamellar pattern on the Al-Si coating, which cracks and uncovers the steel already at strains below 10%, and readily flakes off leaving the steel substrate t

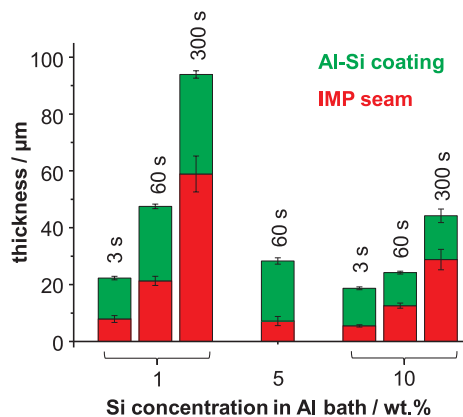
Fig. 1. Thickness of Al-Si coatings and the intermetallic phase seams (IMP) for different bath compositions and dipping times.

The hot-dip experiments were performed with a Rhesca hot-dip simulator 200-A. Steel substrates with a thickness of 0.9 mm of DC06 European grade, cut to plates of 100 mm by 200 mm, were dipped in Al baths containing 1, 5 and 10 wt% Si, respectively, at a temperature of 685 °C under a protective atmosphere of  $N_2 - 5\% H_2$  preventing the steel from oxidizing. Dipping times of 3, 60 and 300 s were applied. The thicknesses of both Al coating and IMP seam was measured by image analysis (ImageJ software) on SEM images (FEG-SEM Quanta-450). The resultant thickness values for the respective IMP seams and Al coatings are compiled in Fig. 1. The chosen HDA conditions allow for straightforward comparisons between samples of different Si concentrations and / or IMP thicknesses at similar thickness of the Al coatings. It should be noted that the growth-suppressive effect of Si is complex and

Three HDA conditions were selected in order to investigate the influence of Si on the mechanical performance, namely Al-1 wt% Si and 3 s dipping time, Al-5 wt% Si for 60 s and Al-10 wt% Si for 3 s, as the resultant IMP seams were of comparable thickness (between 5 and 8  $\mu m$ ; Fig. 1). All three HDA conditions showed similar behaviour under standard tensile loading conditions. As shown on selected samples in Fig. 3, a fishnet-like pattern can be observed on OM images of the coating surface 45° with respect to the tensile direction after about 10%

The influence of the IMP thickness was evaluated on steel dipped into Al – 10 wt% Si (the most relevant bath composition from an industrial point of view) for 3, 60 and 300 s. These HDA conditions resulted in similar Al-Si coating thicknesses of about 10–15  $\mu\text{m}$ , but varied the thickness of the IMP seam from about 5 to about 30  $\mu\text{m}$  (Fig. 1). Samples with thinner IMP seams, i.e. those dipped for 3 and 60 s, showed a behaviour as those samples described in the previous chapter, i.e. a fishnet-like pattern on the coated surface and small, mostly perpendicular cracks within the IMP seam (Fig. 3). The sample dipped for 300 s, however, behaved differently. As shown in Fig. 5, after about 10% tensile strain (on standard tensile samples) lines perpendicular to the tensile direction appear, and the much thicker IMP seam ( $> 20 \mu\text{m}$ ) shows less (about 2 cracks per 100  $\mu\text{m}$  interfacial length) but broader perpendicular cracks, as well as horizontal ones. Investigations on micro-tensile specimens revealed a critical local strain (i.e. where the coating fails and the steel is exposed to the atmosphere) of less than 15%. With further increasing nominal strain the coating was observed to flake off the steel substrate to a growing extent, exposing it at mm wide areas. Samples dipped into Al – 1 wt% Si for 60 and 300 s had comparable IMP seam thicknesses (Fig. 1) and behaved similarly than those dipped into Al – 10 wt% Si for 300 s, but less flaking of wide areas of coating due the enhanced ductility of the coating with less Si.

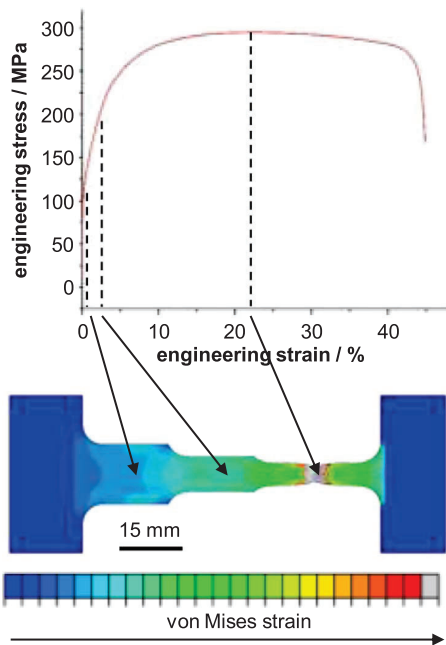
Fig. 2. Example of a stress/strain curve (standard geometry, steel dipped in Al – 10 wt% 10 for 3 s) and FEM calculation result of the three-gauge geometry for corrosion experiments after mechanical pre-deformation.

- Standard tensile testing was performed with a hydraulic testing machine Instron 8511 on specimens according to DIN 50125 E with gauge dimensions of 30 mm length and 8 mm width. The stress and strain levels were approximated by the concepts of engineering stress and strain (i.e. dividing force by initial area and dividing displacement by the initial gauge length, respectively), and the outer surface was observed after the tests by optical microscopy (OM; Keyence digital microscope VHX-5000). All samples showed similar macro-mechanical behaviour, with approximate values of 110 MPa yield stress, 290 MPa ultimate tensile stress, 20% uniform and 40% total elongation. Samples with thicker IMP seams (Fig. 1) generally showed reduced uniform and total elongations.

- In order to efficiently investigate the corrosion protection of different coatings affected by varying degrees of mechanical pre-deformation, tensile samples with three gauge sections of identical length (15 mm each) but different width were designed. Based on the data obtained from the standard tensile data, finite element analysis (FEM) for the associated von Mises stress fields was performed using the commercial solver Abaqus/Standard, an isotropic elastic-plastic law and a Young's modulus of 215.623 GPa on a mesh of 33513 linear hexahedral elements of type C3D8R, and 42 linear wedge elements of type C3D6. As shown in Fig. 2, a sample with three separate gauge widths of 15, 9 and 6 mm, respectively, was derived. These dimensions translate to about 100 MPa (i.e. in the elastic region), about 190 MPa (i.e. low plastic strain) and about 290 MPa (i.e. large plastic strains close to necking) at a load of about 1500 N and 6.5 mm crosshead displacement, applied in the hydraulic testing machine Instron 8511 at  $5 \mu m s^{-1}$ . After the tensile pre-deformation the specimens were subjected to corrosion tests in a salt spray chamber under a constant fog according to the ASTM B117 standard (5 wt% NaCl in water, 35 °C, 100% humidity, up to 300 h). The cut-edges of the samples were painted with an epoxy paint to prevent their corrosion in order to study the effects of the pre-deformed coatings only.

Results of more detailed investigations on the damage initiation and progress with increasing tensile strain, performed on micro tensile samples, are compiled in Fig. 4, exemplified on steel dipped for 3 s into Al – 1 wt% Si. Cracks start to form in the IMP seam (about 5–10 per 100  $\mu\text{m}$  interfacial length) perpendicular to the tensile direction at strains below 15% (the limit for reliable strain measurements of the applied DIC setup), covered by a 'bridge' of the Al-based coating. These cracks broaden with increasing strain and horizontal cracks (parallel to the interface with Al-coating and steel substrate) start to appear in the IMP seam. The perpendicular cracks in the IMP widen to about 5–10  $\mu\text{m}$  with increasing strain, and from about 15% elongation the Al coating covering them ruptures (in a ductile manner). Even though the steel is far from mechanical failure at these strain levels (Fig. 2), it is now in

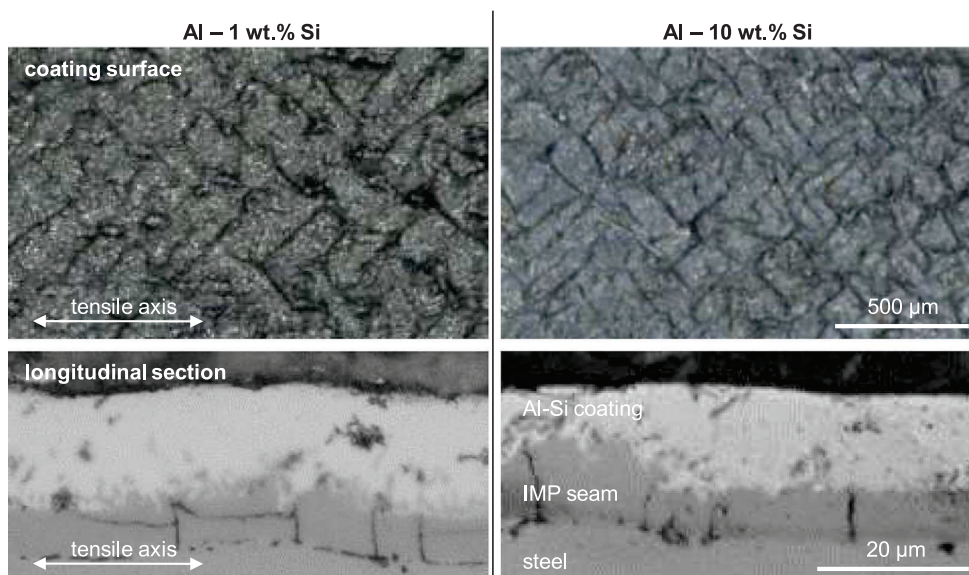
Fig. 3. Optical microscopy characterization results of samples dipped for 3 s and strained to about 10% elongation.

engineering strain, as well as small cracks in the IMP seam.

The Si concentration alone did not have a significant impact on the micromechanical and corresponding corrosion behaviour of the investigated HDA coated steels (Figs. 3 and 6). While Si turned out to slightly embrittle the Al-Si coating, no pronounced influence on the damage evolution was detected (Fig. 4). Significant differences in failure mechanism and critical deformation levels, however, could be observed depending on the thickness of the IMP seam, which was in turn related to the Si content and dipping time (Figs. 1, 5 and 6). The observed different failure patterns in the Al-Si coating ( $45^\circ$  fishnet w.r.t. the tensile direction for thinner IMPs,  $90^\circ$  rectangular and larger cracks for thicker IMP seams) and the underlying failure initiation and progressing mechanisms may be rationalised by the schematic sketch shown in Fig. 7. At the top the theoretically expected deformation behaviour of the separate components of an HDA steel sheet (steel substrate, IMP seam and Al-Si coating) under tension are shown. The

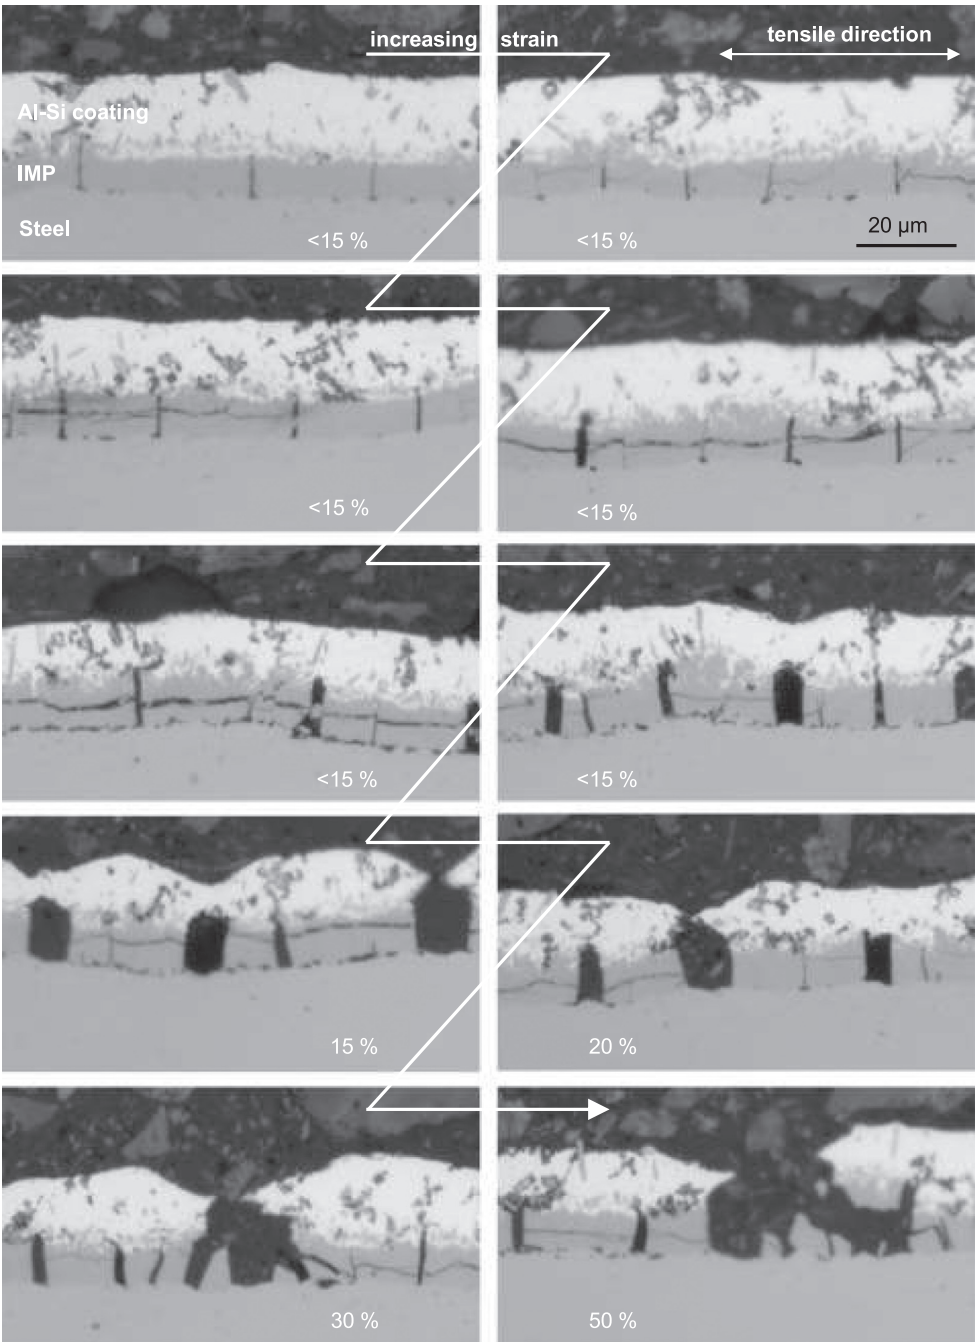
Fig. 4. Damage evolution with increasing local strain (micro-tensile geometry) in longitudinal sections of a sample dipped into Al – 1 wt% Si for 3 s.

direct contact with the surrounding atmosphere and thus potential corrosion, oxidation or decarburisation phenomena (see Section 3.3). No difference could be observed between the three HDA conditions with regards to the basic sequence of damage initiation and progress, as well for the micro-mechanical behaviour of the different IMP phases (all similarly brittle). The critical local strain (i.e. where the coating ruptures and its protection for the steel substrate expires), however, decreases with increasing Si content (from about 20% for Al – 1 wt% Si to 15% or less for 5 and 10 wt% Si), illustrating the Si-induced embrittlement of the Al-coating "bridges" covering the IMP cracks.

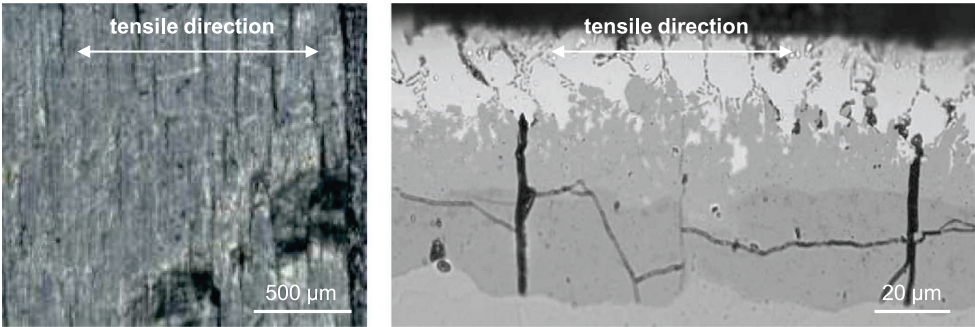
Fig. 5. Optical microscopy characterization results of a sample dipped into Al – 10 wt% Si for 300 s and strained to about 10% elongation (left: coating surface, right: longitudinal section).

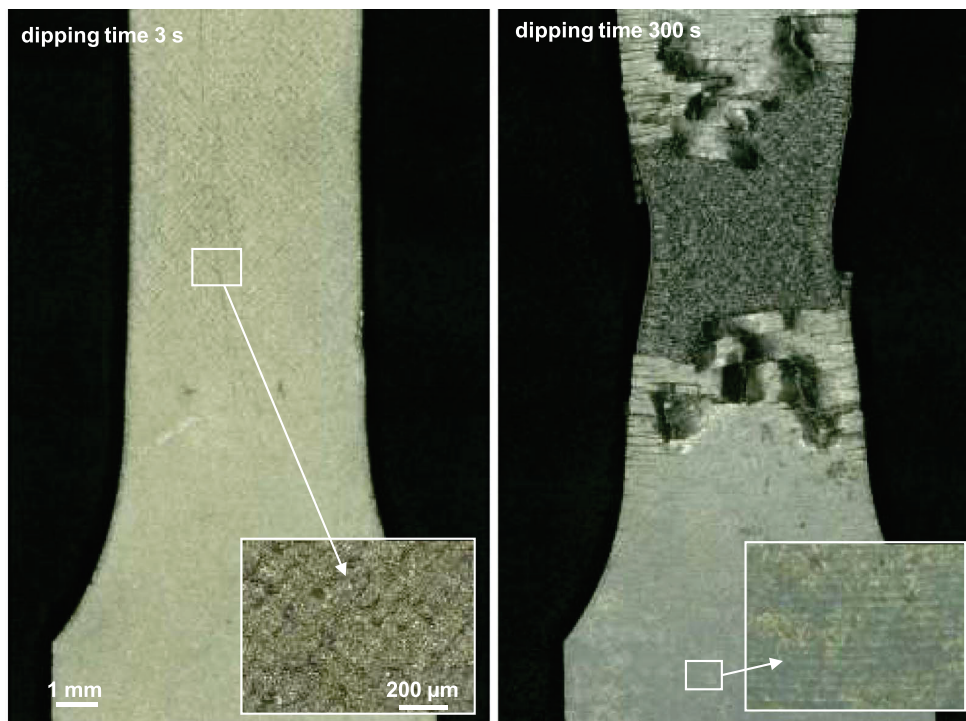
Fig. 6. Surface damage visualized by optical microscopy characterization results of steel samples dipped into Al – 10 wt% Si for different times and corresponding IMP thicknesses. Shown are the thinnest gauge sections of three-gauge samples after mechanical loading prior to the corrosion experiments.

After the mechanical pre-deformation, the specimens from the first three HDA conditions – all with comparatively thin IMP seams – exhibited the previously observed fishnet-like pattern in the medium and thin gauge sections (i.e. those with low and high plastic strain), but no flaking of the coating could be observed (Fig. 6 left) even after severe pre-deformation. Despite the fact that the Al-Si coatings from these three HDA conditions are criss-crossed by crevices leaving the steel substrate exposed, red rust could only be observed at the thinnest gauge section after 300 h exposure within the harsh chloridic environment. The Al-Si coatings are able to protect the steel as its  $\text{Al}_2\text{O}_3$  surface layer is affected at high chloride environments and leaves Al available to sacrifice itself [23], and rusting appears from the moment at which the coating is consumed.

The much thicker IMP seam of the sample dipped for 300 s, however, caused the coating to flake off in the highest strain gauge section (Fig. 6; right), and started to show red rust already after 2 h of salt-spray testing. The lesser strained gauge sections exhibited lamellar fracture patterns and a similar corrosion behaviour than the samples with thinner IMP seams.

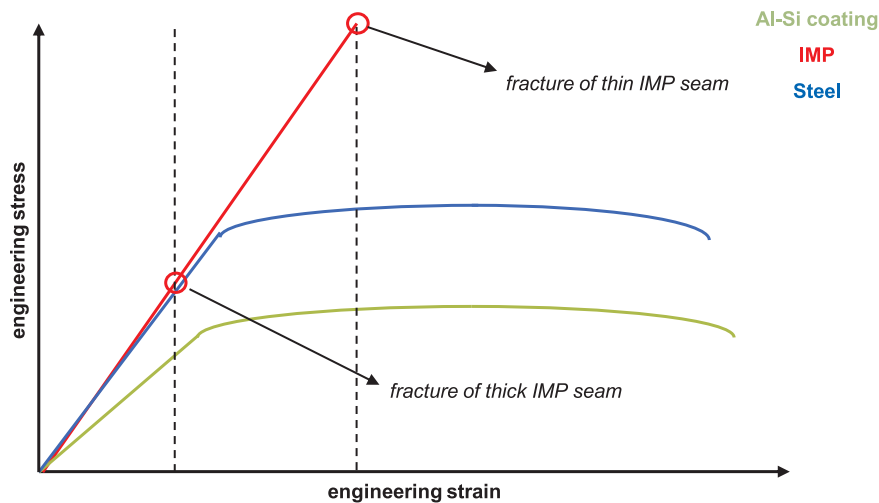
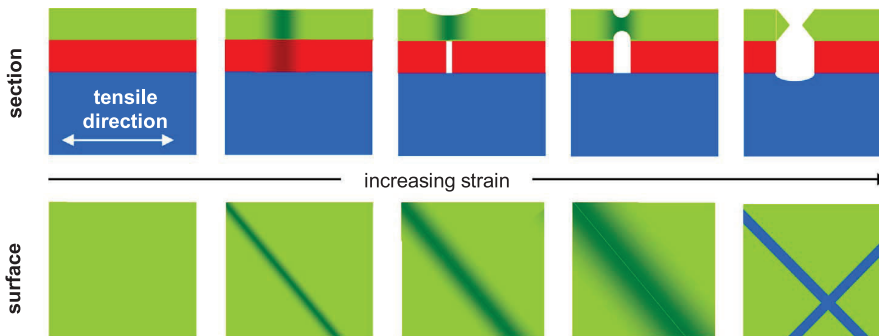
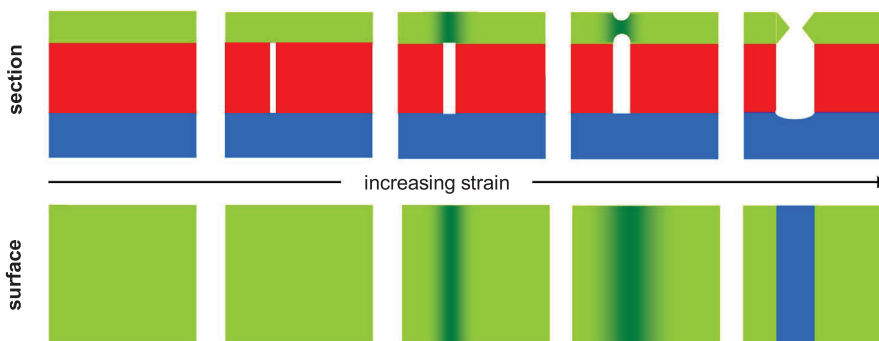
Fig. 7. Sketch of the micromechanical mechanism causing the differing behaviour between hot-dipped aluminized steels with thin and thick intermetallic phase seams (IMP).

**Thin IMP seam** (high Si concentration in Al, short dipping times, low temperatures)

**Thick IMP seam** (low Si concentration in Al, long dipping times, high temperatures)

Young's modulus of the Al based coating can be expected to be only a third of that of DC06 steel (about 70 GPa vs. 210 GPa), while the intermetallic layer has a Young's modulus similar to steel [20]. The consequences are illustrated in the bottom rows of damage evolution schemes. While intermetallic phases are brittle irrespective of their thickness, thicker IMP seams are expected to start cracking at lower strains than thinner ones, with a critical thickness of about 3–10  $\mu\text{m}$  [7]. Thus, the Al coating may already deform plastically before thin IMP seams (obtained after higher Si concentrations and short dipping times) start to crack. As the more ductile Al-Si coating will deform by ductile shear ( $45^\circ$  to tensile axis), correspondingly formed shear bands may concentrate stress and thus be the initiation point for IMP cracking, thereby imprinting the deformation pattern of the coating on the IMP seam.

On the other hand, thicker intermetallics (here above about 10  $\mu\text{m}$ ) start to crack at lower global strain levels, i.e. before the Al coating could undergo significant (plastic) deformation, and fracture will occur similar to a brittle material under normal tension (i.e.  $90^\circ$  to the tensile direction). As these cracks widen, they concentrate stress at the ductile but soft Al layer, and, at sufficiently high strain levels, cause the remaining coating 'bridges' to fail at the original locations of the first IMP cracks in a lamellar pattern. While these cracks (in a lamellar or angled arrangement) left the steel substrate open for contact with a potentially corrosive environment, they were apparently thin enough to not affect the protective performance of the coatings unduly in the salt-spray experiments conducted in this study (i.e. leaving sufficient amount of Al relative to the crack size to be sacrificially consumed). This should not apply though for oxidation and decarburisation phenomena as during annealing in a hot stamping operation. Our study thus highlights the importance of obtaining regular and thin IMP seams (via appropriate Si additions and short dipping times) in combination with ductile Al-based coatings, as well as the adaption of forming operations and post-processing parameters to maximise the effect of HDA coated steel.
