WRDC-TR-89-4138

## X-RAY COMPUTED TOMOGRAPHY OF CASTINGS

Interim Report for Period April 1989 - September 1989

MATERIALS LABORATORY  
WRIGHT RESEARCH AND DEVELOPMENT CENTER  
AIR FORCE SYSTEMS COMMAND  
WRIGHT-PATTERSON AIR FORCE BASE, OH 45433-6533

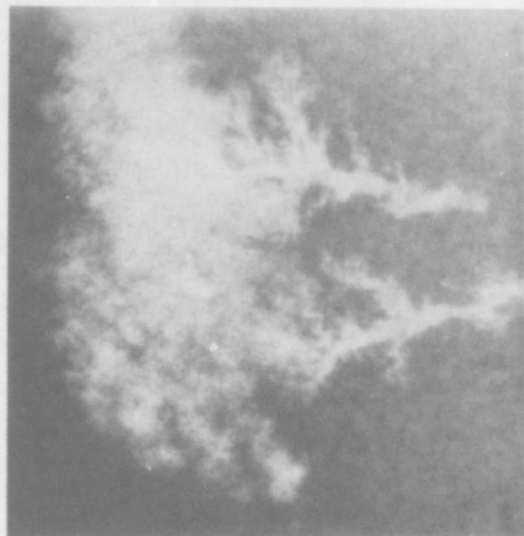
Figure 3.1-4 PID #132, dendritic (feather ) shrinkage

An example of large shrinkage was found in a sample aluminum casting. The area was excised to form a 170 x 100 x 25 mm (6.7 x 3.9 x 1 inch) slab-like section (PID #132), as shown in Figure 3.1-4(a). The flaws, assigned ASTM F6 - F8 shrinkage, consist of two dendritic (or feathery) shrinkage patterns as shown in the radiograph in Figure 3.1-4 (b). A DR taken on System I is shown in Figure 3.1-4(c). A CT scan normal to the surface, taken on System B, is shown in Figure 3.1-4(d). The CT slice was effective in providing flaw depth and distribution information which is unavailable in the RT or DR images.
