# Final Report:

## Vehicle Infrastructure Integration

### Proof of Concept

### Results and Findings

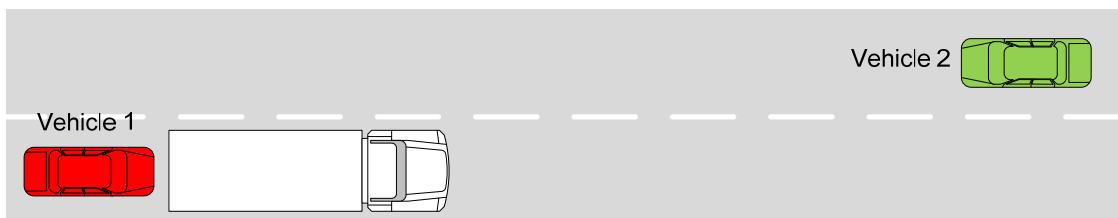
**Figure 4-36 Test HB-2 Setup**

The goal of this test was to evaluate the behavior of Heartbeat message exchange between two approaching vehicles in the presence of occluding vehicles (in this case a large truck). As illustrated in Figure 4-36, the two vehicles were driven past each other in opposite directions at 50 mph, and one vehicle was traveling behind the truck. The Heartbeat message transmission and reception at each vehicle was logged and the data was subsequently analyzed. The road segment used for this test was the same as that used in Test HB-1.
